Winnebago Industries, Inc. submits the following report pursuant to Part 573 of the NHTSA regulations. The numbered paragraphs below correspond to those found at Part 573.6(c).

SUBJECT: Campaign #101 - Sightseer® and Sunova® Range Cabinet Partition

INSTRUCTIONS TO PERFORM CAMPAIGN 101 RANGE CABINET PARTITION

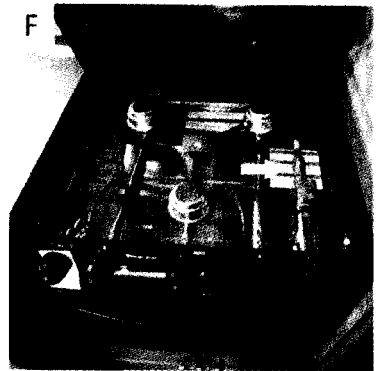
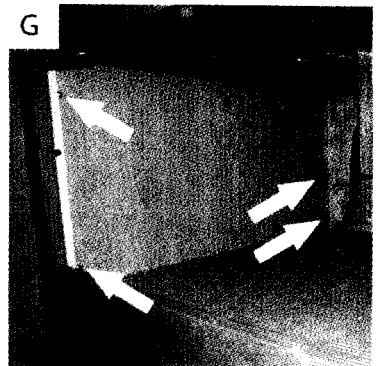
4. Cut a panel to the size of 21 1/4" x 16 5/8" (541mm x 422mm)
5. Install the panel to stickwork along left side of the cabinet with the #10 screws (shown in photo G). Assure that there are no gaps that will allow air exchange.
6. If you have a stovetop only model, reinstall the drawer assembly and the drawers. If you have the stovetop with oven model, reinstall the oven and drawer.
7. If the propane supply line has been disconnected, perform a propane gas leak test.
