2006-1-12 1:29  
#  
DEFECT INVESTIGATION

06V-2912  
(9 pages)

**SUBJECT: Campaign #102 – Range/Furnace Cabinet Panel**

## INSTRUCTIONS TO PERFORM CAMPAIGN 102 RANGE/FURNACE CABINET PANEL

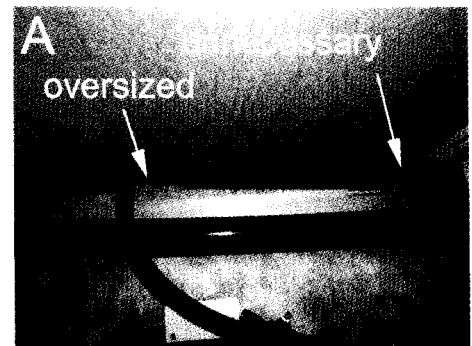
1. If you have a stovetop only model, open the door below the stovetop. If you have a stove with oven model, remove the drawer beneath the oven.
2. Inspect for unnecessary and oversized holes (Photo A). Unnecessary holes need to be covered and holes in use need to be reduced to a size no greater than 2" x 2".
3. For the stove with oven models, you will need to remove the appliance.
  - a. Turn off the main propane supply at the tank.
  - b. Lift top of stove.
  - c. Remove the stove mounting fasteners (2 screws each on left and right sides) and then disconnect the gas supply line from the burner regulator. (Photo B)
  - d. Lift out from cabinet and set aside.

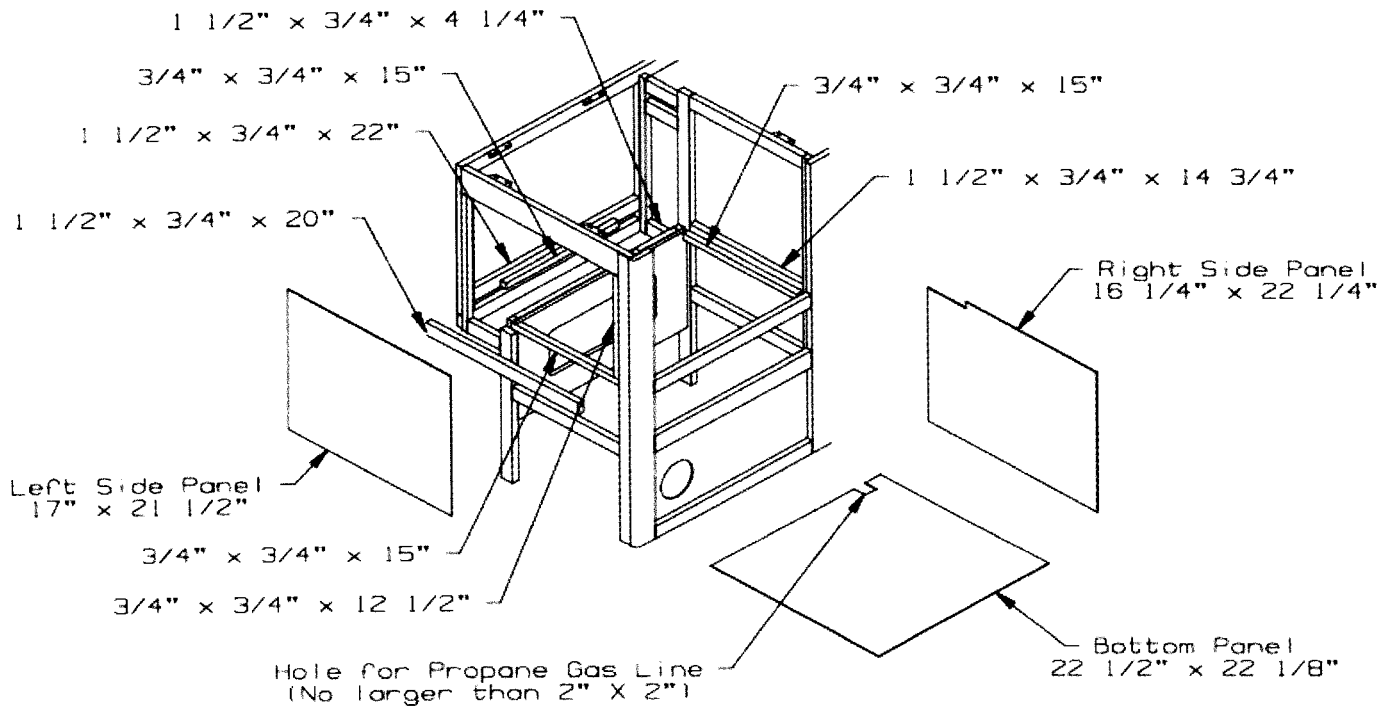
### Diagram G

**Sizes are approximate. Measure your cabinet to ensure correct fit.**

- i. Attach (4) 1 1/2" x 3/4" lumber sticks to the cabinet as shown in Diagram G.
- ii. Attach (4) 3/4" x 3/4" lumber sticks to support the new panels as shown in Diagram G.

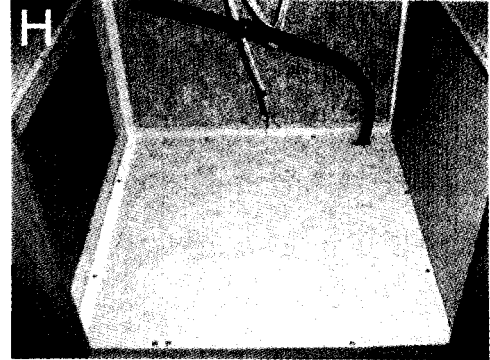
- iii. Cut and install the new panels to the new and existing stickwork (Photo H). Leave a hole no larger than 2" x 2" for the propane gas line in the bottom panel.
- d. Reinstall the oven brackets and oven.
- e. Perform a propane gas leak test.

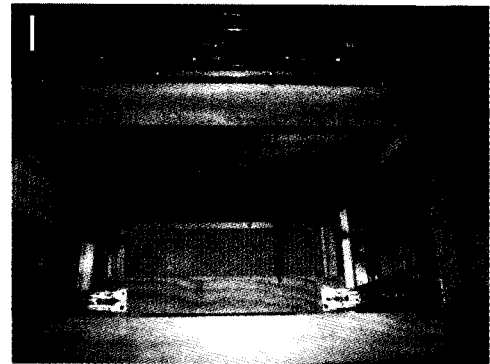
- a. Cut a piece of paneling to cover the opening below the stovetop, leaving a hole for the propane gas line.
- b. Position the panel and screw sticks below to keep the panel in place (Photo I).
