Safety Defect and Noncompliance Report Guide for Vehicles
PART 573 Defect and Noncompliance Responsibility and Reports¹

On November 20, 2006, 2006, Nu Wa Industries Inc.
[MFR] decided that (a defect which could arguably relate to motor vehicle safety) may exist in the motor vehicles listed below, and is furnishing notification to the National Highway Traffic Safety Administration in accordance with 49 CFR Part 573 Defect and Noncompliance Responsibility and Reports.

GLIDE RIDE PIN PLATE REPLACEMENT

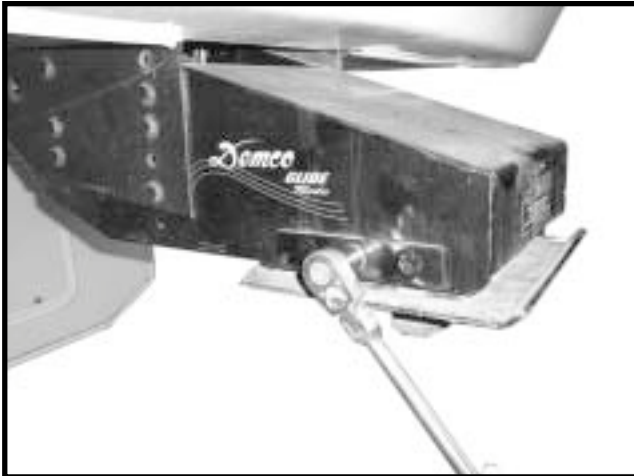
1. Remove 1/2" bolt from pin plate using 3/4" wrench or socket. **NOTE: Replace one side at a time to prevent skid assembly from falling out.**

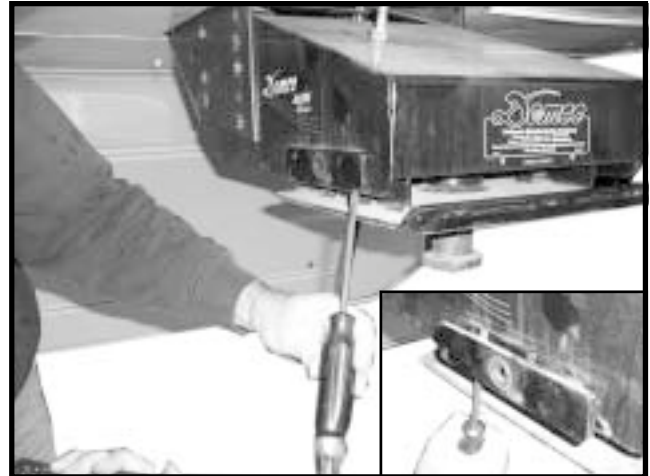
2. Using a flat screw driver or thin chisel and hammer, tap between pin plate and Glide Ride box on bottom to get pin plate started out. Pry pin plate out by going from side to side by the 1" pin until pin plate can be totally removed.

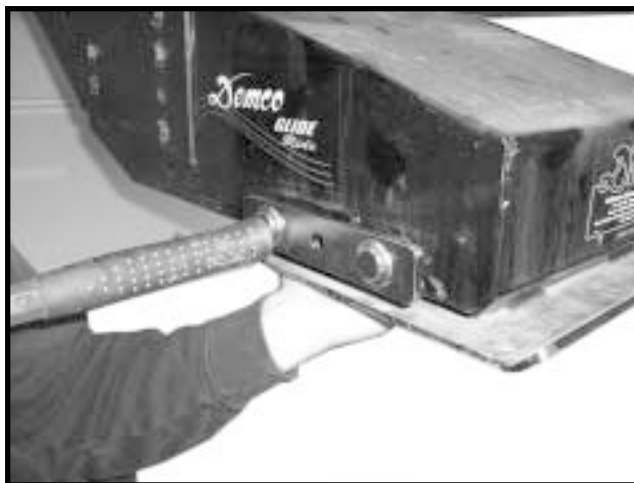
3. Install the new yellow plated pin plate where old one was previously removed. Note: Inner skid assembly may have fallen down slightly when pin was removed. This assembly may have to be pushed up to get pin plated aligned with inside links.

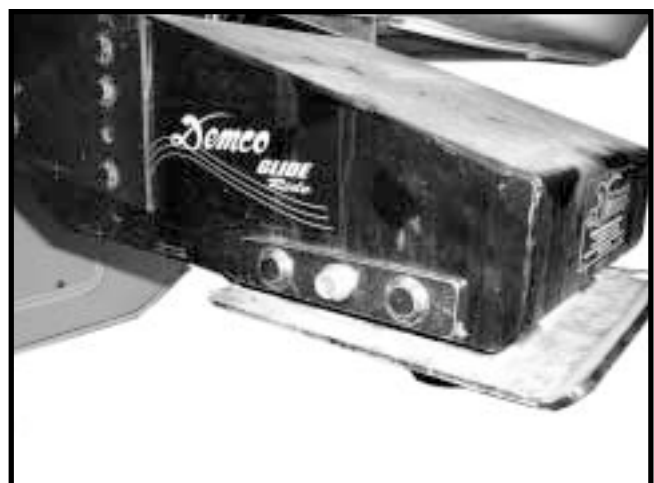
4. Tap pin plate tight against Glide Ride box and reinstall previously removed 1/2" bolt and tighten to 85 ft-lbs.

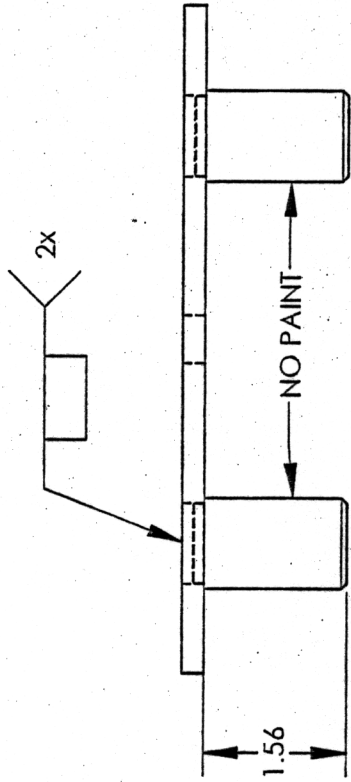
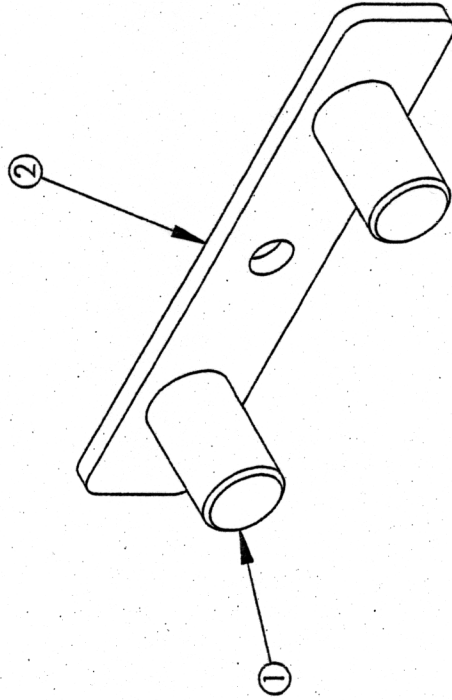
Demco drawing 11941 attached.

On a removable pin box manufactured with the name of Demco Glide Ride two metal parts welded together can fail. The parts called a fifth wheel glider pin and the pin plate form part of the mechanism that attaches the pin box to the king pin.

The method of attachment, a plug weld, used to connect the fifth wheel glider pin and pin plate in some circumstances does not support the load stress.

Cracking in the powder coat paint around any of the four glide pins would indicate that the welds are failing.

ITEM	PART #	DESCRIPTION	Default/QT Y.
1	64126	FIFTH WHEEL GLIDER PIN	2
2	64127	PIN PLATE	1

Replace the two pin plates, one per side, on each pin box with pin plates that have more robust welds around the pin and plate. The replacement pin plates will be a different color for visible identification of inspected and repaired pin boxes.

On the remedy assembly, the fifth wheel glider pin will extend beyond the pin plate side exposing a greater surface for the weld. The plug weld technique as used on the recall assemblies will no longer be used.
