**Gulf Stream Coach Incorporated**  
**503 South Oakland Avenue**  
**Nappanee, Indiana 46550**

**06V-435**  
**(12 pages)**

**573.6 (c) (5) – Description of the Noncompliance**

Title: Fuel Tank Retaining Bracket Installation	ID: VA 58.4.09.0273	Page: 2 of 2
Approved by: First Page Only	Effective date:	Rev. 0 Draft

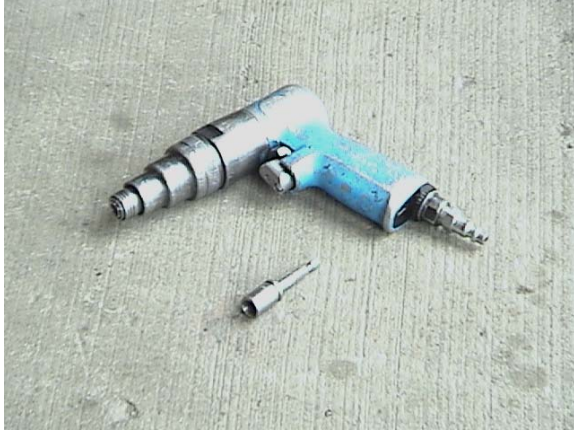
<p>✂ Tools required: 3/8" socket, screw gun.</p>
2

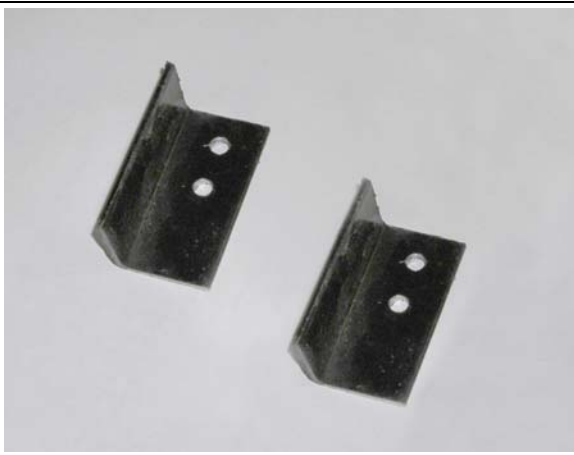
<p>✂ Obtain the two retaining brackets and #14 X 1" hex head drill point screws from the provided kit (kit #49C197).</p>
3

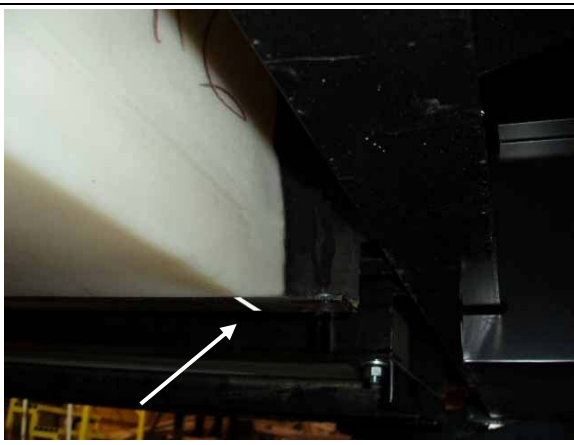
<p>✂ On the non-fill end of the fuel tank, place a mark on the fuel tank brace flush with the end of the fuel tank.</p>
4

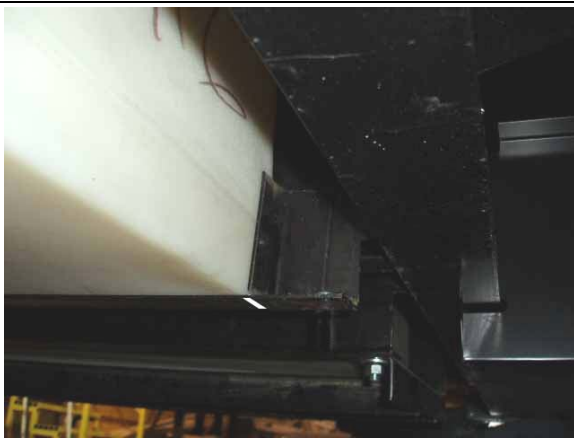
<p>✂ Line up one of the retaining brackets with the line made in Step 3 on the fuel tank brace, as shown to the left.</p> <p>! The retaining bracket must be:</p> <ul style="list-style-type: none"> <li>• Flush with the mark</li> <li>• And flush with the fuel tank's bottom edge.</li> </ul>

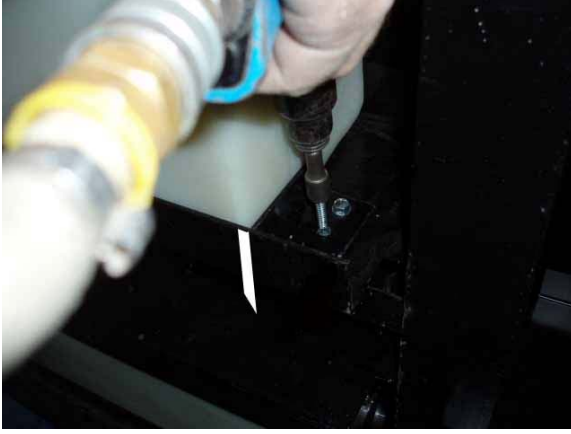
<p>⚙️ If needed, slide the gas tank away from the mark for extra work space.</p> <p>🔧 Install a fastener through each of the predrilled holes into the fuel tank brace in accordance with Step 4.</p>
6

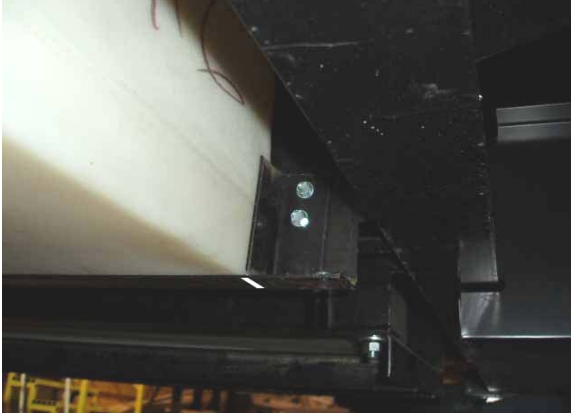
<p>! Ensure the retaining bracket looks like the picture shown to the left.</p>
7

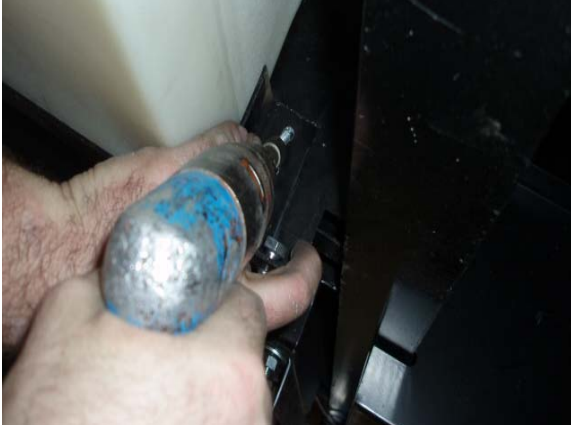
<p>🔧 On the fill end of the fuel tank, slide the fuel tank flush against the retaining bracket installed in Step 5.</p> <p>🔧 Using the remaining two fasteners, install the second retaining bracket at the opposite corner of the fuel tank flush against the fuel tank and flush with the fuel tank's bottom edge.</p>

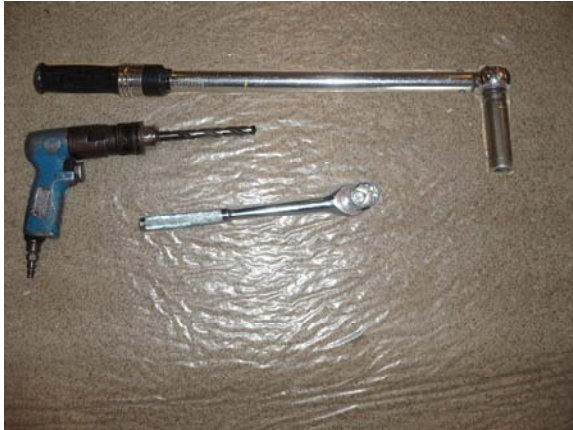
<p>✂ Tools required: 9/16" socket (2), 3/8" drill bit, drill, ratchet wrench, torque wrench.</p>
2

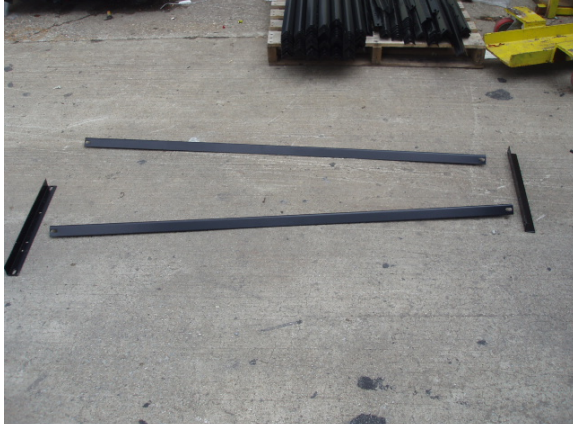
<p>✂ Obtain the gas tank support angles and the assembly fasteners from the provided kit (kit #49C198).</p> <p>! All bolts used in this process are 3/8 x 1" in size and need to be torqued to 30 ft lbs.</p>
3

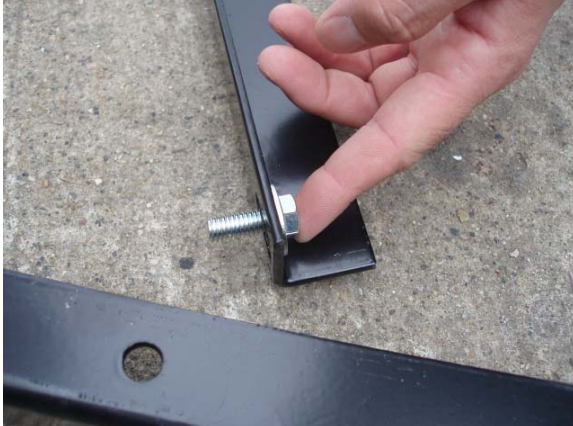
<p>✂ On one of the long angles, place a flat washer over the end of a bolt and insert the bolt through the hole, in the direction shown.</p>
4

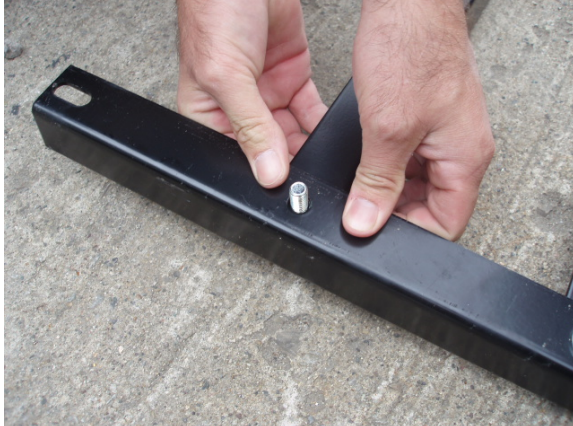
<p>✂ Insert the bolt through the bottom of the short angle's hole with the frame angles aligned as shown.</p>

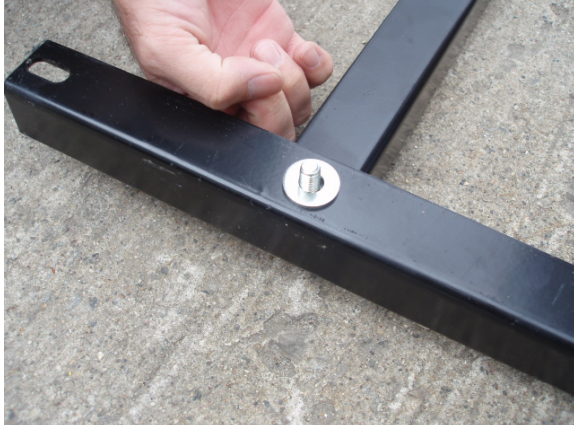
<p>✘ Place a flat washer over the bolt.</p>
6

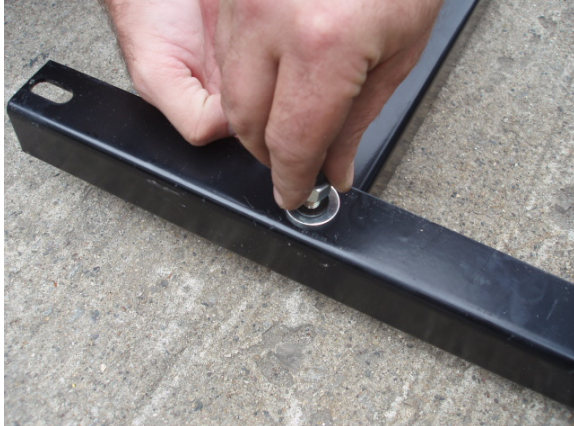
<p>✘ Place a lock washer over the top of the flat washer.</p> <p>✘ Hand tighten a nut onto the bolt.</p>
7

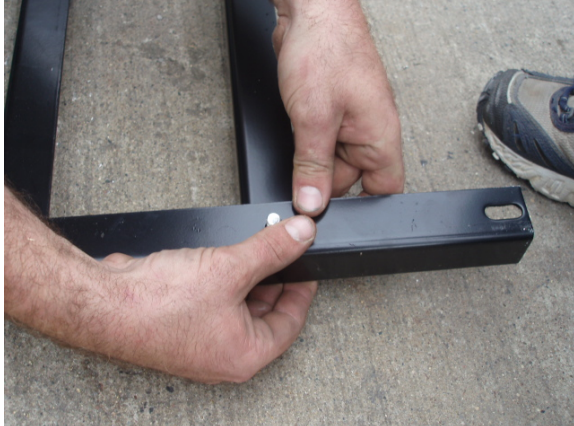
<p>✘ Repeat Steps 3 through 6 for the other end of the short angles and then for the opposite end of the long angles.</p>
8

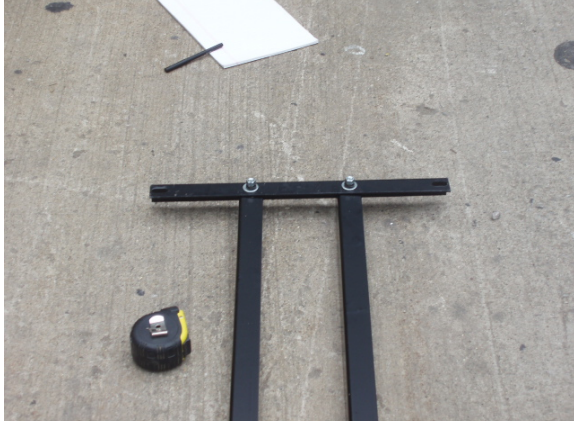
<p>✘ While ensuring the long angle pieces are perpendicular to the short angle pieces, tighten each of the 4 nuts on the support assembly to 30 ft lbs using a torque wrench and a ratchet.</p>

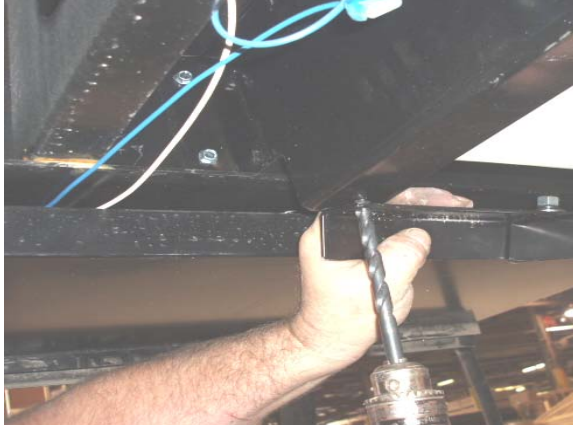
<p>✘ Line up the edge of the support assembly with the edge of the fuel braces and clamp it in place.</p>
10

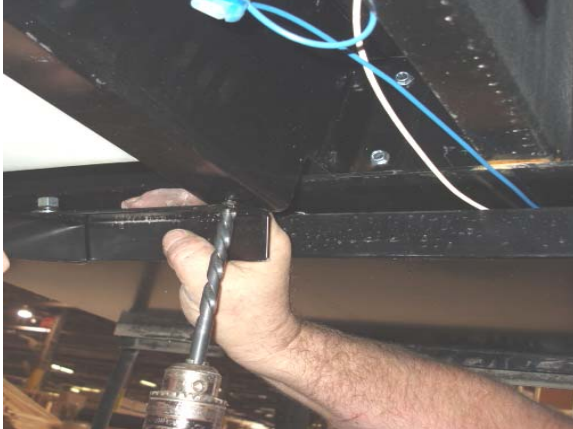
<p>✘ Using the holes in the support assembly as guides, drill through the existing fuel tank braces (4 places) with a 3/8" diameter drill bit.</p> <p>! When drilling the holes, the fuel tank must be positioned away from the drill bit's path.</p>
11

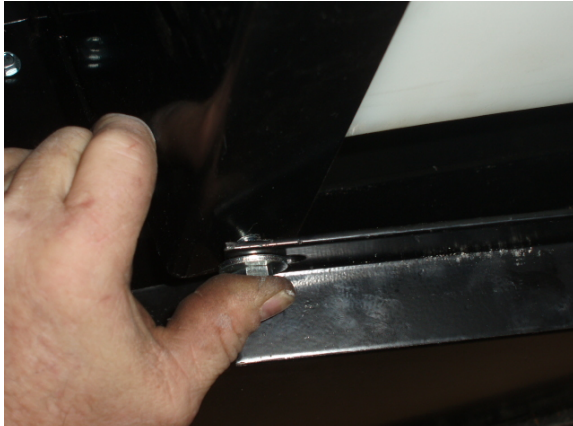
<p>✘ Place a flat washer over the end of a bolt and insert the bolt up through one of the holes drilled in Step 10.</p>
12

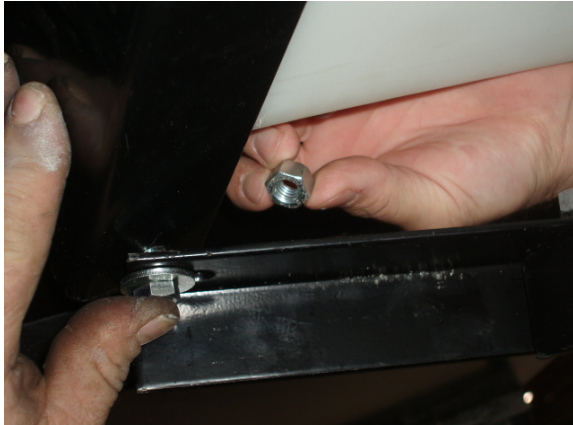
<p>✘ Place a flat washer over the end of the bolt.</p> <p>✘ Place a lock washer on top of the flat washer.</p> <p>✘ Hand tighten a nut onto the bolt.</p>

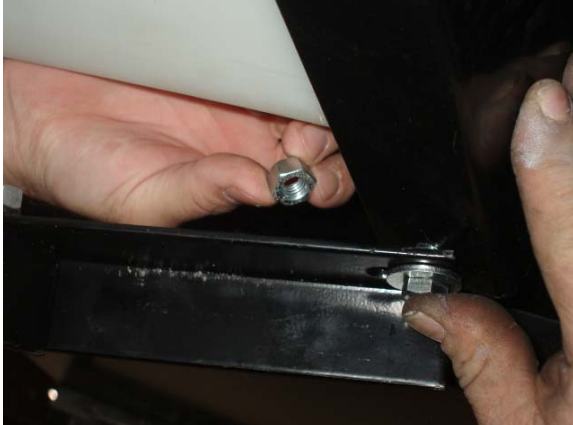
<ul style="list-style-type: none"> <li>✘ Repeat Steps 11 and 12 for the remaining holes on the tank support.</li> <li>✘ Remove any clamps or blocks used to hold the support assembly in place.</li> </ul>
14

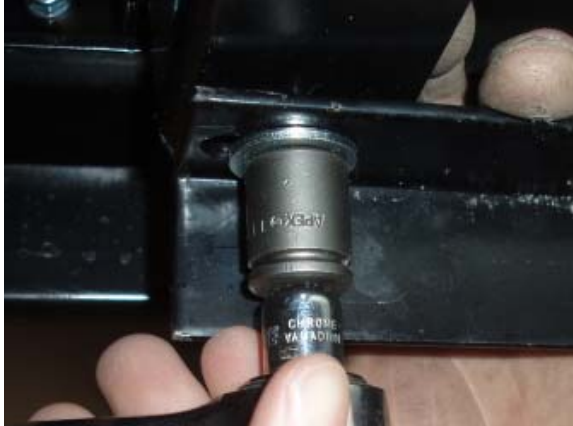
<ul style="list-style-type: none"> <li>✘ Using the torque wrench and a 9/16" socket, tighten the nuts securing the fuel tank support assembly to the fuel tank brace to 30 ft lbs.</li> </ul>
15

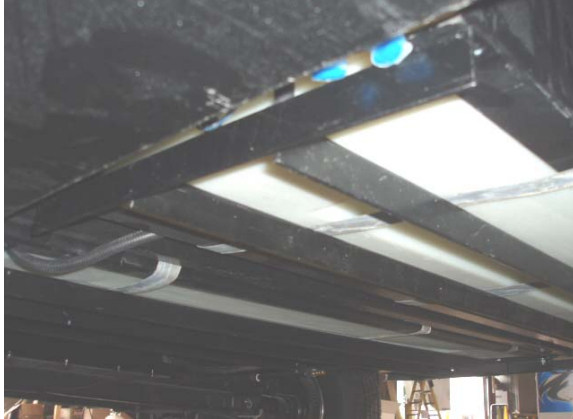
<ul style="list-style-type: none"> <li>💡 The completed installation should resemble the picture shown to the left.</li> </ul>
