Glaval bus has decided that a defect which relates to motor vehicle safety exists in certain glaval buses built between September 1<sup>st</sup>, 2005 and January 31<sup>st</sup>, 2006. The 4" long T-Nut used to secure seats equipped with belts may fail in the event of a crash, potentially resulting in injury to the passenger.

## Identify Parts

## Procedure For Replacement

06V-071

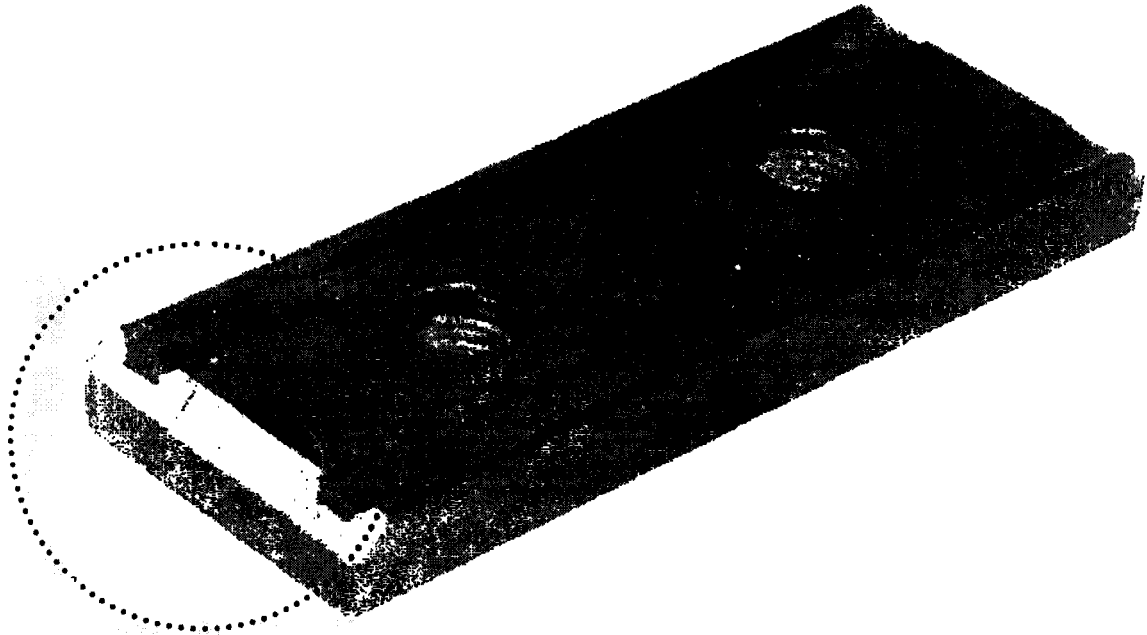
The 4" long T-Nut can be found in the floor track at the rear of a seat leg. The leg will need to be unbolted to visibly verify chamfer.

The picture above shows the correct part with the 1/8" chamfered ends. If the parts have little or no chamfer (pictured below) you will need to order the replacement parts.

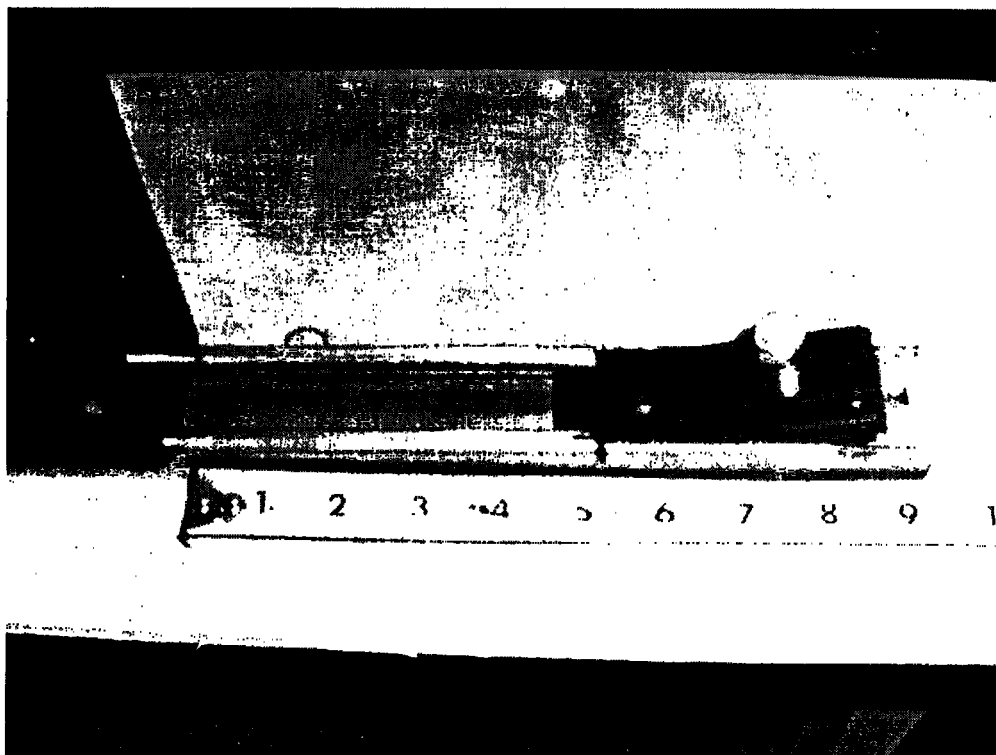
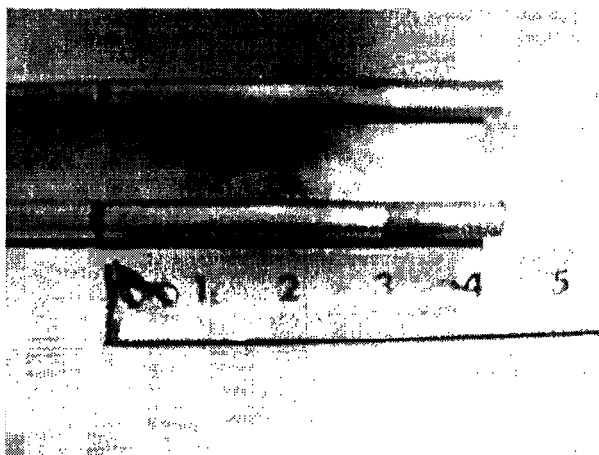
Unbolt seat legs from the floor track and set bolts and washers aside. Unbolting other seat components is not necessary. In order to remove the T-Nuts, the flanges from the top of the track must be cut. The approved location for this cut is a minimum of 5" in front of a seat leg, or 5" behind a seat leg. This is measured from the point of contact between the leg and the track. The cut needs to be 4" in length, preferably at the very front, or rear of the track. (Not in between seats) One cut per track section is sufficient.

Cut 4" of top flange off of seat track.
