IC Corporation

NON-COMPLIANCE RECALL 06507

The configuration of the mounting bracket for the 39 inch track mounted CE White child safety seat does not provide sufficient strength to meet the requirements of FMVSS 210 if seat belts are attached.

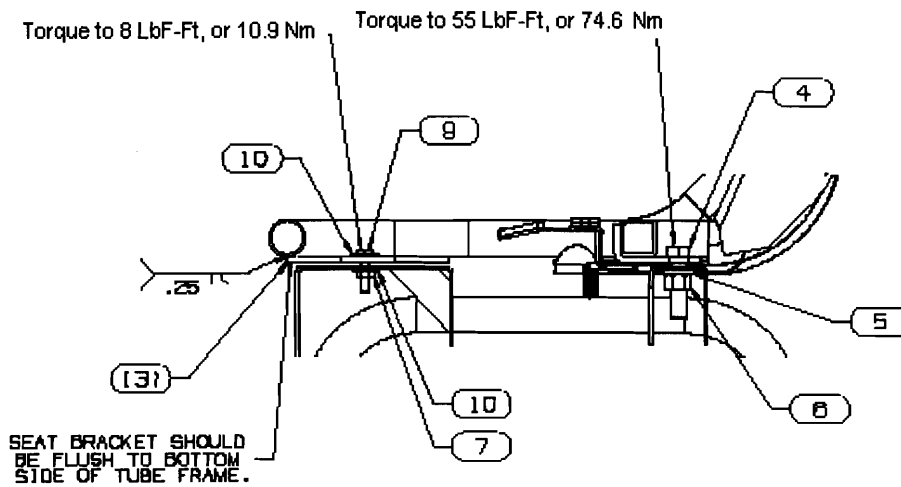
Figure 4-Section B-B

SCALE 1:2

6. Verify dimensional locations of the bracket. After verifying that the bracket is located correctly, complete the welding process as shown in section B-B. The weld should consist of a .25" bead along the outside edge of the bracket and seat frame. A weld blanket should be used to protect the seat back and seat belts.

9. Prime and paint welded area. Prime and paint surrounding areas as needed.
10. Install new legs provided with the kit. See Figure 1, Section B-B, and section C-C.
