IC Corporation

SAFETY RECALL 06512

February, 2007

There are four issues that may exist for the National Seat ABTS (All Belts To Seat) driver's seat that this recall will remedy.

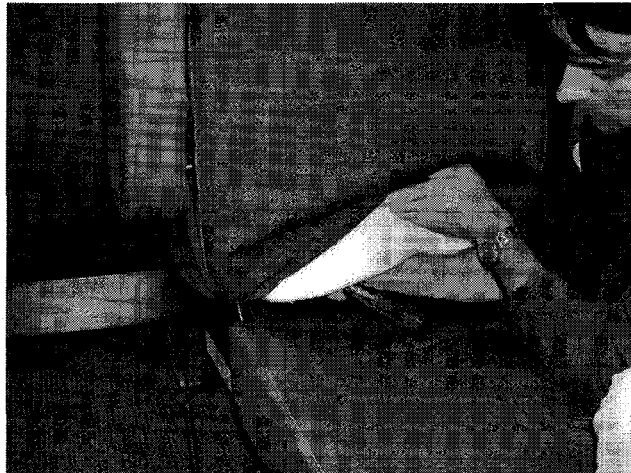
1. Arrange the steering wheel and seat to allow access to rear of upper seat back, on driver's seat (seat should be in forward and upright position).
2. Remove any items stored behind the driver's seat.
3. Remove inside seat arm.
 - a. Access the armrest tube underneath the foam and seat cover, as shown in FIGURE 2.

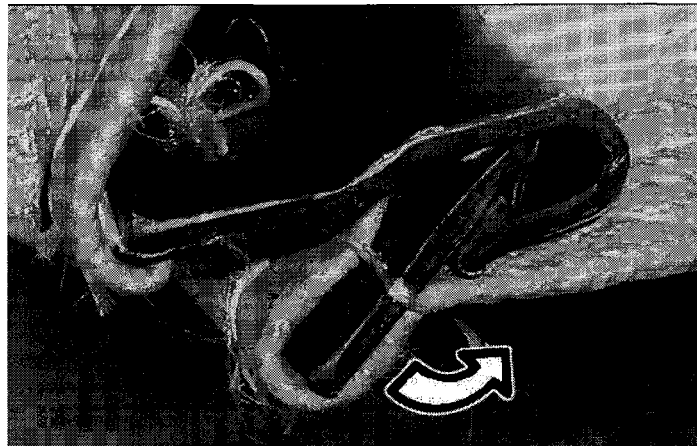
4. Partially remove cover from upper seat back.
 - a. Front flap of cover is clipped to back flap of cover at bottom of seat back. The clip piece attached to the front flap must be pulled forward (rotated) to disconnect it from the clip piece attached to the back flap. See FIGURE 5.
 - b. Starting at the bottom, roll the cover up one or two rolls; then, grasping the rolled material, slip the cover upward until the upper left corner of the seat back is exposed. See FIGURES 6 & 7.

FIGURE 5. Two Piece Clip for Seat Back Cover (Rotate to Disengage)

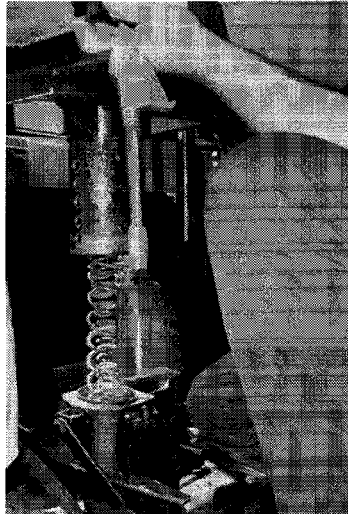
NOTE: The following step is a two person operation. While one person lowers the seat assembly, the other person must guide the seat assembly to insure that the springs, cylinders, and up-stop mechanism are correctly aligned. See FIGURE 17.

11. Assemble the seat by lowering the seat assembly onto the lower seat base. Once the base components are correctly aligned, raise (disengage) the seat height lever

and push down on the seat. When the seat reaches its top position, release the lever to engage the seat height locking pin. Step 11 is not required if proceeding to complete Repair Procedure 3.

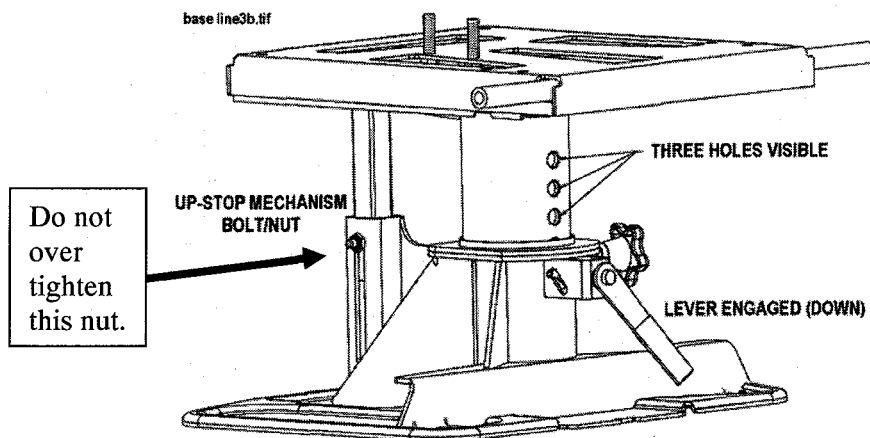
12. Verify that the seat is in its top position (3 holes visible in seat base cylinder). See FIGURE 18. If the seat is equipped with an up-stop mechanism, install the limiting bolt and nut that were removed at the beginning of this procedure. The limiting bolt will prevent the seat from being raised beyond its top position. Do not over tighten the nut, or the seat will not move up and down. Step 12 is not required if proceeding to complete Repair Procedure 3.
13. Leaving the seat in its top position, connect the seat-to-floor tethers and adjust them to a tight condition. Step 13 is not required if proceeding to complete Repair Procedure 3.

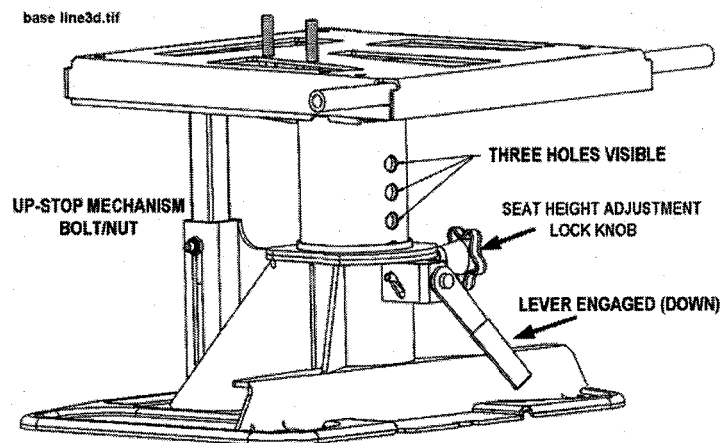
1. Disconnect any seat-to-floor tethers by unbolting them from the seat. **DO NOT** unbolt the tethers from the vehicle floor. If continuing from Repair Procedure 2, this step should already be complete.
2. If seat is equipped with an up-stop mechanism, remove the limiting bolt and nut. See FIGURE 19. Retain this hardware for use during assembly. If continuing from Repair Procedure 2, this step should already be complete.
3. Loosen the seat height adjustment lock knob enough to allow seat height adjustment. If continuing from Repair Procedure 2, this step should already be complete.

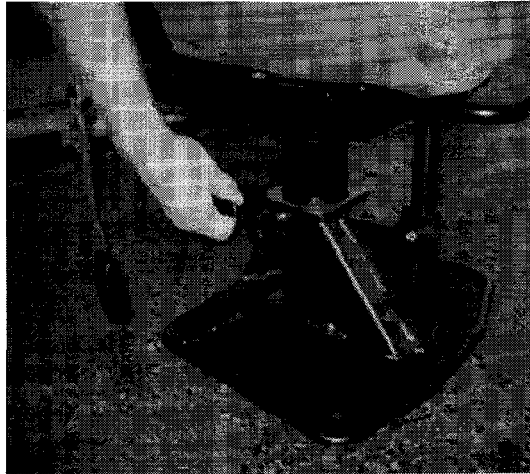
Before Completing Repair 4, inspect the seat in order to determine if it has an up-stop mechanism. If your bus has this mechanism, Repair Procedure 4 will not have to be completed. See FIGURE 26.

Up-stop
mechanism
(Vertical slot
with bolt and
nut)
