SAFETY RECALL RVXX0601 FEBRUARY 2006

Volvo Trucks North America has decided that a defect which relates to motor vehicle safety exists in certain Volvo VHD, VNL, and VNM model vehicles manufactured with a Volvo D12 Engine from November 2002 through January 2006. These vehicles may be subject to a safety issue in the event that an Exhaust Gas Recirculation ("EGR") Cooler Pipe becomes damaged or loose.

INSPECTION INSTRUCTIONS

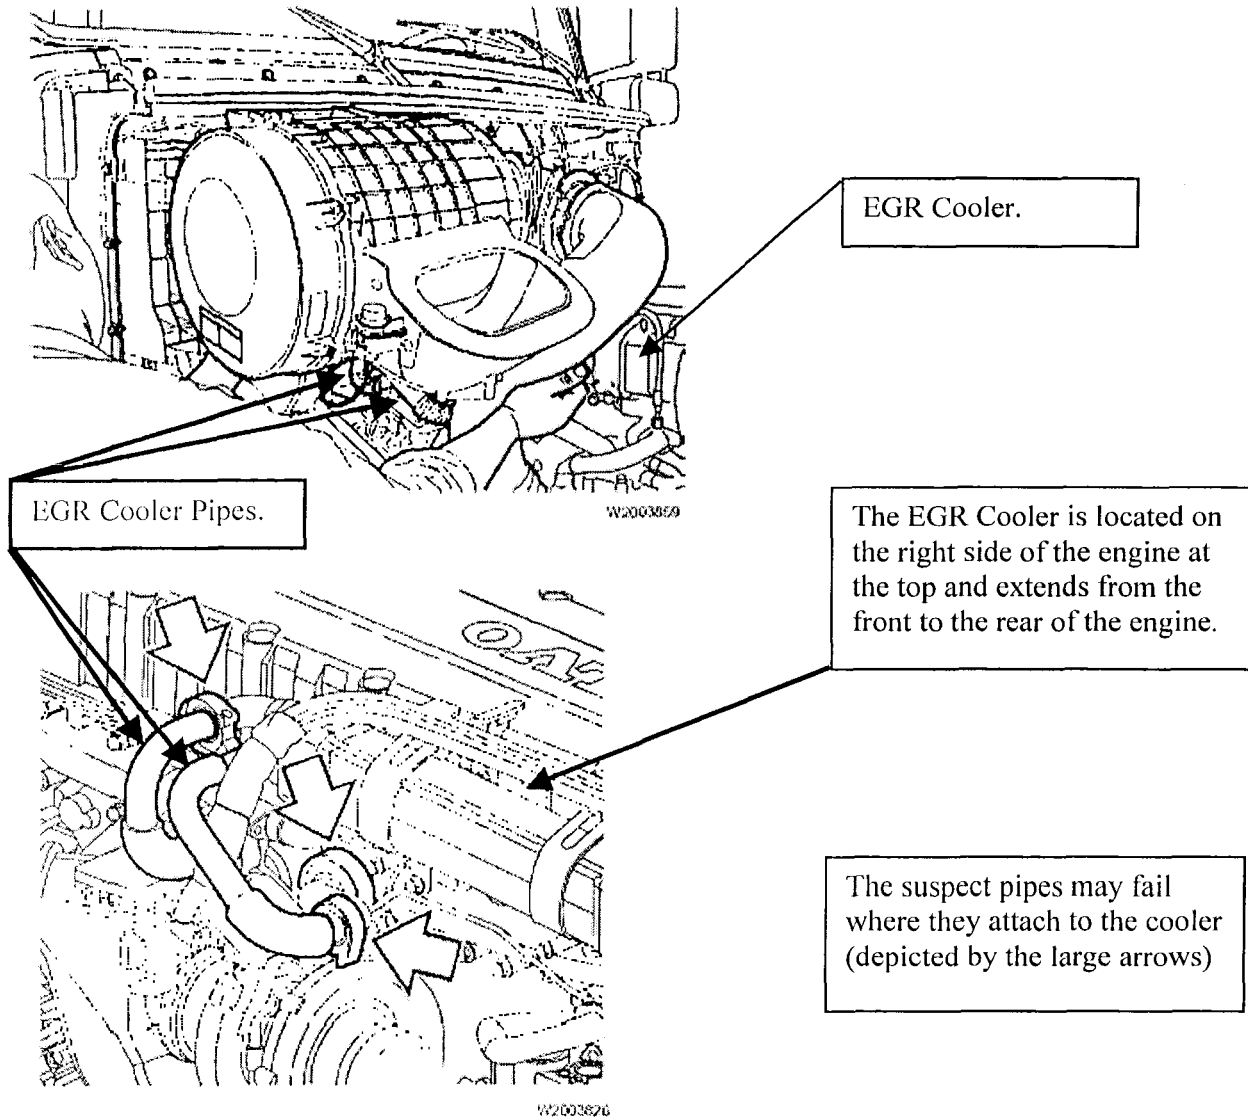
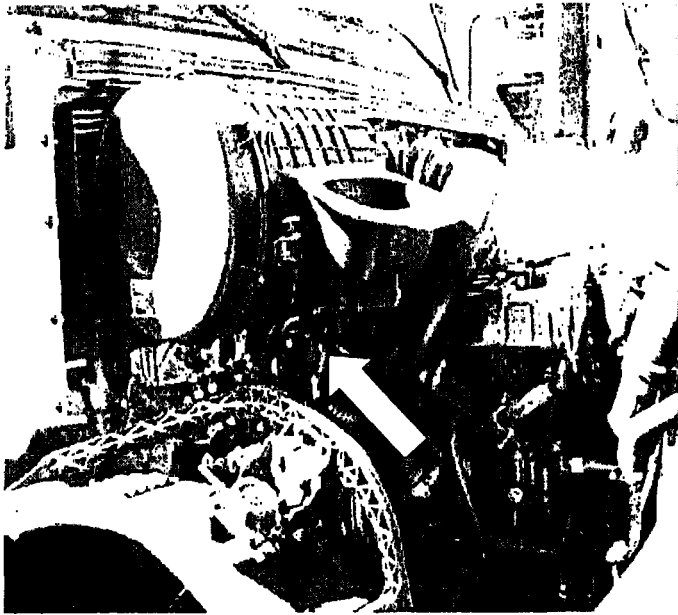
The EGR Cooler Pipes are located under the hood on the upper right side (passenger side) of the engine and can be seen by looking under the air cleaner at the rear of the engine. The following images/pictures show the EGR Cooler pipes and the inspection locations:

Arrows depict EGR Cooler Pipes
