**Subject: Recall Campaign M8 (06V-043)
2006 Model Year New Beetle Equipped with 17-inch Wheels
and a 2.5L Engine
Install New Tire Information Label**

**Subject: Compliance Recall M8
2006 Model Year Volkswagen New Beetle Vehicles Equipped with 17-Inch Wheels
and a 2.5L Engine
Install New Tire Information Label**

Compliance Recall Circular

Label Installation Instructions

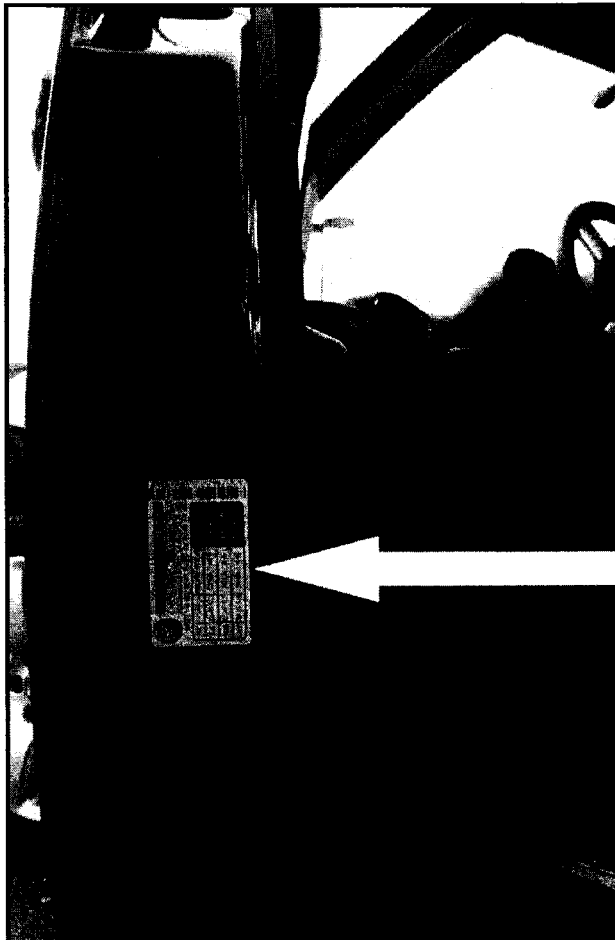
- Open driver's side door
- ⇐ Locate existing TIRE AND LOADING INFORMATION label –arrow–
- Thoroughly clean present label with soap and water and dry completely
- ⇐ Remove backing from new TIRE AND LOADING INFORMATION label and affix over existing label
- Ensure that no bubbles appear under new label
- Close driver's side door

Set the parking brake fully. Move the selector lever to P (Park) for an automatic transmission or N (Neutral) for a manual transmission. Switch off the engine and remove the ignition key.

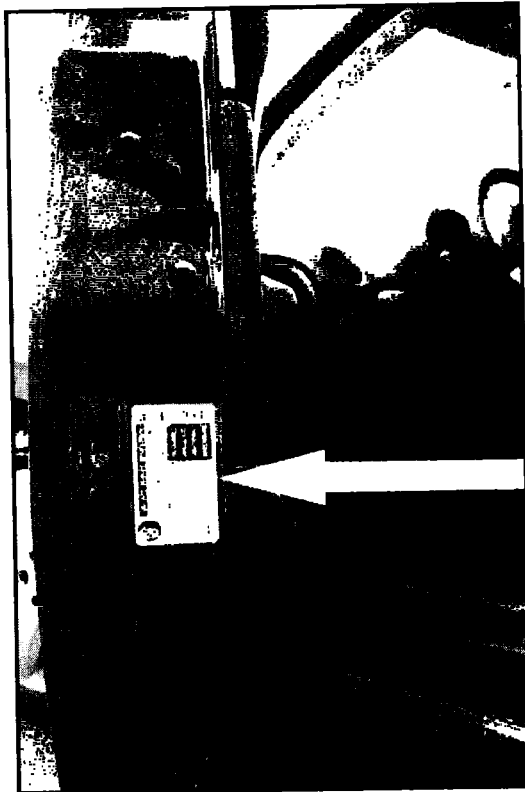
Work Sequence

- Open driver's side door
- ⇐ Locate existing TIRE AND LOADING INFORMATION label –arrow–
- Thoroughly clean present label with soap and water and dry completely
- ⇐ Remove backing from new TIRE AND LOADING INFORMATION label and affix over existing label
- Ensure that no bubbles appear under new label
- Close driver's side door

Set parking brake fully. Move selector lever to P (Park) for automatic transmission or N (Neutral) for manual transmission. Switch off engine and remove ignition key

WORK IS COMPLETE
