# RECALL CAMPAIGN BULLETIN

NTB06-024

## VOLUNTARY RECALL CAMPAIGN SECOND-ROW SEAT BELT PROTECTORS

**APPLIED VEHICLE:** 2003-05 Murano (Z50)

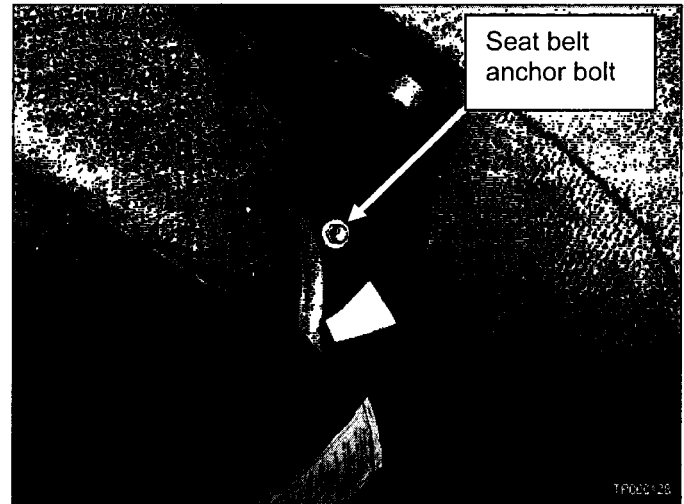
Figure 4

3. Remove the seat belt anchor bolt (see Figure 4).

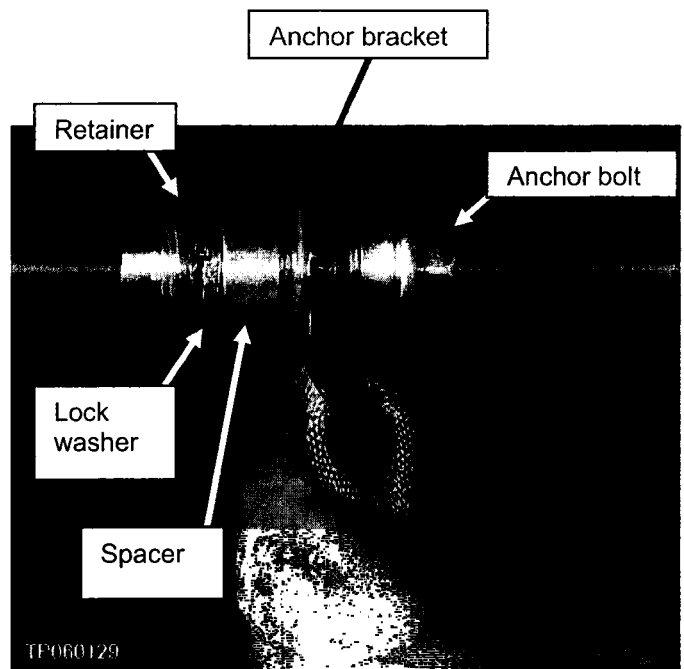
Figure 5

4. Remove the seat belt anchor bolt, spacer, lock washer, and retainer from the seat belt anchor bracket (see Figure 5).

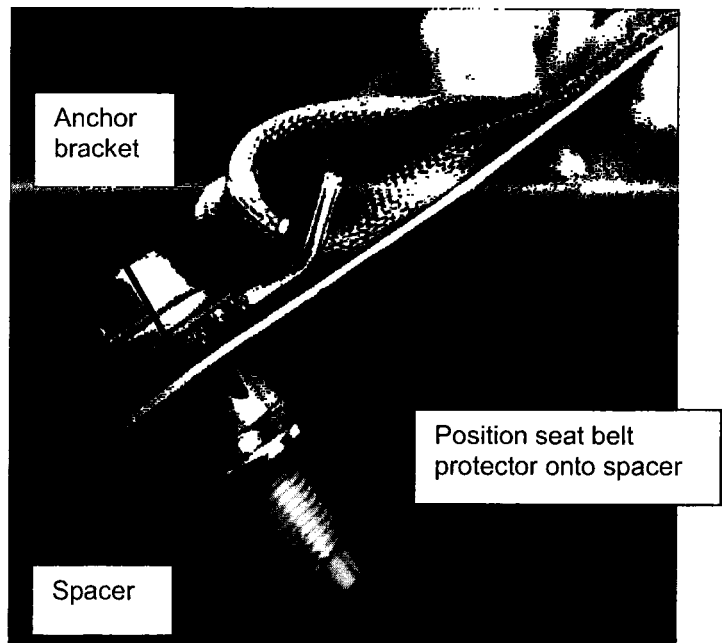
Figure 7

6. Re-install the seat belt anchor bolt, spacer, lock washer, and retainer on to the anchor bracket (see Figure 7).

- Make sure the hole in the seat belt protector is positioned onto the spacer, not between the spacer and the seat belt anchor bracket (see Figure 7).
