Subject: 2006 Titan King Cab Door Latch Voluntary Safety Recall Campaign

06V-064

# TITAN RIGHT REAR UPPER DOOR LATCH INTERIM REPAIR INSTRUCTION

VEHICLE AFFECTED:	2006	NISSAN	TITAN / KING CAB	DATE: 03/16/2006
Vehicle built between:	1N6*A06**6N543640 – 546599			
	ATTN: SERVICE MANAGER		DLR: ALL	
Description:	REPLACE RIGHT REAR UPPER DOOR LATCH

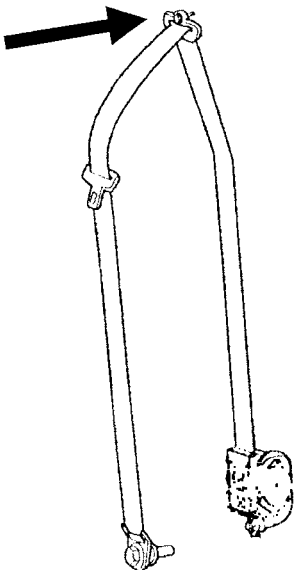
3	<ul style="list-style-type: none"><li>Remove upper seatbelt anchor bolt.</li></ul>	GO TO STEP 4

A line drawing of a seatbelt assembly. It shows a long, thin strap with a buckle at the bottom and a smaller strap at the top. A black arrow points to the top anchor point where the two straps meet.
4	<ul style="list-style-type: none"><li>Remove arm rest.</li><li>Remove three 10mm door panel bolts located behind armrest.</li></ul> <p><b>Note:</b> Use a Philips screwdriver to remove bolts.</p>	GO TO STEP 5

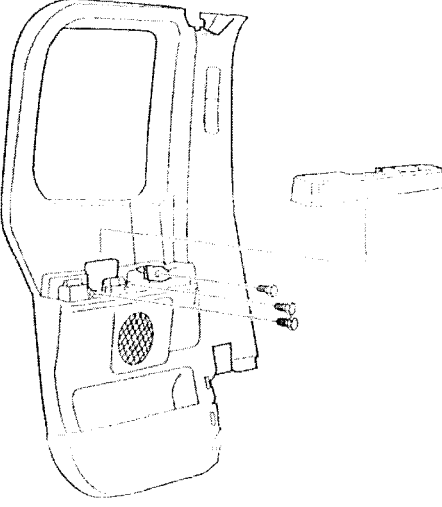
A line drawing of a car door panel. The armrest is shown in its raised position. Three bolts are highlighted with dashed lines, indicating their locations behind the armrest. A Philips screwdriver is shown to the right, pointing towards the bolts.

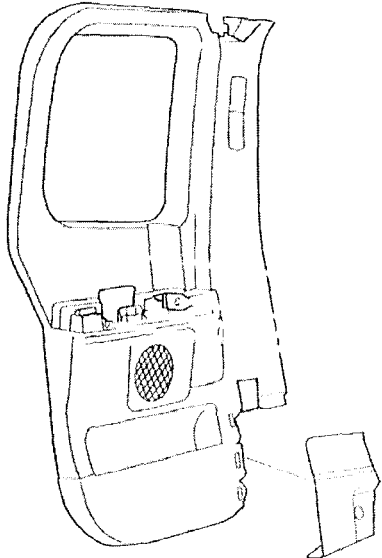
5	<ul style="list-style-type: none"><li>• Remove seatbelt retractor cover.</li><li>• Remove door finisher clips.</li></ul> <p><b>Note:</b> Start at lower left corner and continue counter-clockwise.</p> <ul style="list-style-type: none"><li>• Remove door panel.</li></ul>	GO TO STEP 6

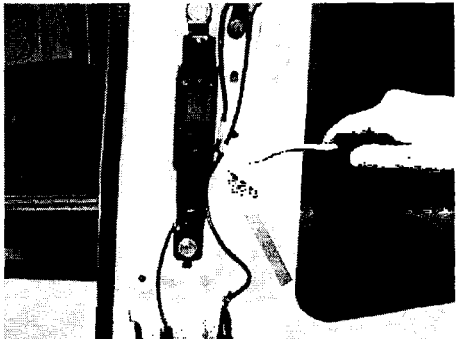
6	<ul style="list-style-type: none"><li>• Remove handle release cable from upper door latch white cable clip on door.</li><li>• Remove upper door latch white cable clip from door.</li></ul>	GO TO STEP 7

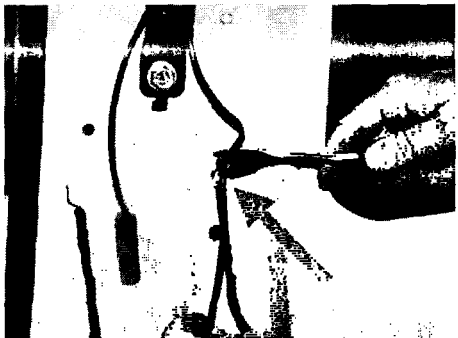
7	<ul style="list-style-type: none"><li>• Remove upper door latch gray cable clip from door.</li></ul>	GO TO STEP 8

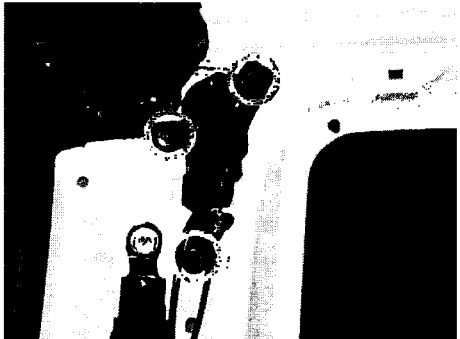
<p>10</p>	<ul style="list-style-type: none"> <li>• Remove three 10mm bolts from upper door latch.</li> </ul> <p><b>Note:</b> Observe wiring harness routing.</p>	<p>GO TO STEP 11</p>

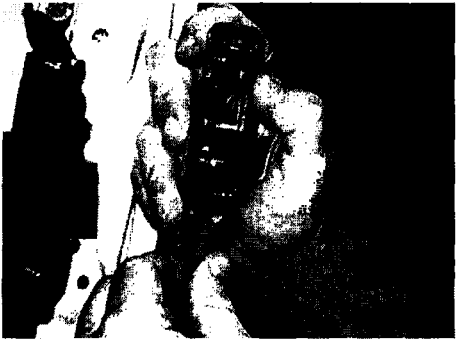
12	<ul style="list-style-type: none"> <li>Install barrel cable end onto new upper door latch.</li> <li>Install cable sheath into receiving notch on new upper door latch.</li> </ul>	GO TO STEP 13

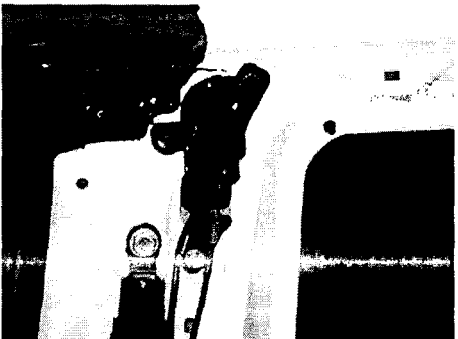
13	<ul style="list-style-type: none"> <li>Install upper door latch to door with three 10mm bolts.</li> <li><b>Torque bolts to 51 in-lb</b></li> </ul> <p><b>Note:</b> Observe wiring harness routing. Do not pinch wire harness between door and upper door latch.</p>	GO TO STEP 14

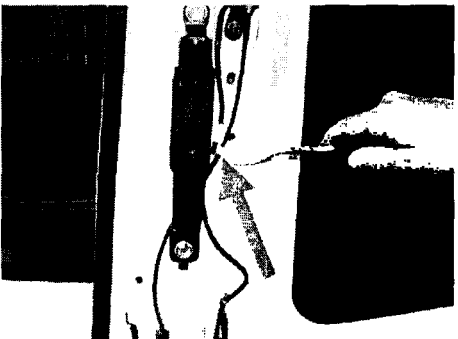
14	<ul style="list-style-type: none"> <li>Reinstall upper door latch white cable clip into door.</li> </ul> <p><b>Note:</b> Use lower locating hole.</p> <ul style="list-style-type: none"> <li>Reinstall handle release cable into upper door latch white cable clip on door.</li> </ul>	GO TO STEP 15

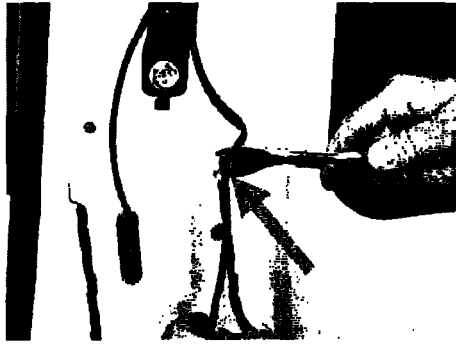
<p>15</p>	<ul style="list-style-type: none"> <li>• Reinstall upper door latch gray cable clip into door.</li> </ul>	<p>GO TO STEP 16</p>

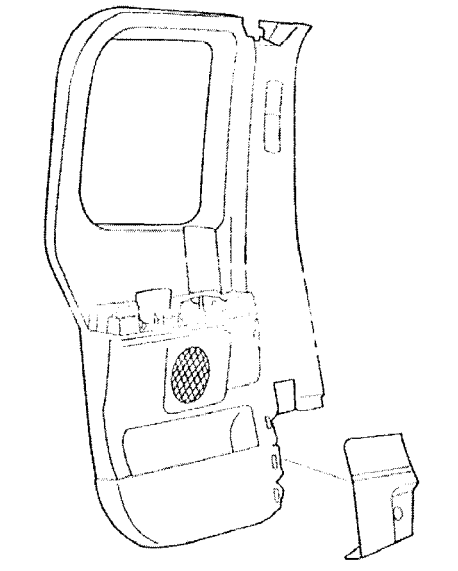
19	<ul style="list-style-type: none"><li>• Check that all door finisher clips are installed (replace any broken or missing door finisher clips).</li><li>• Reinstall door panel.</li><li>• Reinstall seatbelt retractor cover.</li></ul>	GO TO STEP 20

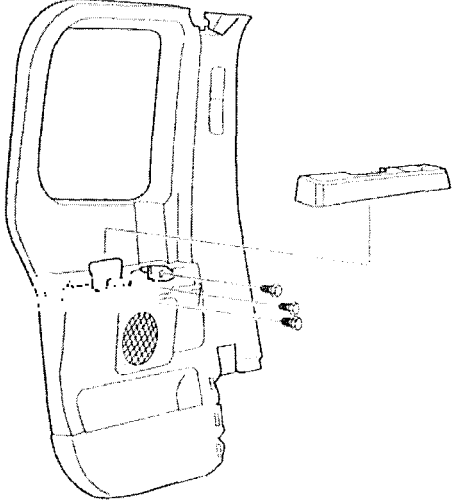
20	<ul style="list-style-type: none"><li>• Reinstall three 10mm door panel bolts located behind armrest.</li></ul> <p><b>Note:</b> Use a Phillips screwdriver to remove bolts. Do not over tighten bolts.</p> <ul style="list-style-type: none"><li>• Reinstall arm rest.</li></ul>	GO TO STEP 21

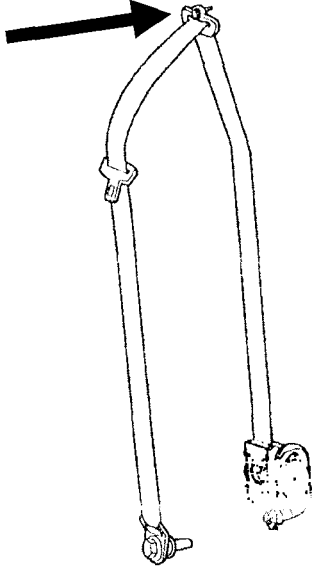
21	<ul style="list-style-type: none"><li>• Reinstall upper seatbelt anchor bolt.</li></ul> <ul style="list-style-type: none"><li>• <b>Torque bolt to 36 ft-lb</b></li></ul>	GO TO STEP 22
