Subject: 2005-06 Frontier King Cab Fuel Filler Cap Recall Campaign Update #1

VOLUNTARY RECALL CAMPAIGN 2005 – 2006 FRONTIER FUEL CAP TETHER

CAMPAIGN I.D. # / NHTSA #: R0603 / 06V-092

APPLIED VEHICLES: 2005 – 2006 Frontier (D40)

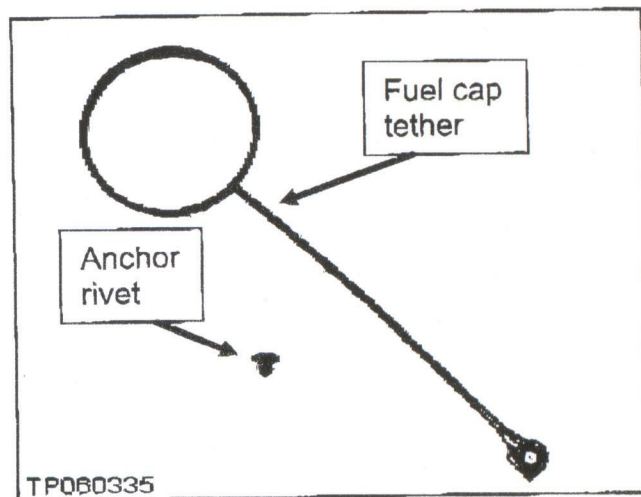
Figure 1

- The new fuel cap tether is slightly longer than the old one.
- Refer to the Parts Information for the part number.

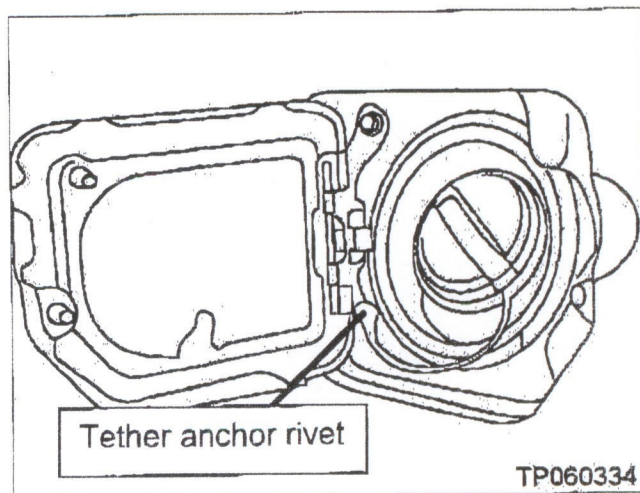
Figure 2

1. Open the fuel fill door.
2. Disconnect the tether anchor.
 - Use a plastic trim tool to remove the plastic anchor rivet.

NOTE: Plastic "Trim Tool Set" J-46534 (an "essential tool") is available from TECH-MATE at 1-800-662-2001—option 1.

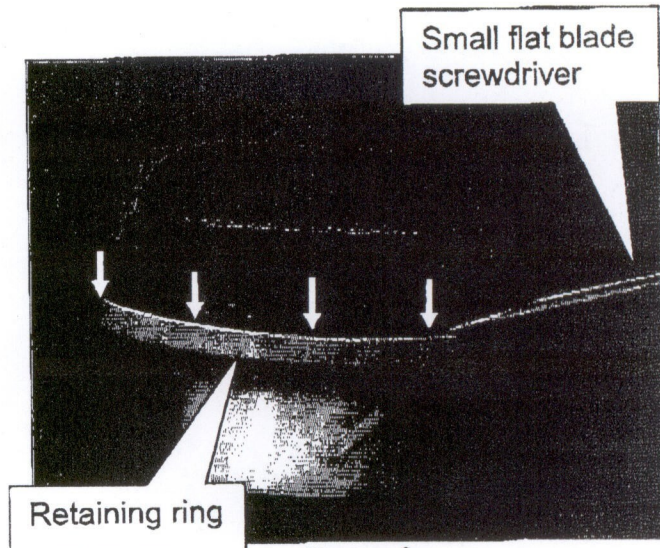
Figure 3

3. Remove the fuel cap from the vehicle.
 - Turn counterclockwise

4. Use a small flat blade screwdriver to snap the retaining ring loose from the fuel cap.
 - The retaining ring is a light gray color.
 - Snap loose at 4 or 5 spots around the ring.

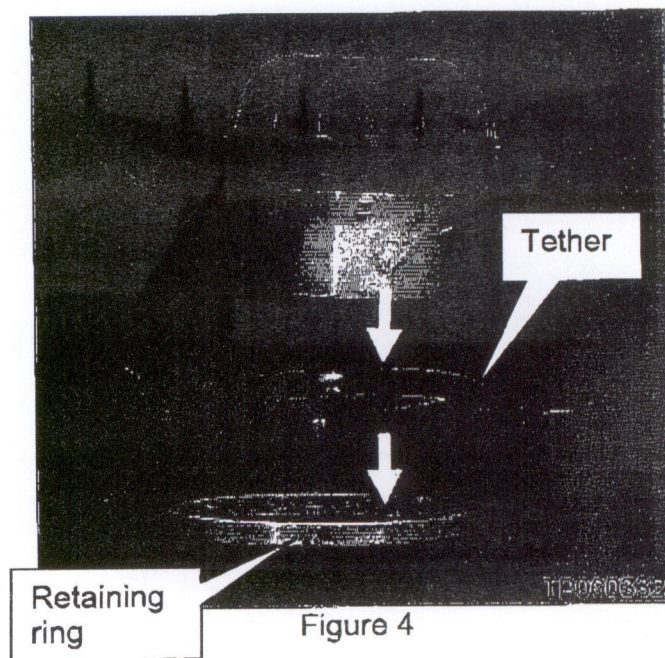
Figure 4

5. Remove the retaining ring and the tether.

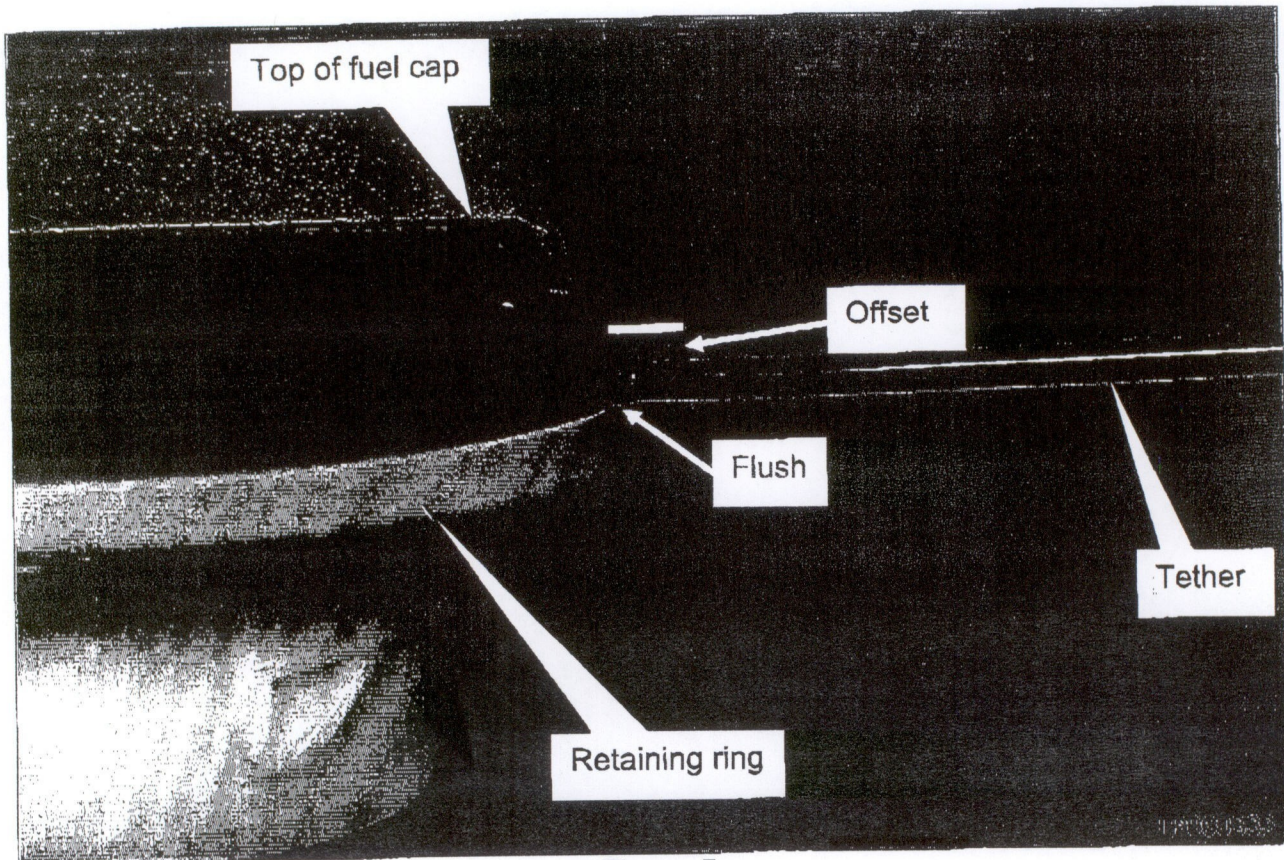
Figure 5

6. Install the new tether onto the fuel cap as shown in Figure 5.

- Make sure the "offset" is positioned as shown.

7. Snap the gray retaining ring back into place (see Figure 5).

- Make sure it is fully seated / snapped onto the fuel cap.

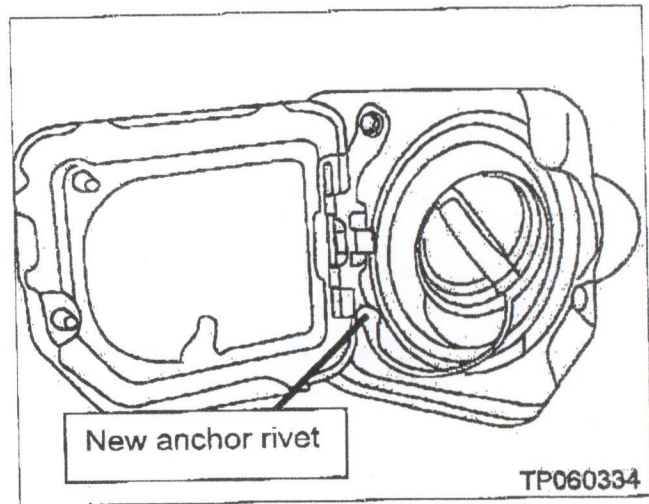
Figure 6

9. Attach the fuel cap tether to the vehicle body with the new plastic anchor rivet.

- Make sure the **Tether is NOT Twisted.**
- Push the rivet through the tether anchor hole and into the body with your thumb.
