## Recall Information Bulletin

**No:** C1000720 **Issued:** 8/14/2006  
**NHTSA No:** 06V-195  
**Transport Canada No:** 06-131  
**Re:** ALLISON A/T Selector Lever  
**Group:** 23 **Models:** FK/FM

Safety Recall C1000720 - ALLISON A/T Selector Lever

## Modification Procedure for Unexpected vehicle movement on FK/FM with ALLISON LCT A/T

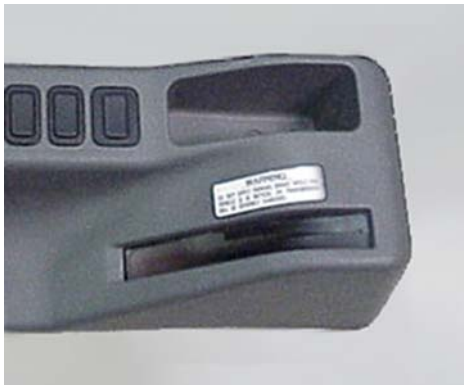
PHOTO 1

1. Park the vehicle on a flat, level surface, shut off the engine, apply the parking brake, chock the wheels and disconnect the battery cables. **CAUTION! Do not remove the wheel chocks or disengage the parking brake until all modification work has been completed.**
2. Perform the Recall using the attached modification procedure, subject to the additional instructions below:
  - Affix the white parking brake warning label (19) on the shift lever console assembly (17), as indicated below in **Photo 1**.
  - Reuse the white plastic grommets when replacing the shift lever console assembly (17), as indicated below in **Illustration 1**.

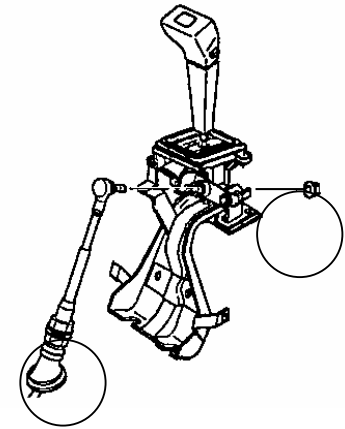
Fig1.Removing Cable Tightening Nut

1. Loosen four console mounting bolts ※ and remove Selector Lever Console from Cab Floor
2. Disconnect the oil level switch
3. Loosen ○-marked 2 Nuts shown in Figure 1, and remove A/T Shift Control Cable from Selector
4. Disconnect OD Switch Harness Connector and Illumination Lamp Harness Connector.
5. Loosen four Bolts and remove A/T Selector from Cab Floor.  
Remove Grommet Screw (2 places) ※ from Selector
6. Tilt the Cab up.
7. Loosen the Bolt for Cable Clip※ under Cab Floor, and remove A/T Shift Control Cable

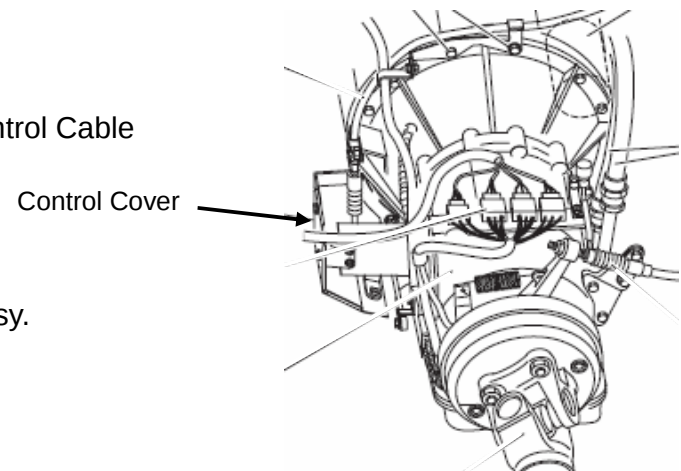
Fig1-1. Control Cover

1. Remove Control Cover as shown in Figure1-1. ※
2. Loosen Cable Tightening Nut※ on the Bracket which is on left side of A/T Assy.
3. Remove the A/T Shift Control Cable from Adjuster.

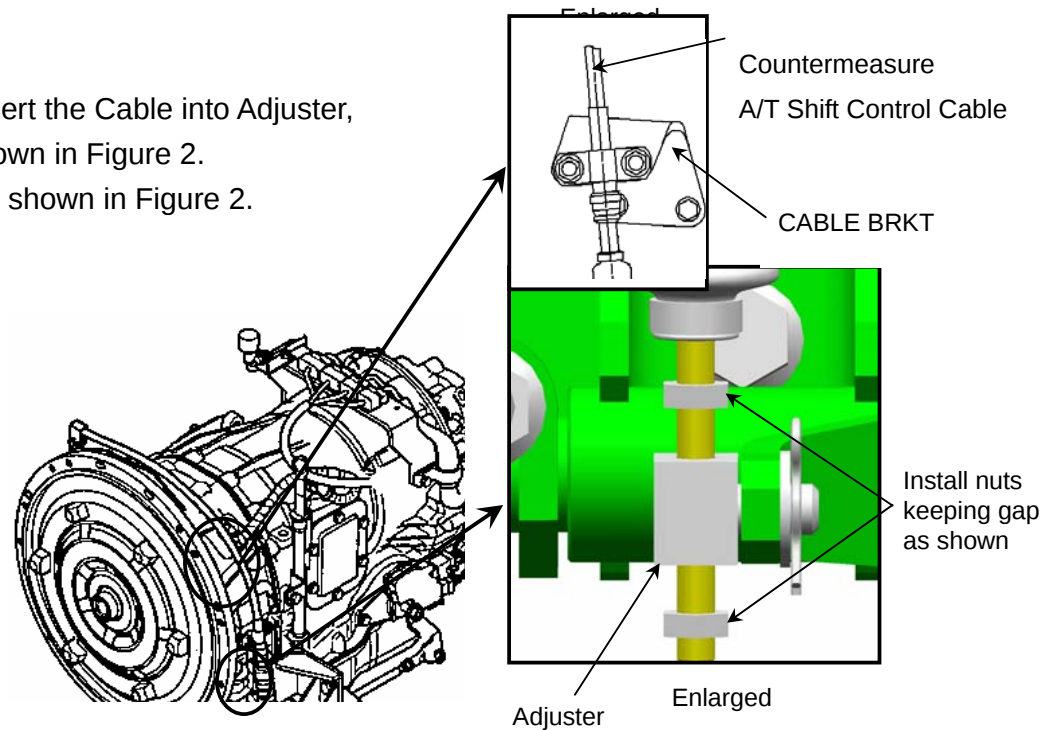
Fig 2. Installation of A/T Control Cable into A/T

1. Hand tighten the Nut to the A/T Shift Control Cable and insert the Cable into Adjuster, and then hand tighten the other Nut with keeping gap as shown in Figure 2.
2. Fix the new Cable to Cable Bracket by tightening the nut as shown in Figure 2.  
(Tightening torque : 15.5 ~ 22.9 ft-lbs {21~31N·m})

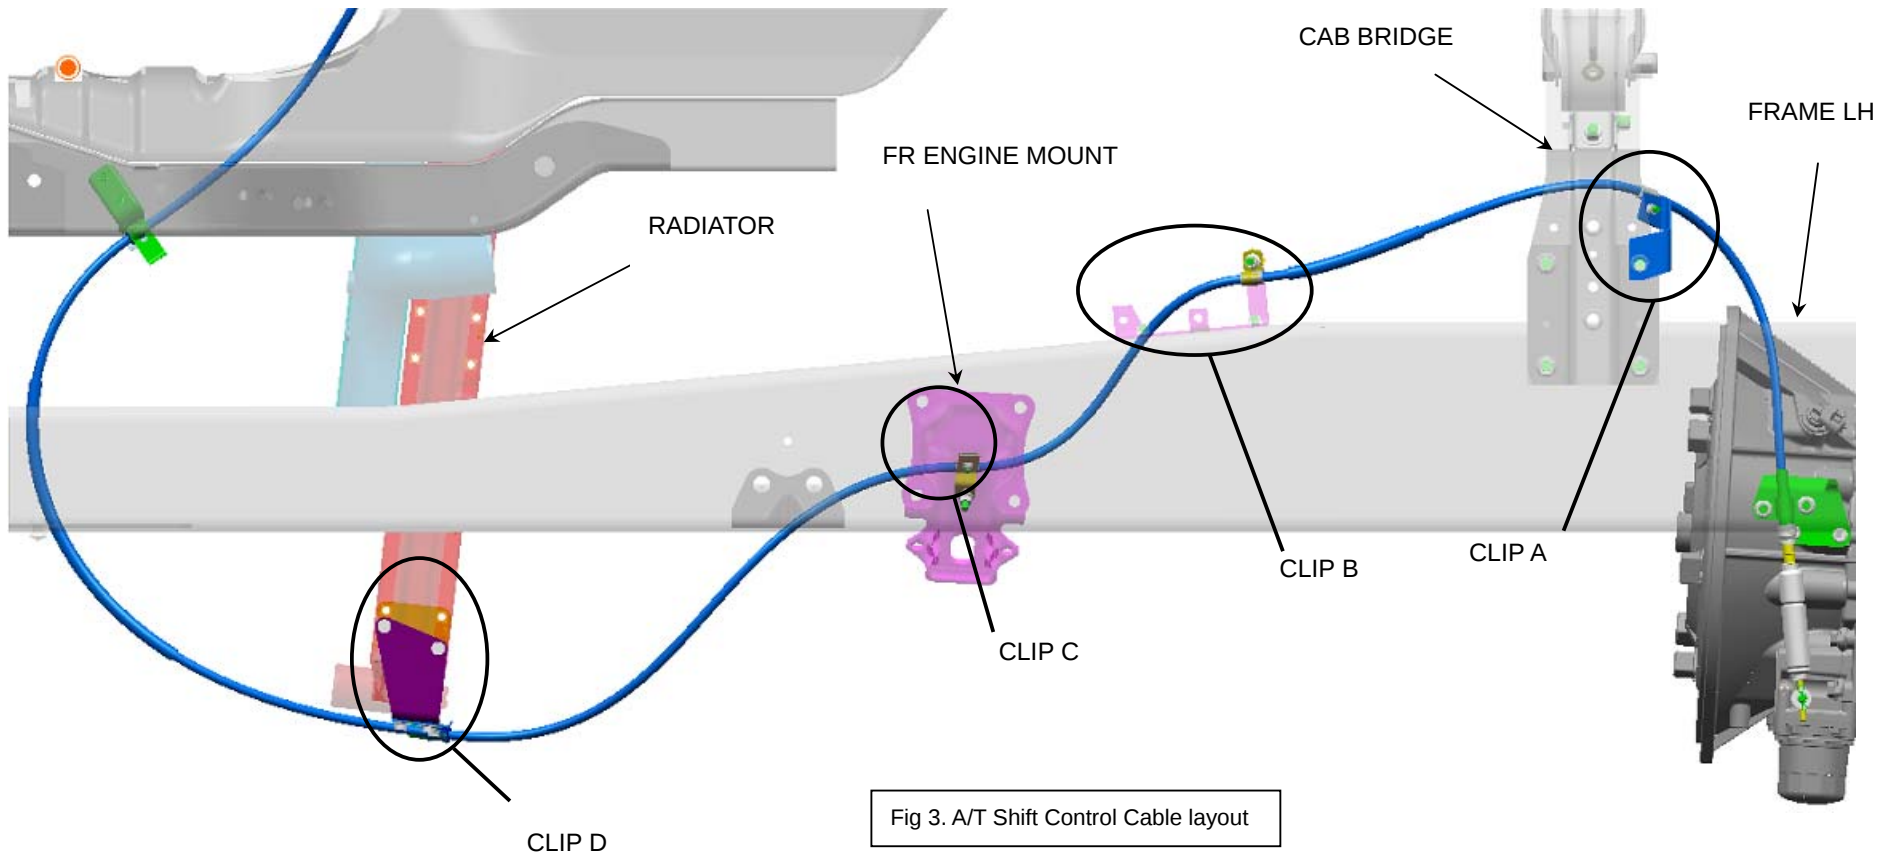
1. Install the A/T Shift Control Cable as shown in Figure 3
2. Install the Cable in the Clips in the following order: A→B→C→D.

3. At Clip A, B and C, fix the cable so as to align the center of Clips and the matching white tape mark on the cable.

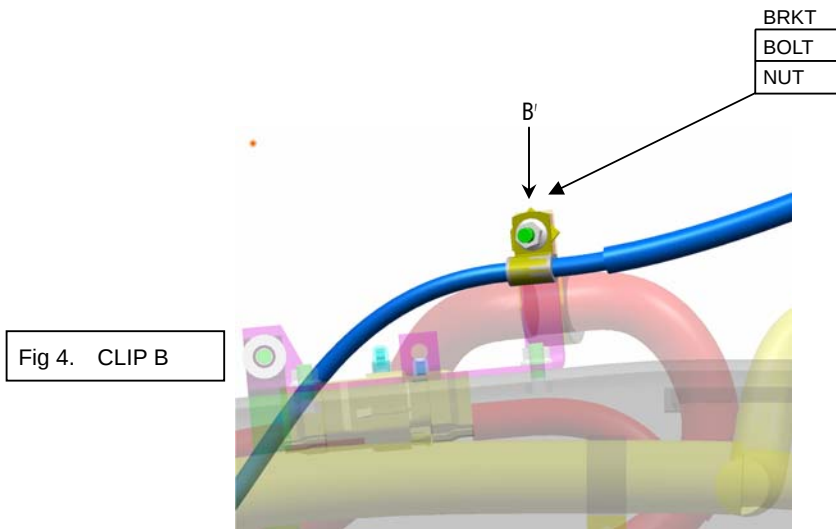
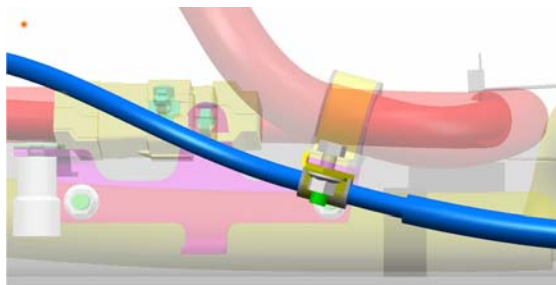
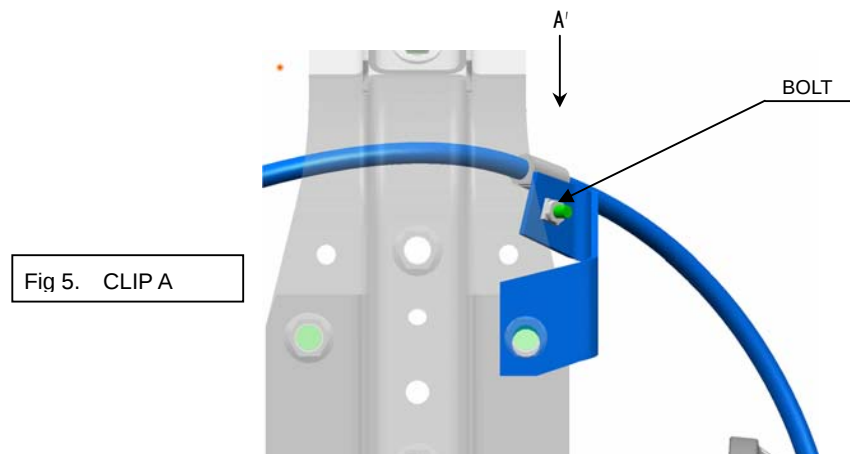
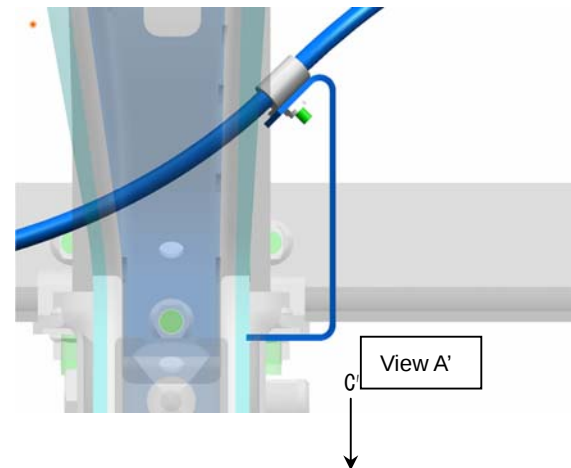
View B'

4. Fix the Cable Clips in the direction as shown in Figure 4~7.

(Fixing Bolt and Nut Tightening torque : 3.0~4.4ft-lbs {4~6N·m})

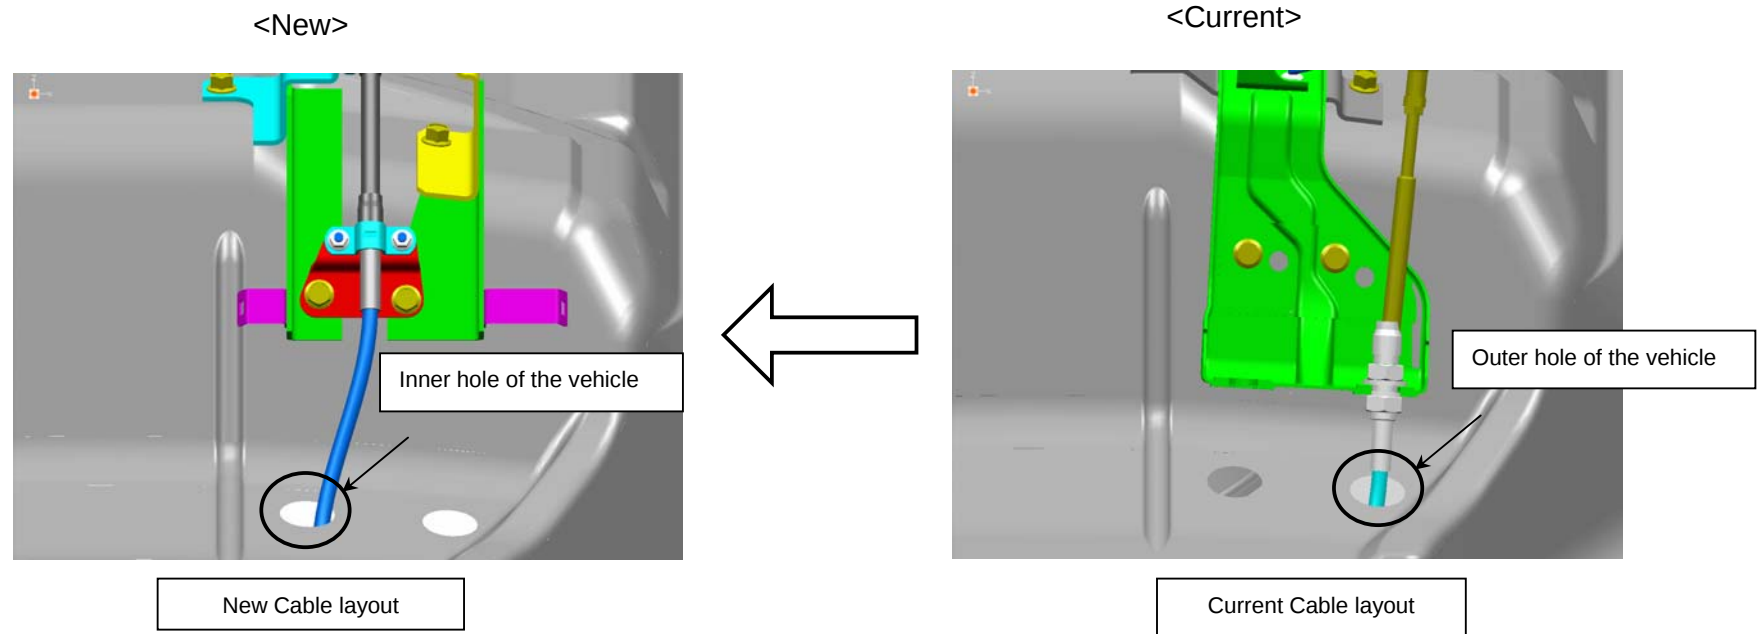
Fig 8. Cable layout in the hole on Cab Floor (Front View)

1. Reposition the Plug ※ from Cab inner hole to Cab outer hole.
2. Insert the Cable through Cab inner hole.

Note: New Cable goes through inner Hole from current one as shown in Figure 8.

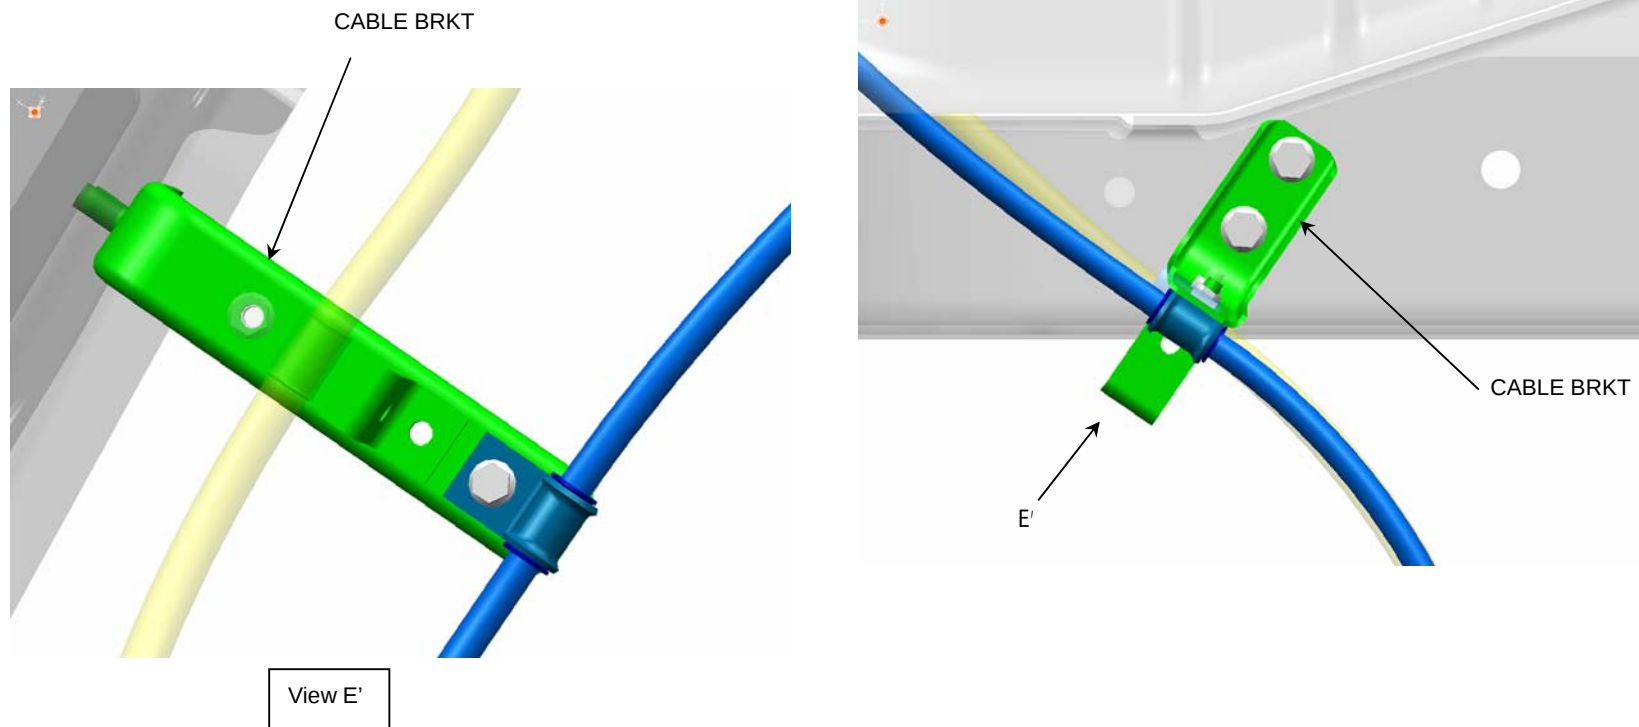
Fig 9. Installation of Cable under the Cab

3. Affix the Cable to the Bracket under Cab Floor as shown in Figure 9.  
(Tightening Torque : 3.0~4.4ft-lbs {4~6N·m})

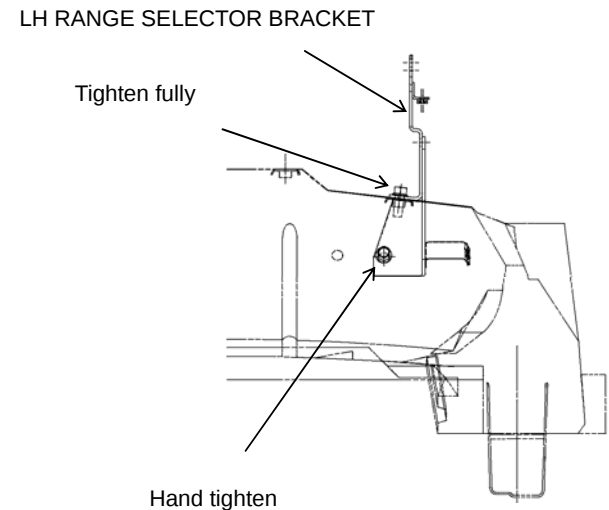
Fig 10. Installation of LH Bracket (Front View)

1. Transfer the white plastic grommets for the console mounting screws to the RH and LH brackets **(4 & 5)**
2. Install LH RANGE SELECTOR BRACKET on the Cab Floor as shown in Figure 10. (Tighten rearward Bolt fully, hand tighten Forward Bolt)  
LH RANGE SELECTOR BRACKET ASSEMBLY **(4)**  
FLANGE BOLT [10X25] **(12)** (Tightening torque : 36.9~47.9ft-lbs {50~65N·m})
3. Install Selector Bracket RH on the A/T Selector as shown in Figure 11.  
RANGE SELECTOR **(3)**  
RH RANGE SELECTOR BRACKET ASSEMBLY **(5)**  
FLANGE BOLT [6X12] **(13)** (Tightening torque : 5.9~8.9ft-lbs {8~12N·m})

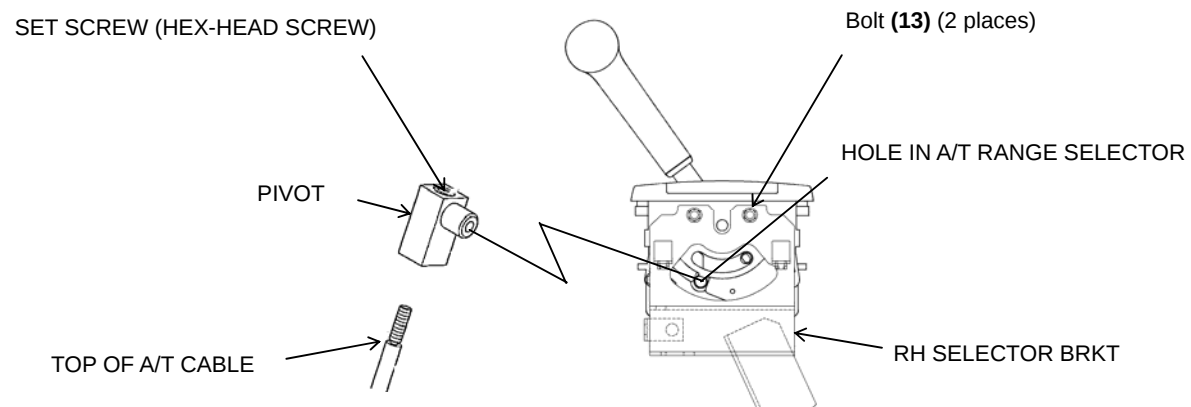
Fig 11. Installation of RH Bracket and A/T Cable. (Right side View)

3. As shown Figure 11, install the pivot **(7)** on the new A/T Shift Control Cable **(16)** and tighten the set screw when the pivot **(7)** aligns with the hole in the range selector **(3)** (the set screw should not protrude from the top surface of the pivot **(7)**).

PIVOT **(7)** (Tightening torque : 1.4~2.2ft-lbs {2~3N·m})

4. Shift the Selector Lever into "L" Position and insert the pivot **(7)** into the Hole of the Lever from right side as shown in Figure 11

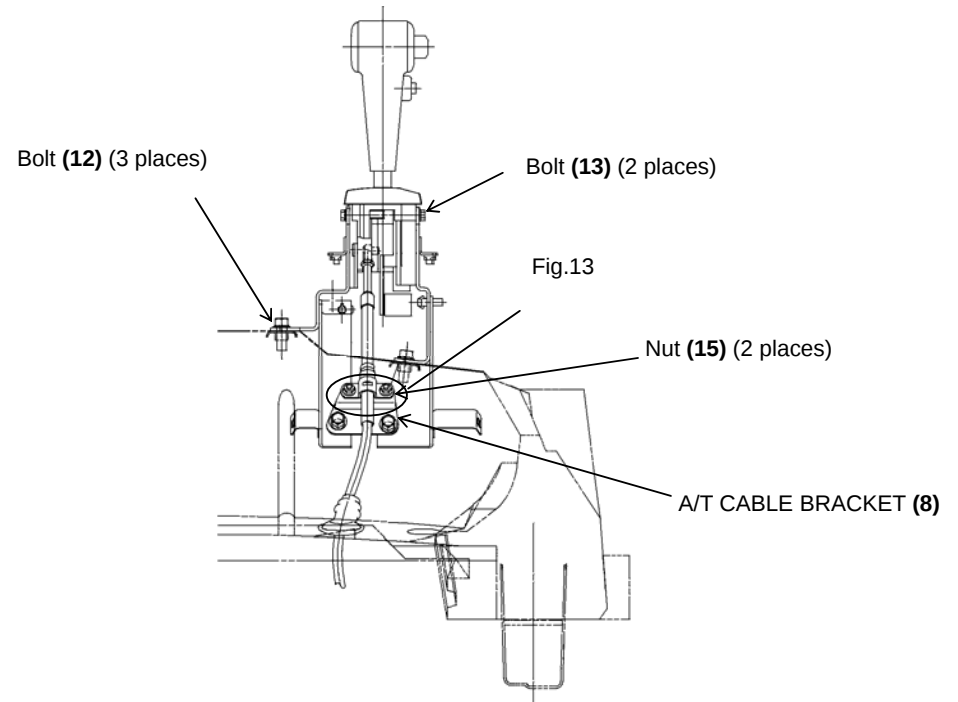
Fig 12. Installation of Selector (Front View)

5. Shift the Selector Lever into “N” Position, and install the Selector and the LH Bracket as shown in Figure 12.

FLANGE BOLT [6X12] **(13)** (Tightening torque: 5.9~8.9ft-lbs {8~12N·m})

6. Install the Selector Bracket to Cab Floor. Tighten Selector Bracket together with the Cable Bracket as shown in Figure 12.

A/T CABLE BRACKET **(8)**

FLANGE BOLT [10X25] **(12)** (Tightening torque: 36.9~47.9ft-lbs {50~65N·m})

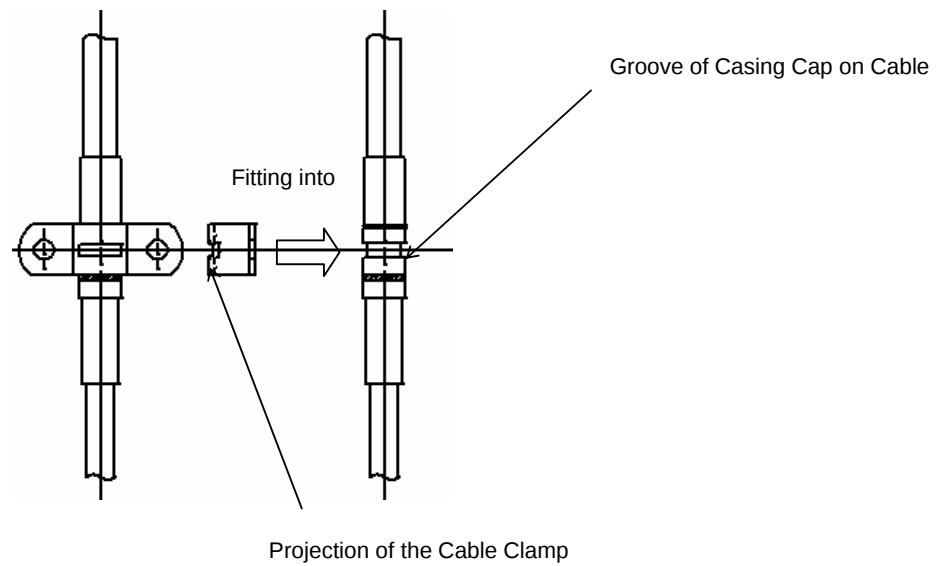
Fig 13. Fitting Clip into groove

7. Align the projection of the Cable Clip into the groove on Casing Cap on the Cable, and install the Cable Clip into the Cable Bracket as shown in Figure 12, 13.

CABLE CLAMP **(6)**

FLANGE NUT [6] **(15)** (Tightening torque : 3.0~4.4ft-lbs {4~6N·m})

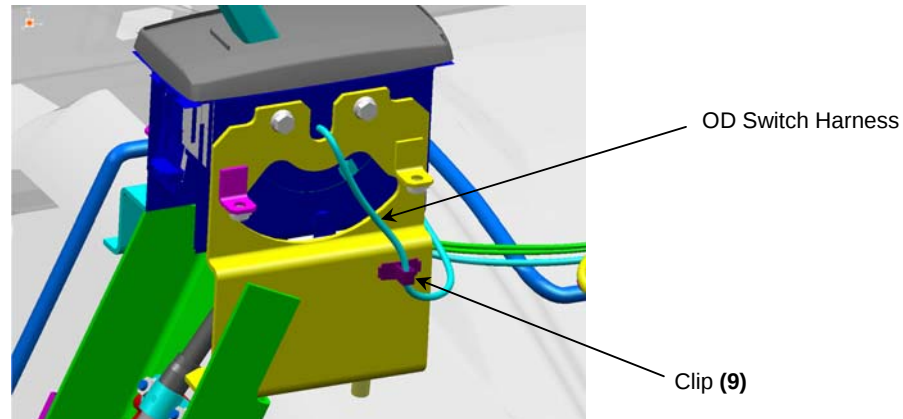
Fig 14. Routing LH side Harness

8. Install the Clip into Selector Bracket LH and route O/D Switch Harness as shown in the Figure 14.

**CLIP (9)**

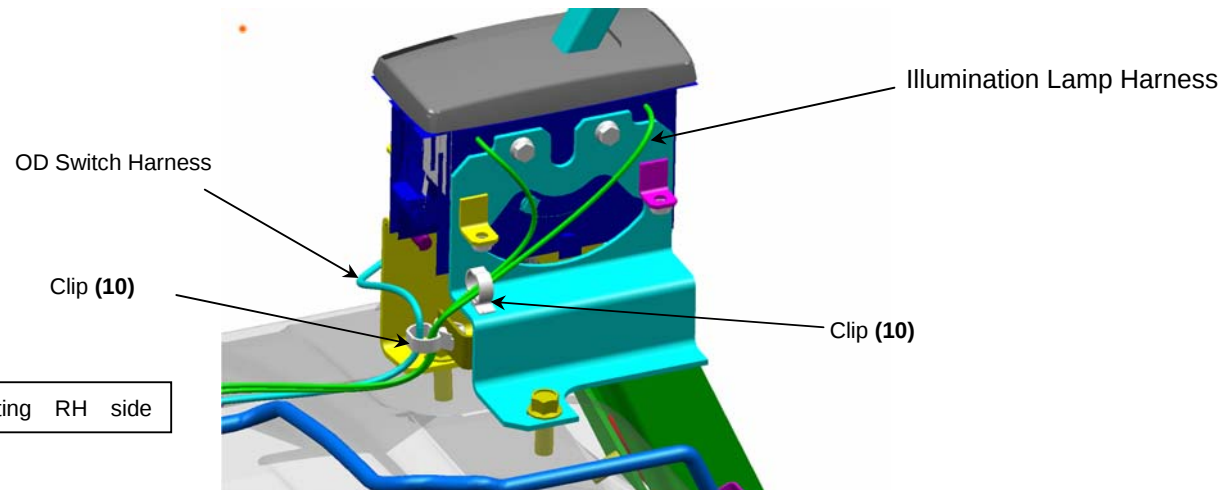
Fig 15. Routing RH side

9. Install the Clip into RH Selector Bracket and route O/D Switch Harness and Illumination Lamp Harness as shown in the Figure 15.

**CLIP (10) (2 PLACES)**

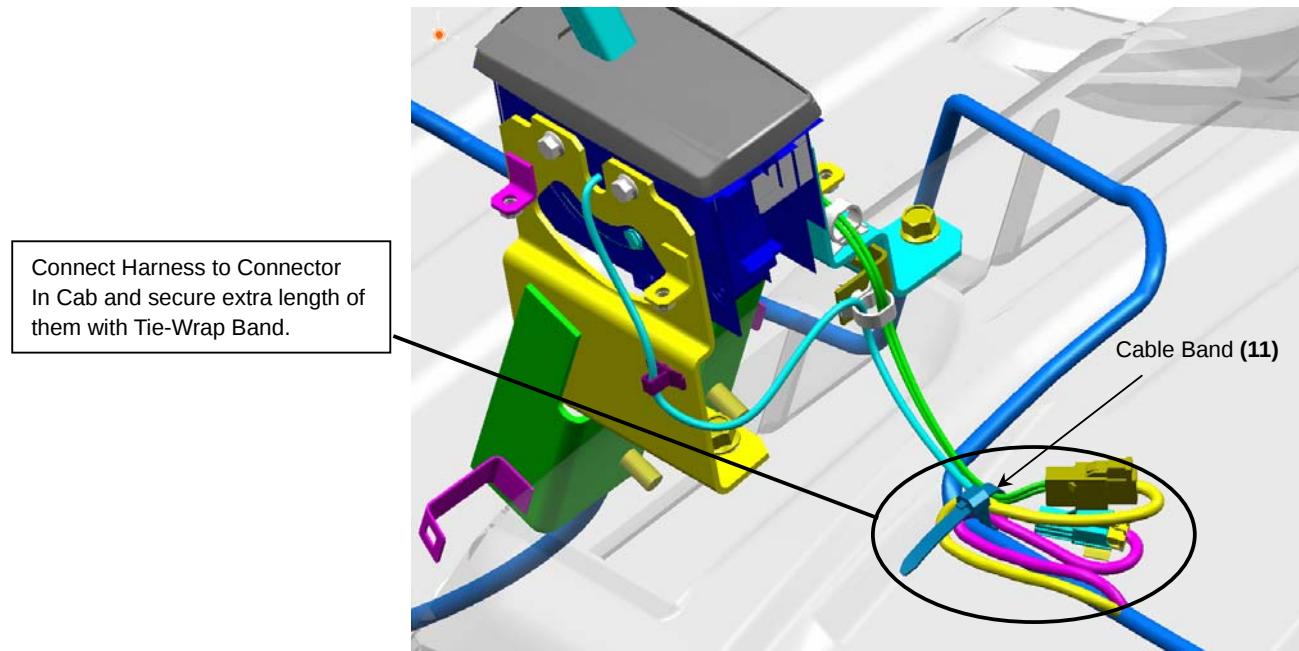
Fig 16. Connecting and securing Harness

10. Reconnect OD Switch Harness Connector and Illumination Lamp Harness Connector to the cab side Connector as shown in Figure 16.

OD-OFF Indicator comes on when OD-Switch activated.

Illumination in Selector comes on when Combination Switch activated.

Secure extra length of Harness with Tie-Wrap Band.

**CABLE BAND (11)**

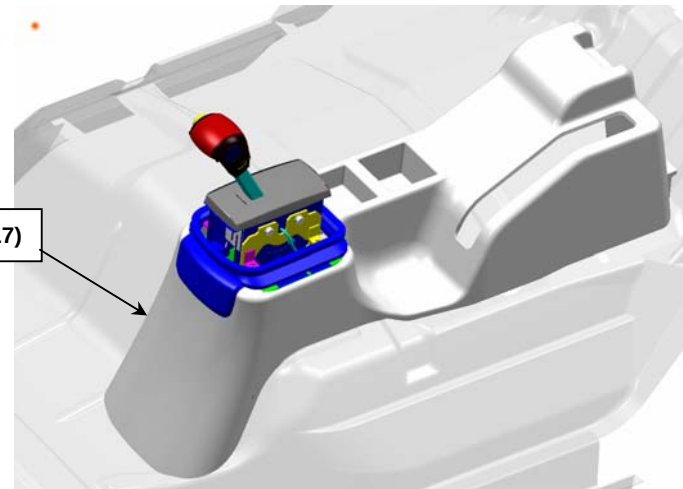
Fig 17. Installation of Shift Lever Console (17)

13. Install Shift Lever Console as shown in Figure 17.

**SHIFT LEVER CONSOLE ASSEMBLY (17)**

Install the Grommet Screws into the holes on Selector Bracket (Both LH and RH, 2 places).

Install Console with Tapping Screw.

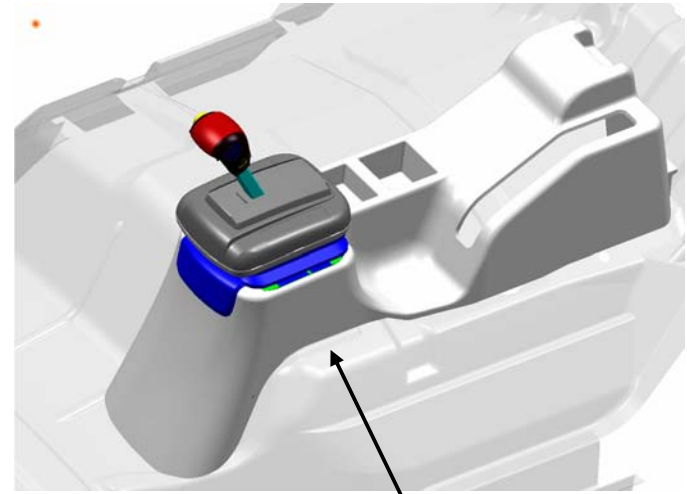
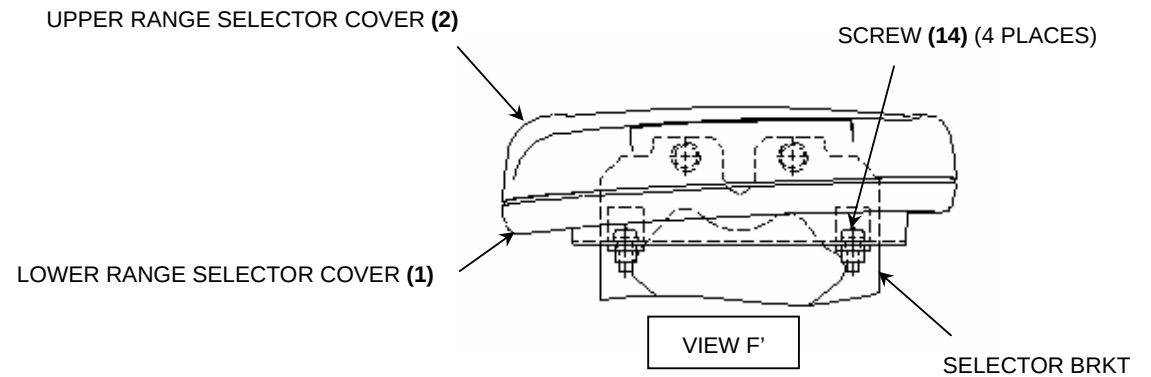
Fig 18. installation of Selector Cover

14. Install Selector Cover as shown in Figure 18.

Install Selector Cover Lower to the Selector (Both LH and RH) Bracket with 4 Screws.

LOWER RANGE SELECTOR COVER (1)

ASSEMBLED SCREW & WASHER [6X16] (14)

(TIGHTENING TORQUE : 3.0~4.4ft-lbs {4~6N·m})

Install Selector Cover Upper into the Selector Cover Lower.

UPPER RANGE SELECTOR COVER (2)

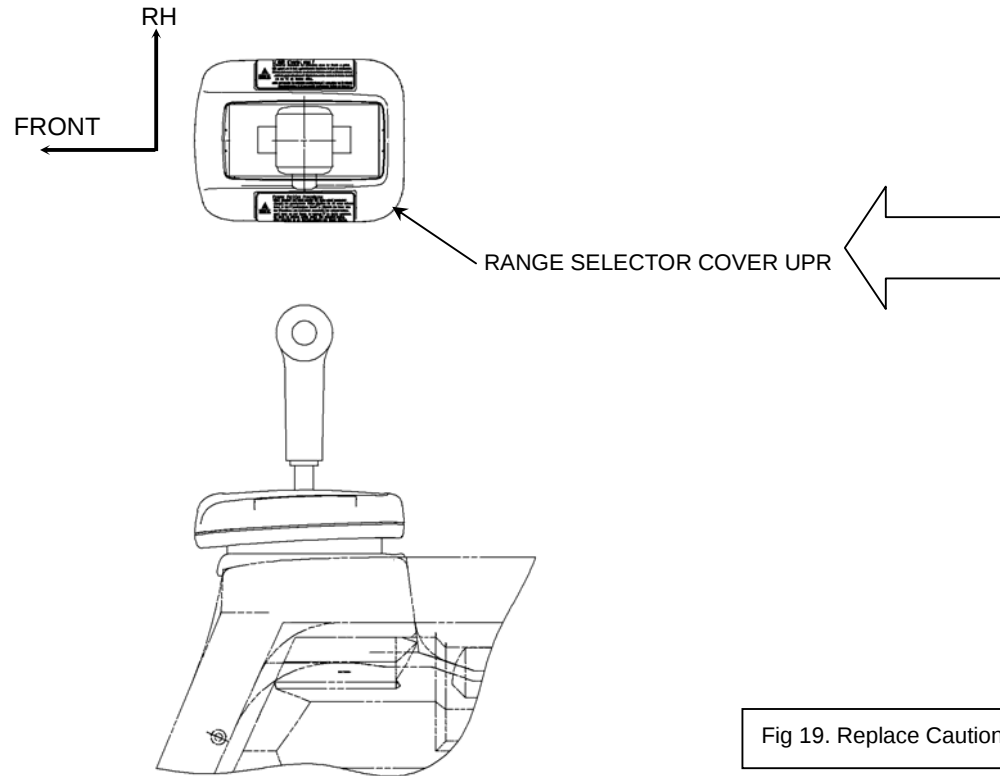
Fig 19. Replace Caution Plate

16. Replace the orange Proper Parking Procedures warning label with countermeasure label **(18)** as shown in Figure 19.

ORANGE PROPER PARKING PROCEDURES LABEL **(18)**

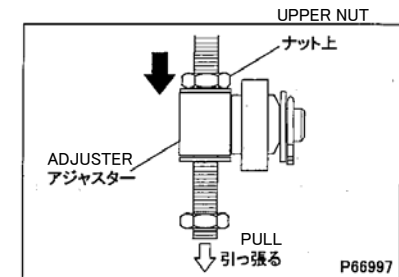
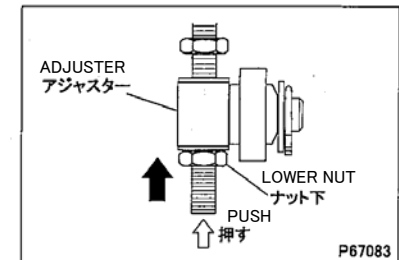
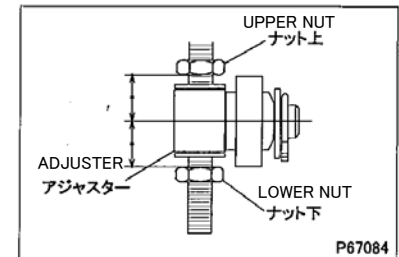
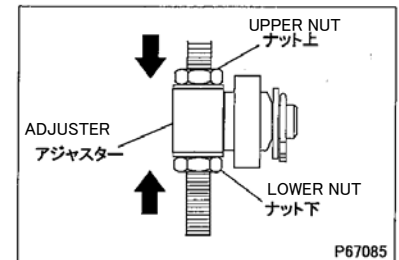
1. Align Control lever on A/T Assy. into "N" Position, and then align Selector lever into "N" Position  
If the Cable Boot is twisted, straighten the Boot.
2. Pull down the end of the Wire of A/T Shift Control Cable.
3. While pulling the Wire, tighten the upper Nut by hand until the Nut touches the Adjuster.
4. Push the Wire end up using the same force as pulling down.
5. While pushing the Wire, tighten lower Nut by hand until the Nut touches to Adjuster.
6. Release the load and align the Adjuster at the center of the upper and the lower Nuts.
7. Tighten the upper Nut by hand until it touches to Adjuster
8. Tighten the lower Nut by hand until it touches to Adjuster.
9. Torque upper or lower Nut.  
(tightening torque : 3.0~4.4ft-lbs {4~6N·m})

CAUTION: When tightening the nut, do not move the position of the adjuster.

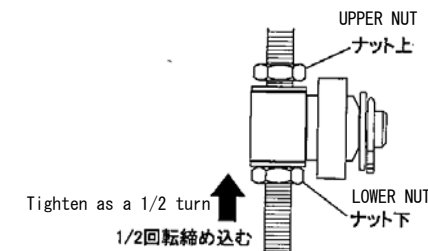
In case of any symptom below is found, please try below step 1, 2 and 3.

- ① Back-up Buzzer sounds when Selector Lever is in "P" Position.
- ③ Firm gear selection engagement is lacking when shifting the Selector from the "L" to "P" range direction.

1. Loosen the upper Nut, and tighten the lower Nut by 1/2 turn.
2. Tighten the upper Nut. (tightening torque : 3.0~4.4ft-lbs {4~6N·m})
3. Re-perform the inspection described previously again and repeat the adjustment if there are any problem.

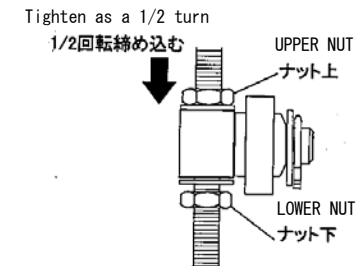
In case of any symptom below is found, please try below step 1, 2 and 3.

①the indication in Allison's diagnosis tool shows misalignment toward "P" position.

②Back Buzzer does not sound when Selector Lever is in "R" Position.

③click stop feeling is lacking in pushing Selector when shifting the selector from "P" to "L" range direction.

1. Loosen the lower Nut, and tighten the upper Nut by 1/2 turn.
2. Tighten lower Nut. (tightening torque : 3.0~4.4ft-lbs {4~6N·m})
3. Perform the inspection described previously again and repeat the adjustment if there are any problem.
