RE: Recall Number 06V-234 Defect Information Report (additional information)
(Hyundai Campaign 076)

HYUNDAI Technical Service Bulletin

Subject
SUN VISOR LABEL REPLACEMENT (CAMPAIGN 076)

Subject: Campaign 076 - 2006 Sonata - Sun Visor Label Inspection and/or Replacement

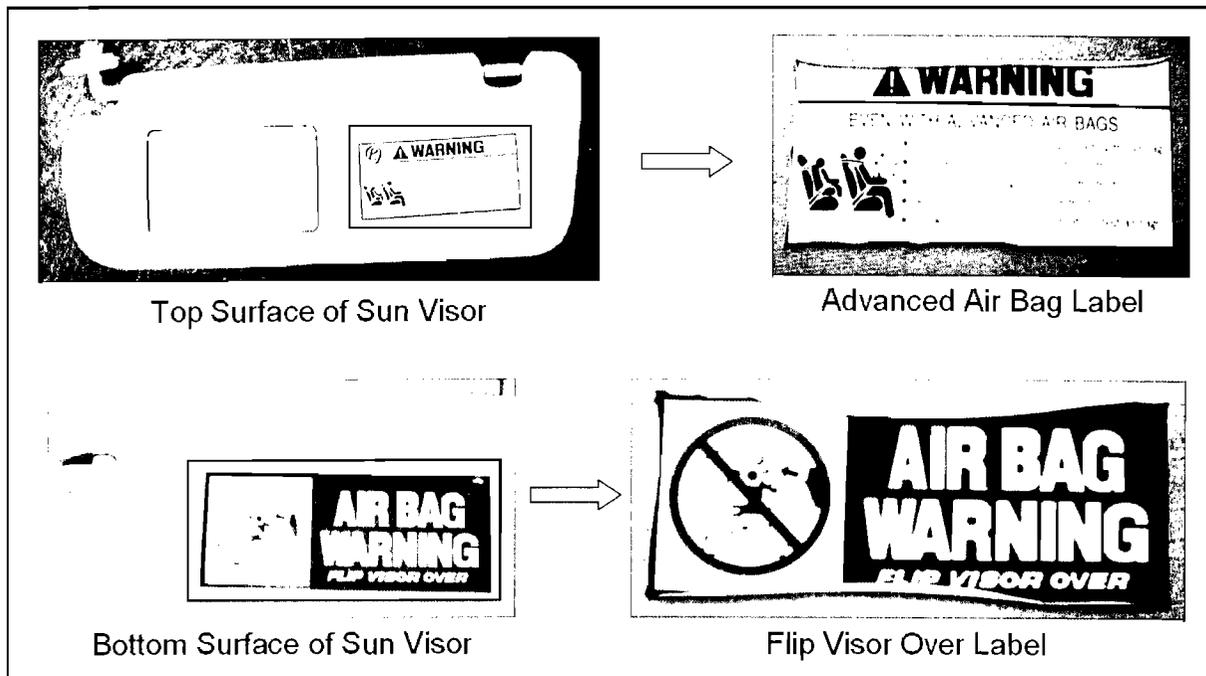
EXAMPLES OF DISTORTED LABELS:

Some vehicles affected by this TSB may have sun visor labels that have become distorted or separated. This TSB provides the procedure for sun visor label inspection and replacement.

Part Name	Figure	Notes
Advanced Air Bag Label

2 each (RH and LH)
Flip Visor Over Label

2 each (RH and LH)

1. Slowly peel the distorted label from the sun visor by steadily pulling a loose edge.

NOTE: Do not use a knife to remove the label

2. Clean the label attachment area with a clean cloth.
3. Peel the backing paper off the new label and attach the new label in the position where the original label was located, as shown in the photos.

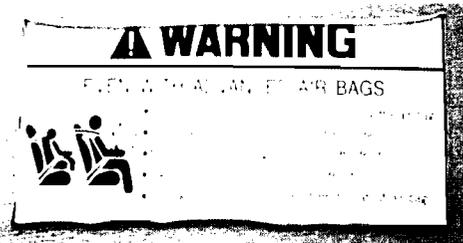
Examples of Distorted Labels:

"Advanced Air Bags" Label
Top Surface of Sun Visors

"Flip Visor Over" Label
Bottom Surface of Sun Visors

1. Slowly peel the distorted label from the sun visor by steadily pulling a loose edge. Do not use a knife to remove the label. A knife may injure you or damage the sun visor.
2. Clean the label attachment area with a clean cloth.
3. Peel the backing paper off the new label and attach the new label in the position where the original label was located, as shown in the photos below:

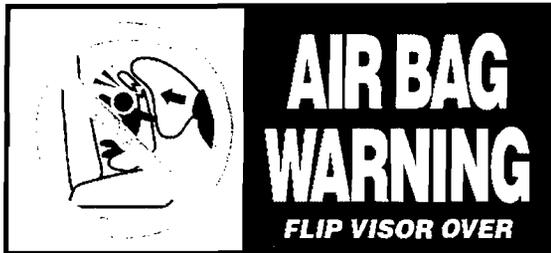
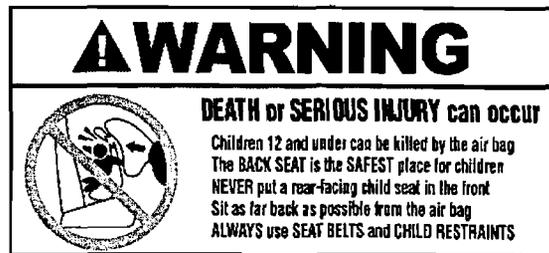
- Labels containing air bag warning information, illustrated below, are attached to your vehicle's sun visors. Some of these labels may not have been properly installed, causing them to distort or separate from the sun visors. If the labels are distorted or missing, the driver or front seat passenger will not have information available that may help protect them in the event of a crash.

- We are asking you to inspect your sun visors to make sure that the air bag warning labels are securely attached. If the labels are secure, do not take any further action. If any label is distorted, not securely attached or missing, we urge you to replace that label. Enclosed with this letter are two replacement labels for each of the above air bag warning label types. An instruction sheet is enclosed to help you to properly install the replacement labels, if it is necessary.
