RE: Safety Recall 06V-267

Georgie Boy has decided that a defect that relates to motor vehicle safety exists in 2006 and 2007 Landau, Cruise Master and Pursuit motorhomes manufactured between January 21, 2006 and July 6, 2006.

**The following is a field program procedure to ensure the fastening of the Front Television and TV Cabinet for Georgie Boy Pursuit, Landau and Cruise Master Motorhomes. Please follow each step carefully to ensure the proper attachment method will be obtained when you are complete.**

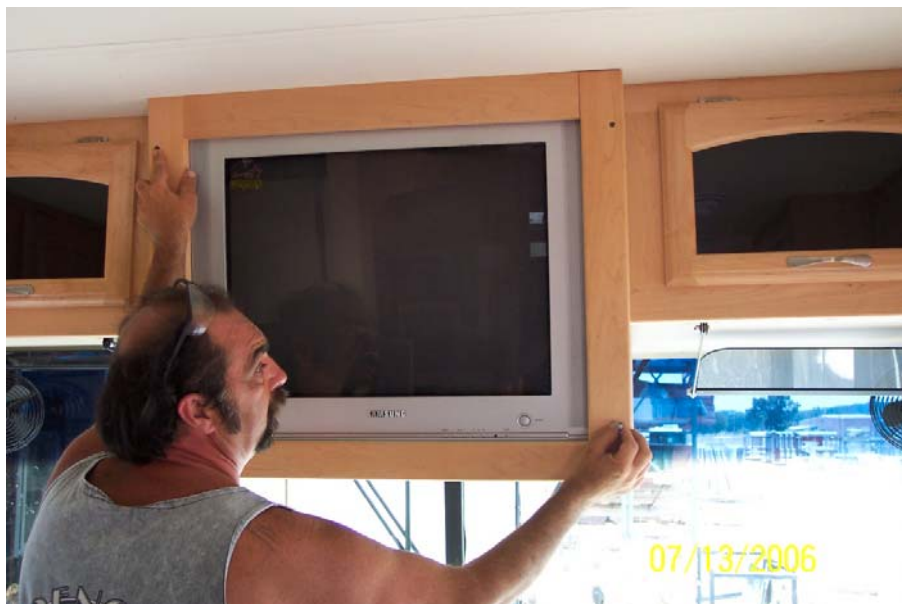
**STEP 1:** Remove the existing Wood buttons and screws from each corner of the TV Trim Ring. The buttons should be easily removed by prying them off with a flat edge paint scraper or similar tool. Be cautious to not scratch the surface of the TV Trim Ring, as a replacement has NOT been provided with this program.

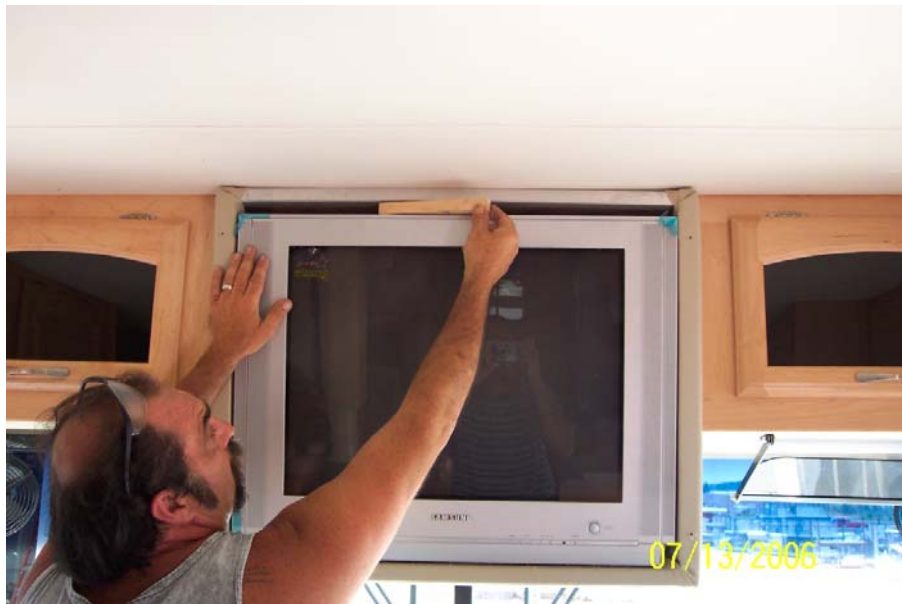
**STEP 2:** Remove the TV Wedge located between the top of the TV and the bottom side of the TV Box. Be CAUTIOUS that the TV doesn't slide from the cabinet, as this wedge is the primary force maintaining its securement.

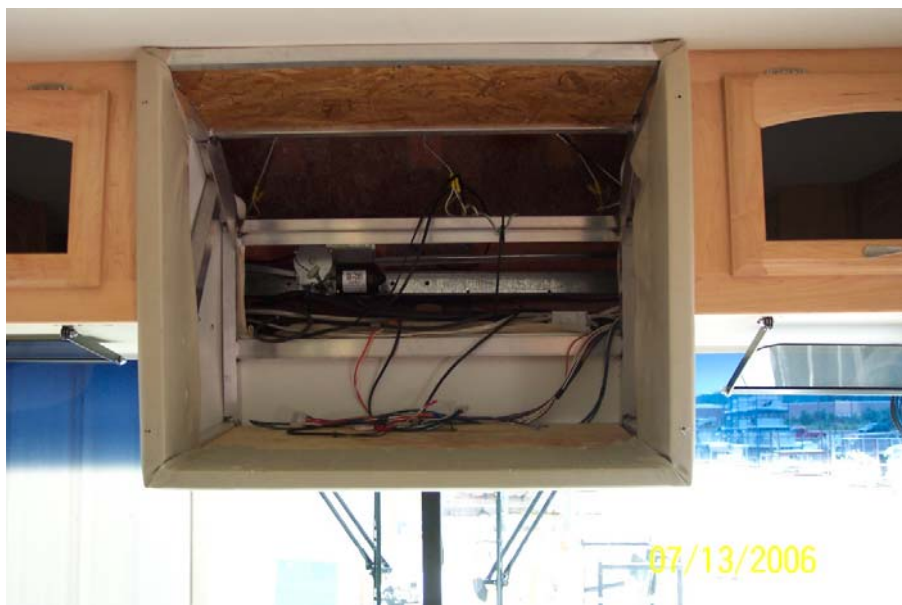
**STEP 3:** To remove TV, disconnect Power Cord, AV Jacks and Cable Wires. Be CAUTIOUS!!! TV is VERY HEAVY. This may require two people due to the size and weight of the TV. Ensure that wires are out of way by securing them to the rear of the TV box.

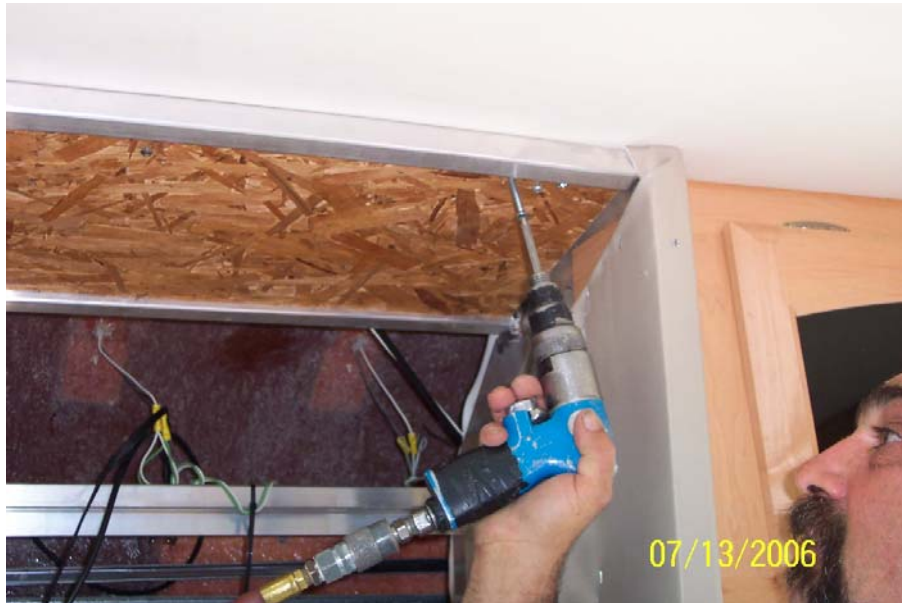
**STEP 4:** Install #8-1 3/4 Rnd Wash Quad screws (10ea) into upper front edge and rear edge of OSB panel (3/4" inward from front and rear edge of OSB).

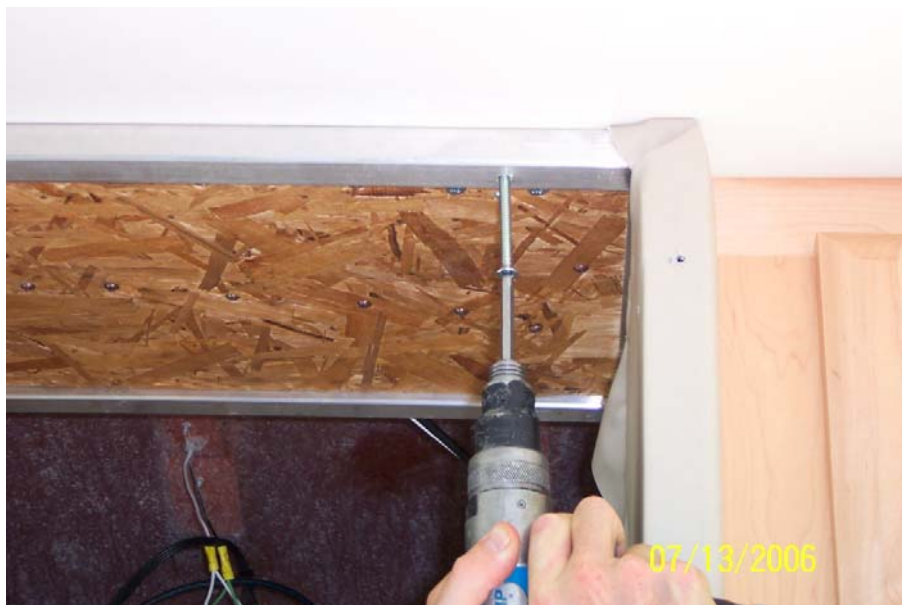
**STEP 5:** Pre-drill TV Box frame with 3/16" drill bit and install 1/4 -20 x 3" Self Tap Flat screws (6ea) equally spaced into upper front Aluminum tube.

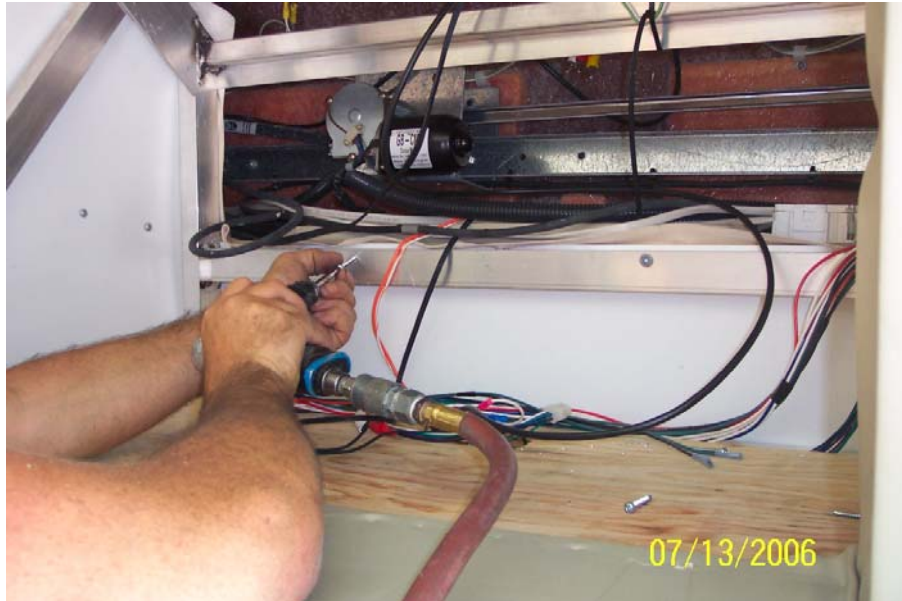
**STEP 6:** Pre-drill TV Box frame and install ¼ - 20 x 3” Self Tap Flat screws (2ea) into Lower Rear Aluminum tube of the TV Box. These fasteners will be secured to the overhead cowl board, try to stay in the top 1/3 of the tube.

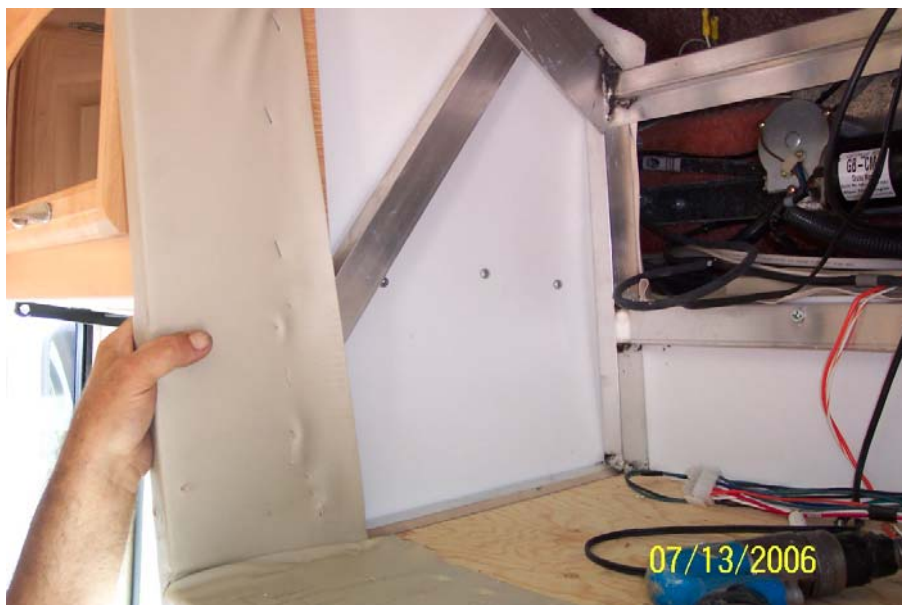
**STEP 7:** Ensure the side fasteners have been installed. If not, install #8- 1 ¾” Round Washer Quad screws (4 per side). You must measure the dimension from the bottom of the outside of the TV Box up to the bottom of the attached side/front cabinet and add 1”. This will locate the fasteners into the bottom of the side/front shelf.

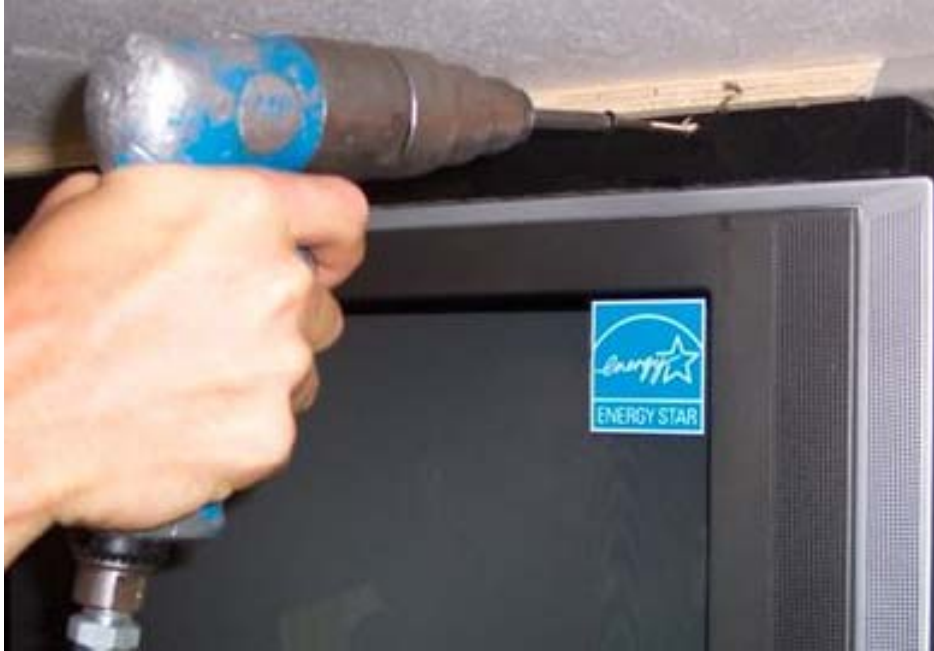
**STEP 8:** Re-Install TV into overhead TV Box and reconnect required power cable and AV Jacks. Install Upper TV Wedge and secure with (4) #8-3” Round Washer Quad Screws ensuring that the screw are angled into the ceiling for proper retention.

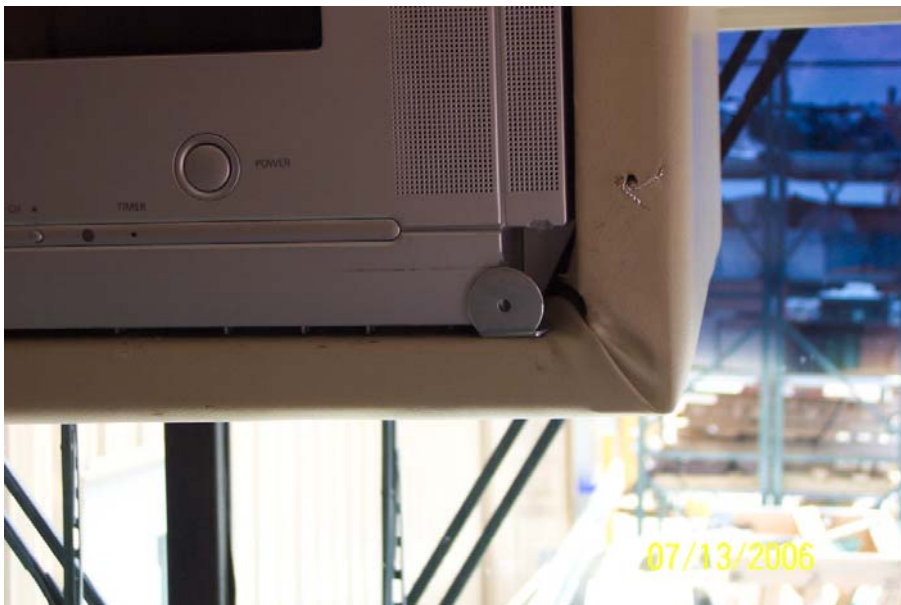
**STEP 9:** Install Bottom Bracket, CRN Zinc Round (2pc) with #8 -3/4” Round Washer Quad Screws.

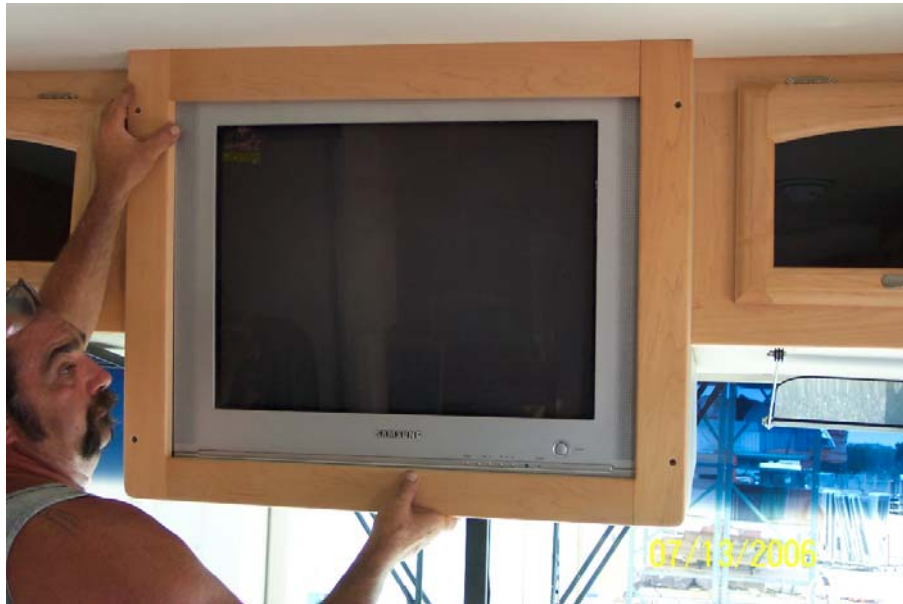
**STEP 10:** Re-Install TV Trim Ring and Buttons.
