MODEL
Rio

NUMBER
064

TECHNICAL SERVICE BULLETIN

SAFETY RECALL CAMPAIGN: 2003MY RIO 4-DOOR AUTOMATIC LOCKING RETRACTOR: FMVSS 208 NONCOMPLIANCE

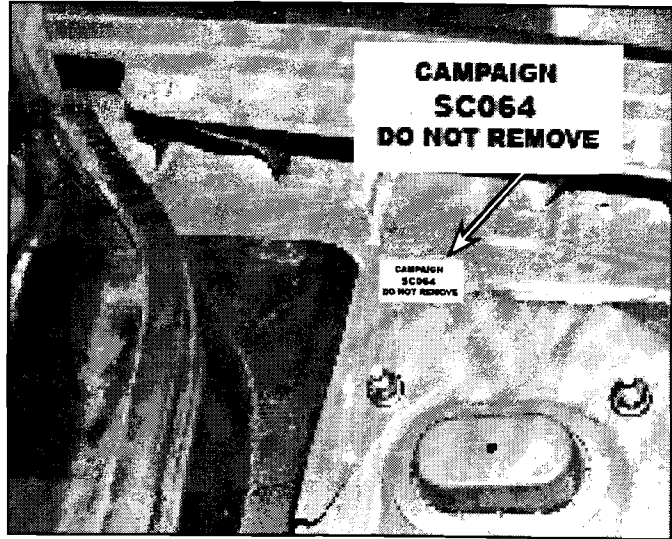
Open the hood and check for SC064 Campaign Completion Label in the engine compartment at the rear of the driver's side strut tower, as shown.

- If label exists, NO FURTHER ACTION IS REQUIRED.
- If label DOES NOT EXIST, continue to Repair Procedure.
