**RE: RECALL CAMPAIGN – CONTINENTAL GT – BRAKE PIPE TO COOLANT  
HOSE CLIP FOUL – RE06/02**

06-01-06-01

**Brakes – Pipe clearance check— Brake pipe to coolant hose clip – RE06/02**

**Applicability:** Bentley Continental GT

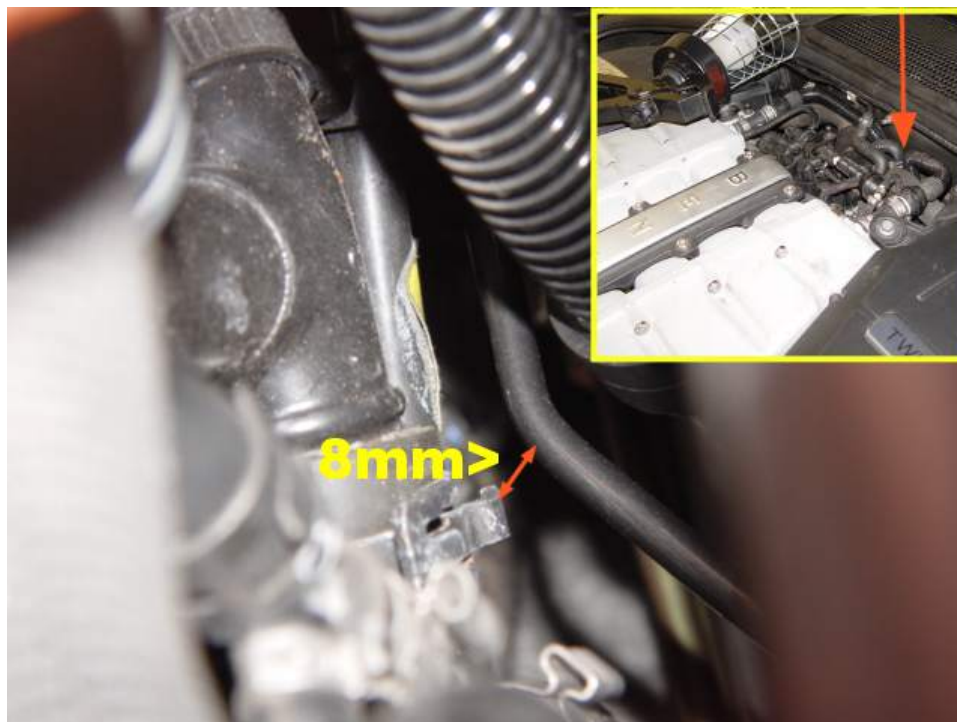
Figure 1

A condition has been identified where the nominal design clearance between the brake pipe (modulator to right hand front brake calliper) and the engine coolant heater hose clip can be compromised. The clip retaining the coolant heater hose can, under certain dynamic conditions, contact the modulator to right hand front brake caliper brake pipe which is secured to the engine bay bulkhead.

1. Raise the bonnet
2. Remove the rear engine cover, to remove gently pull the cover upwards off the ball pins
3. Referencing Figure 1, visually locate the hose clip securing coolant hose (part number 07C121052C) to the coolant pipe (part number 07C121064D)
4. Check the clearance between the coolant hose clip identified in operation 3 and the brake pipe (part number 3W0614724F), the clearance must be greater than 8mm, tool part number WT10067 (Tool Cabinet location AB 16) should be used to check this clearance (See Figure 1)

5. If the clearance is greater than 8mm no further action is required, refit the rear engine cover and affix completion label adjacent to the right hand bonnet hinge (see Figure 4)

If the clearance is less than 8mm, the 3 possible conditions are:

- a. The brake pipe shows no visible sign of a foul
- b. The brake pipe has its protective coating only eroded or missing at the point where the foul has taken place
- c. The brake pipe has its protective coating missing and the pipe outer wall has material damage

6. Check the clearance between the coolant hose clip and the brake pipe and identify the optimum point at which to reform the pipe to give clearance greater than 8mm

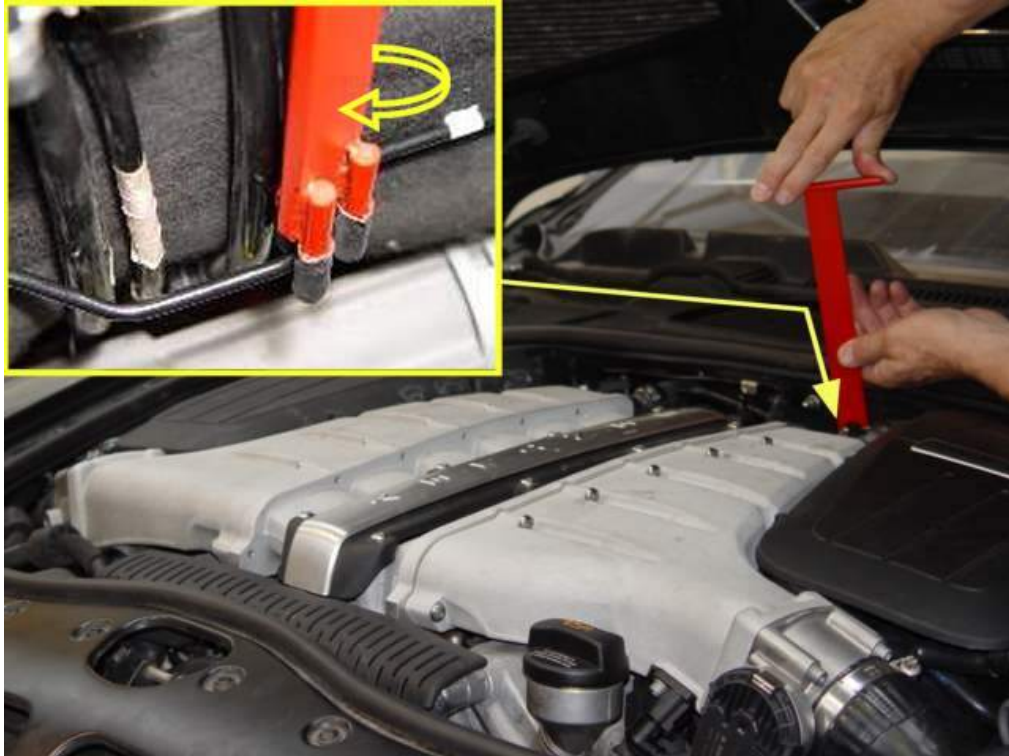
Figure 2

7. Referencing Figure 2, position the pipe forming tool (part number WT10114) onto the brake pipe at the optimum point identified in operation 6
8. Rotate the forming tool until the brake pipe is felt to yield, at this point release the turning force and remove the forming tool, Figure 3 shows the brake pipe after the forming tool has been used with the inset showing the pipe prior to forming, (Note for clarity Figure 3 has been produced with the engine removed)
9. Re measure the clearance between the coolant hose clip and the brake pipe if the correct clearance is still not achieved repeat operation 8 until the correct clearance is achieved
10. With the clearance between the coolant hose clip and the brake pipe now greater than 8mm refit the rear engine cover
11. Affix completion label adjacent to the right hand bonnet hinge (See Figure 4)

**Note:** The forming tool (part number WT10114) is supplied with a quantity of shrink sleeve this is to be used when the protective sleeve pre fitted to the tool becomes worn, do not use the tool if the sleeve is worn as this may damage the brake pipe surface.
