RECALL CAMPAIGN BULLETIN

Reference:
NTB06-083

VOLUNTARY RECALL CAMPAIGN 2007 VERSA; BRAKE FLUID RESERVOIR CAP

CAMPAIGN I.D. / NHTSA # PB024 / 06V-348
APPLIED VEHICLE: 2007 Versa (C11)
APPLIED VINS: 3N1BC13E(*)7L 350001 - 369667

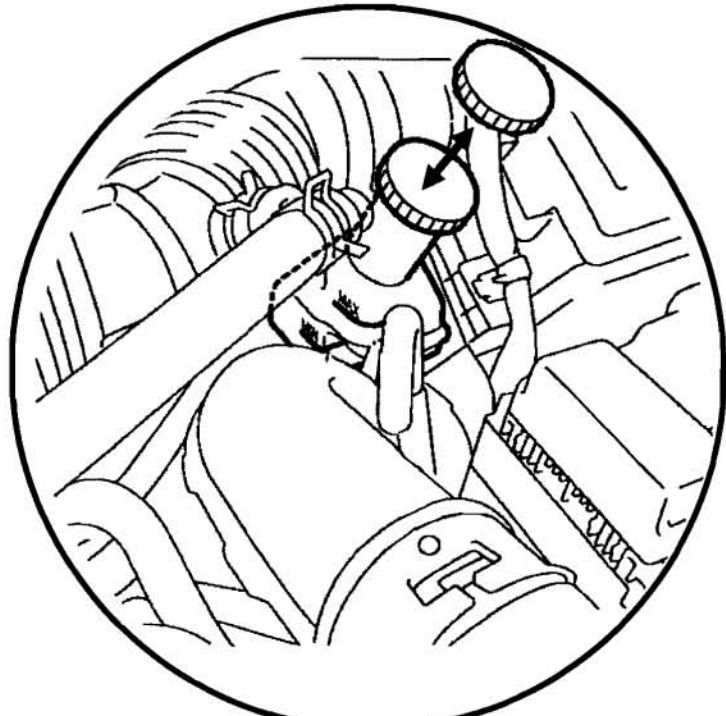
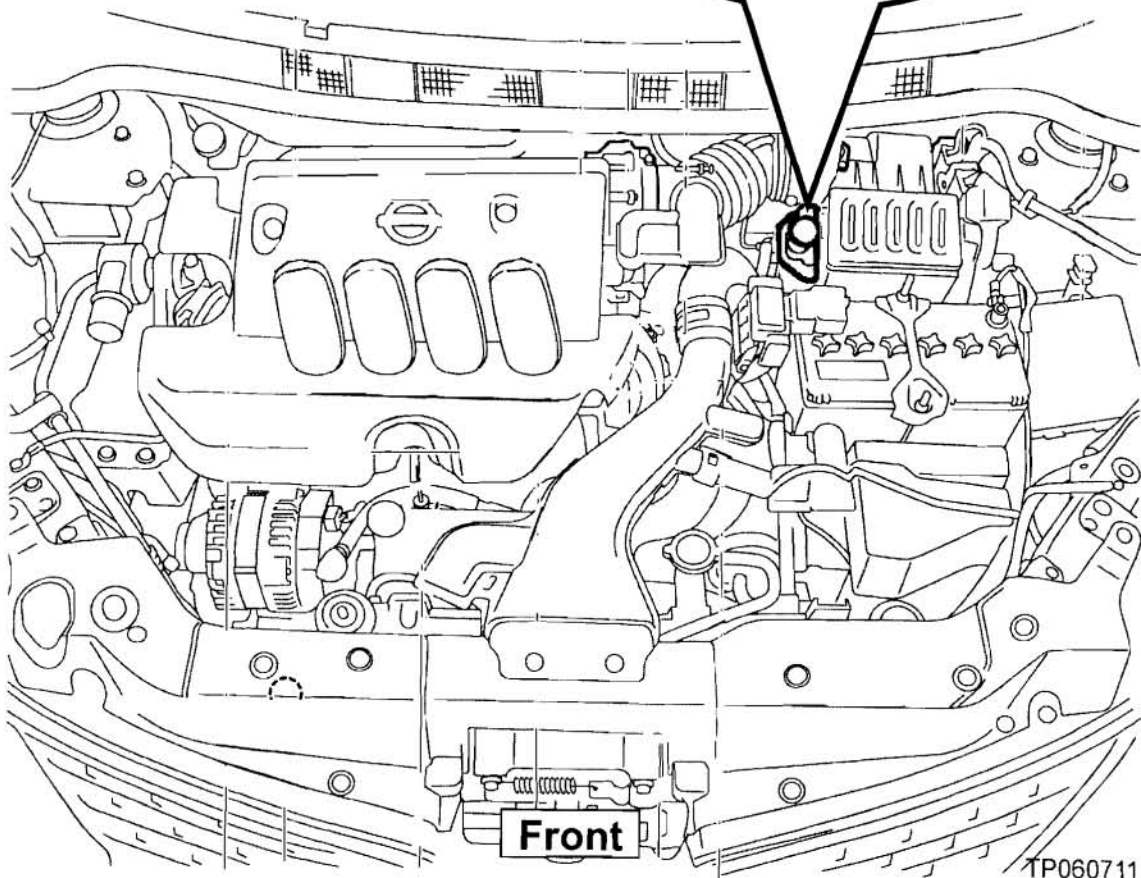
NOTE: The brake fluid reservoir is located under the hood behind the battery.

1. Use a clean cloth to wipe clean the brake reservoir cap and the area around it.
2. Turn the cap counter-clockwise to remove it.
3. Install the new cap. Turn it clockwise until it stops.

The wording embossed on the brake fluid reservoir cap is incorrect and does not contain the statement "WARNING CLEAN FILLER CAP BEFORE REMOVING. USE ONLY DOT3 BRAKE FLUID FROM A SEALED CONTAINER." as required by FMVSS No. 135. To correct this condition, Nissan is conducting a Voluntary Recall Campaign to replace the existing brake fluid reservoir cap with a new brake fluid reservoir cap containing the required labeling.
