MODEL Sedona

NUMBER 065

TECHNICAL SERVICE BULLETIN

SAFETY RECALL CAMPAIGN: 2006 SEDONA EX STOP LAMP SWITCH WIRING REPOSITION

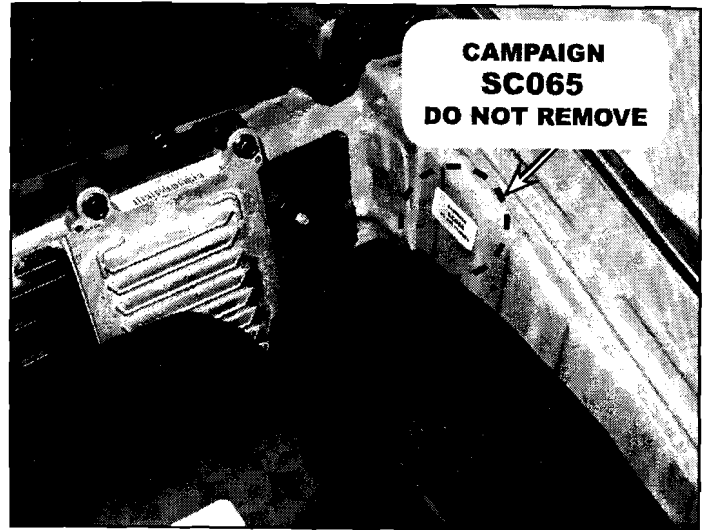
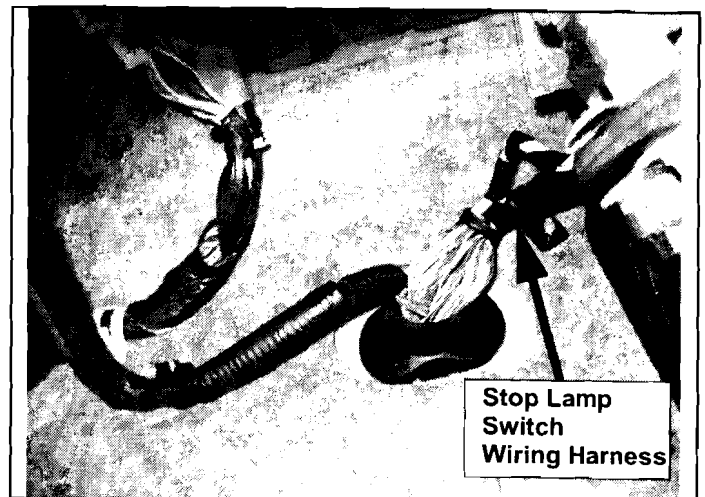
2. Locate the stop lamp switch wiring harness under the instrument panel as shown in photo.
