Subject: Rear Driveshaft U-Joint Strap Kit and Bolts

Bulletin: D100

Campaign #: R0013

Subject: Rear Brake Chamber Air Lines, ABS Sensors and Wiring

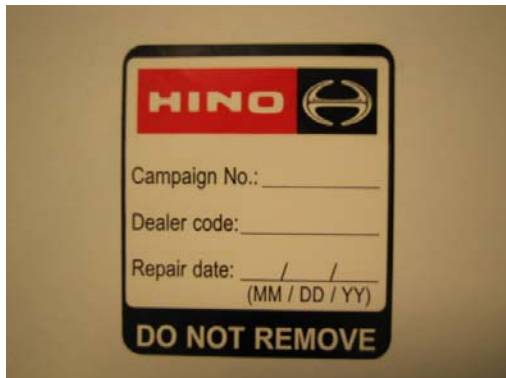
Fill out the Recall Completion sticker as shown in the picture to the left. This sticker should be attached to the door jam above the V.I.N. Plate. Once Recall is completed.

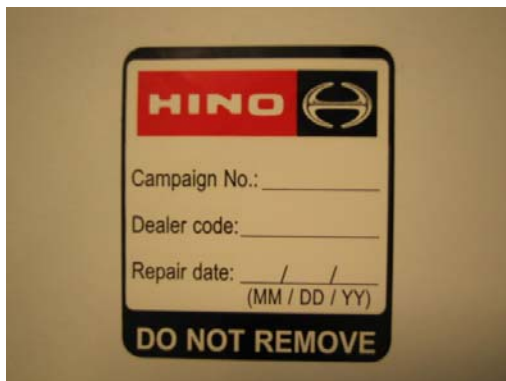
Fill out the Recall Completion sticker as shown in the picture to the left. This sticker should be attached to the door jam above the V.I.N. Plate. Once Recall is completed.

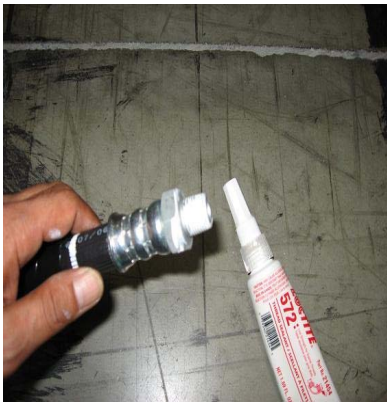
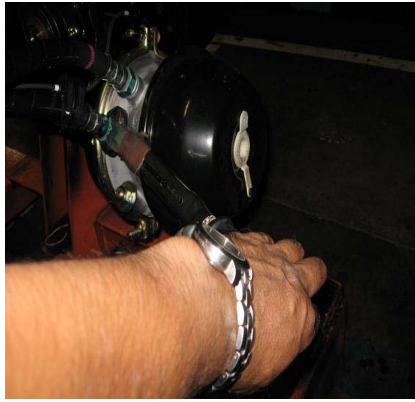
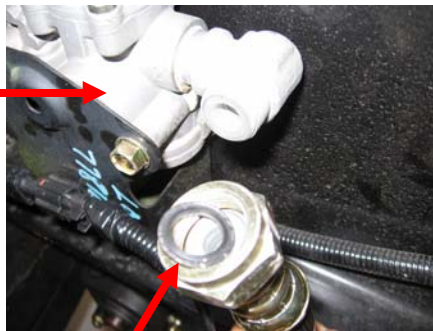
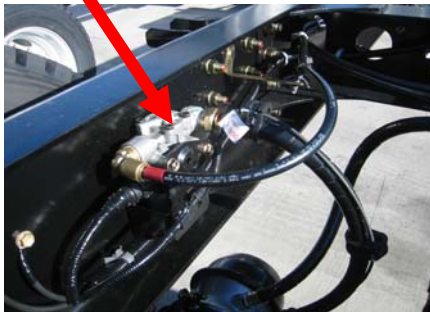
Rear Air Hose Joints

R-1
Service air hose

R-3
Service air hose

R-2
Modulator valve

R-4
Modulator valve

The Photographs to the left are to be used to help identify the location of each fitting.

- Locate the ABS modulator valve inside the left frame-rail above the rear differential.
- Loosen the connection of the air hose located at the #2 delivery ports of the ABS Modulator Valve (**R-2**)
- Remove the service air hose from the brake chamber (**R-1**). Seal threads with sealant and tighten hose into left brake chamber.
- Verify that the sealing washer is in place (**R-5**) at Modulator valve (**R-2**)
- Torque the connection to 31 ft. lbs. using a 1 3/16 crowfoot wrench or a 30mm crowfoot wrench and a ft. lbs. torque wrench.
- When Torque procedure is completed mark the connection with white paint marker pen or equivalent.

- Locate the ABS modulator valve inside the right frame-rail above the rear differential.
- Loosen the connection of the air hose located at the #2 delivery ports of the ABS Modulator Valve (**R-4**)
- Remove the service air hose from the brake chamber (**R-3**). Seal threads with sealant and tighten hose into right brake chamber.
- Verify that sealing washer is in place (**R-5**) at Modulator valve (**R-4**)
- Torque the connection to 31 lbf.ft. using a 1 3/16 crowfoot wrench or a 30mm crowfoot wrench and a ft. lbs. torque wrench.
- When Torque procedure is completed mark the connection with white paint marker pen or equivalent.

- Torque: 31 lbf.ft

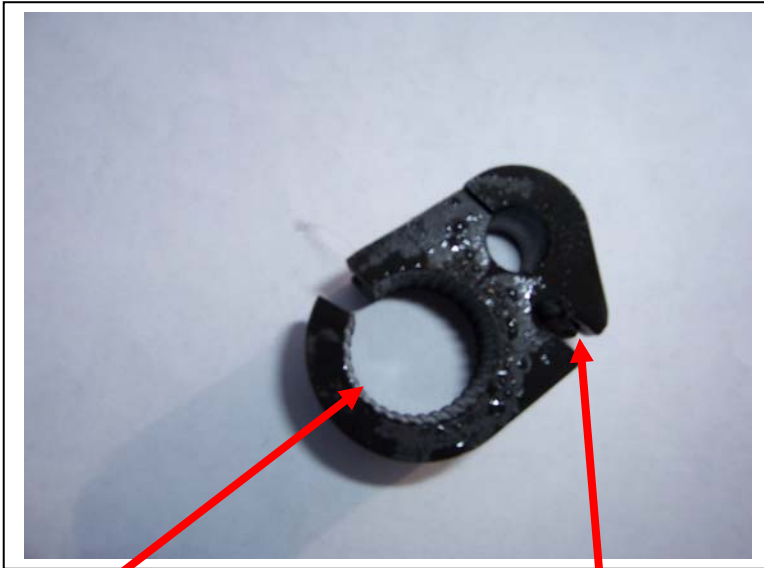
Service Air Line

ABS Sensor Wire

The Photographs are to be used to help identify the location of each component.

- When installing the grommets the large hole wraps around the service brake air hose. The ABS sensor wire is placed in the smaller Slit of the grommet.

- Install 3 grommets on each service brake air hose. Slide in the ABS sensor wire into each grommet and secure with cable tie.
