## Technical Service Bulletin

**Make:** Diamo

**Model:** VELUX

**Component:** FUEL FILL HOSE

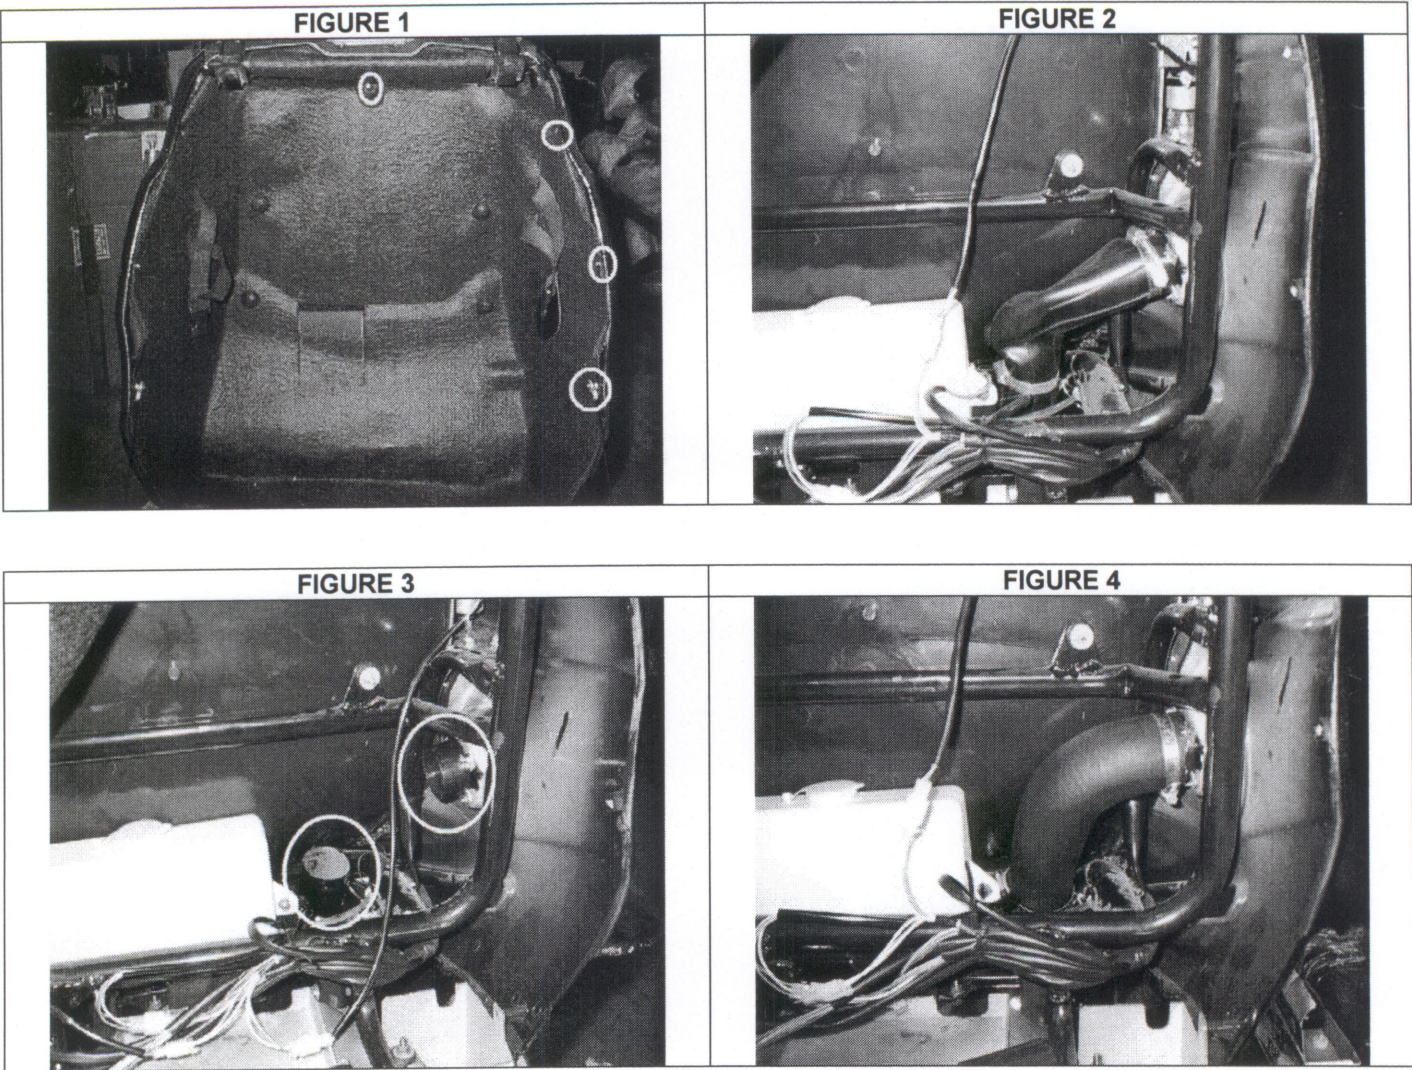
**Figure detail:**

**Issue:** ALL VELUX 150CC AND 250CC MODELS PRODUCED PRIOR TO 9/1/2006 ARE EQUIPPED WITH A FUEL FILL HOSE THAT COULD DEVELOP CRACKS IN THE HOSE RESULTING IN A FUEL LEAK AND POTENTIAL HAZARD FROM FUEL LEAKING ONTO AND NEAR THE ENGINE AND EXHAUST.

- 1) THE FUEL FILL HOSE IS ACCESSED FROM THE TRUNK COMPARTMENT ON ALL VELUX MODELS.
- 2) REMOVE THE UPPER CENTER SCREW AND THE THREE SCREWS FROM THE RIGHT SIDE OF THE FORWARD TRUNK LINER. SEE FIG.1. PULL THE LINER TO THE LEFT TO GAIN ACCESS TO THE FUEL FILL HOSE. SEE FIG. 2.

- 3) LOOSEN THE TWO HOSE CLAMPS THAT SECURE THE FUEL FILL HOSE. THE SEAT MAY NEED TO BE REMOVED TO GAIN ACCESS TO THE LOWER CLAMP, SOME UNITS WERE ASSEMBLED WITH THE CLAMP FACING FORWARD. REMOVE OLD FILL HOSE.

- 4) INSPECT THE FUEL FILL FITTING AND FUEL TANK FITTING FOR DAMAGE. ENSURE BOTH FITTINGS ARE CLEAN AND FREE OF ANY ITEMS THAT MAY INTERFERE WITH THE INSTALLATION OF THE NEW HOSE. SEE FIG. 3

- 5) INSTALL NEW HOSE AND CLAMPS. SOME MINOR TRIMMING MAY BE REQUIRED TO ENSURE A SECURE FIT. HOSE MUST BE INSTALLED IN A MANNER THAT DOES NOT KINK OR TWIST HOSE. USE CARE TO NOT OVERTIGHTEN CLAMPS WHICH COULD DAMAGE THE FITTINGS. SEE FIG. 4
