# RECALL CAMPAIGN BULLETIN

NTB06-090

## VOLUNTARY RECALL CAMPAIGN 2007 MAXIMA STEERING LOCK

**APPLIED VEHICLE:** 2007 Maxima (A34)

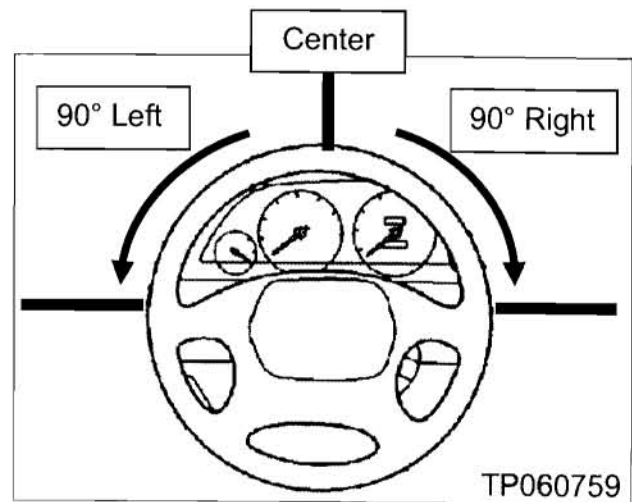
Figure 3

6. Turn the steering wheel 90 degrees to the left and then back to center.

7. Turn the steering wheel 90 degrees to the right and then back to center.

- Steering wheel **did not lock** when turning left and right; **INSPECTION OK**

- Steering wheel **locked** when turning left or right; **INSPECTION NG**

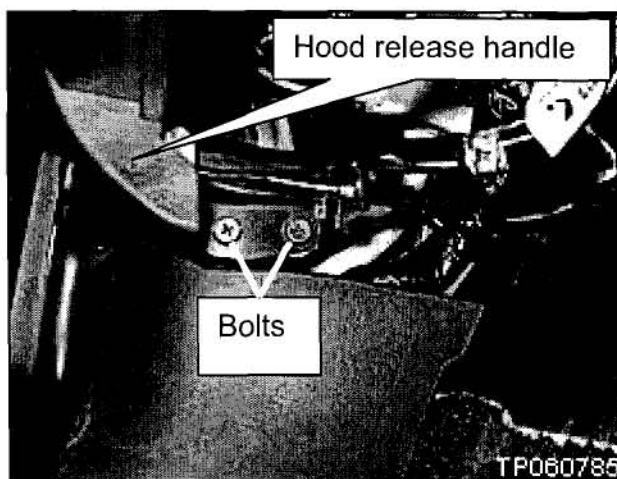
Figure 4

6. Remove the 2 hood release handle bolts.

**NOTE:** This is a side view of the hood release handle.

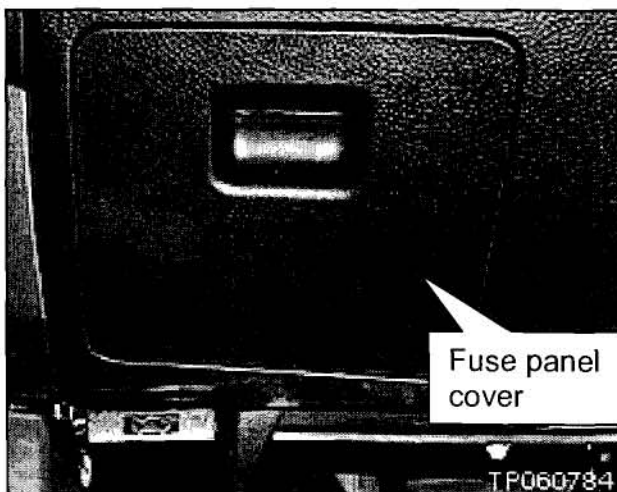
7. Remove the fuse panel cover.

10. Disconnect the 4 connectors shown in Figure 5 from the lower trim panel.

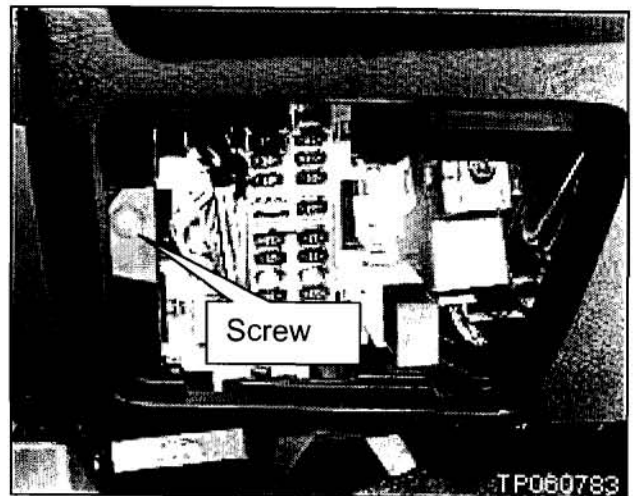
Figure 6

8. Remove two screws from the lower trim panel (see Figures 6 and 7).

- One near the fuse panel.

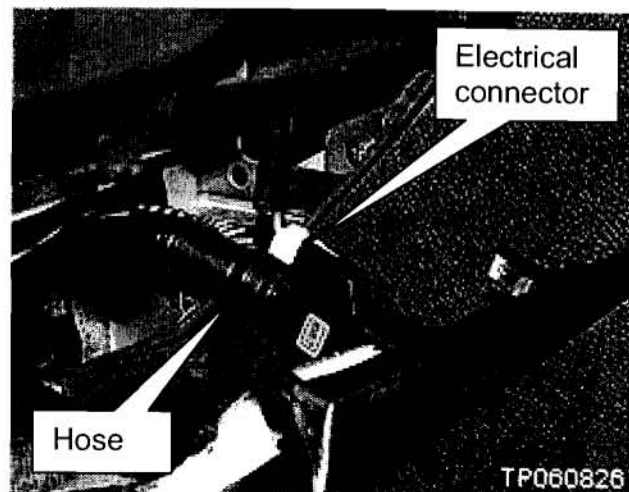
Figure 10

12. Disconnect the temperature sensor hose and electrical connector from the trim panel.

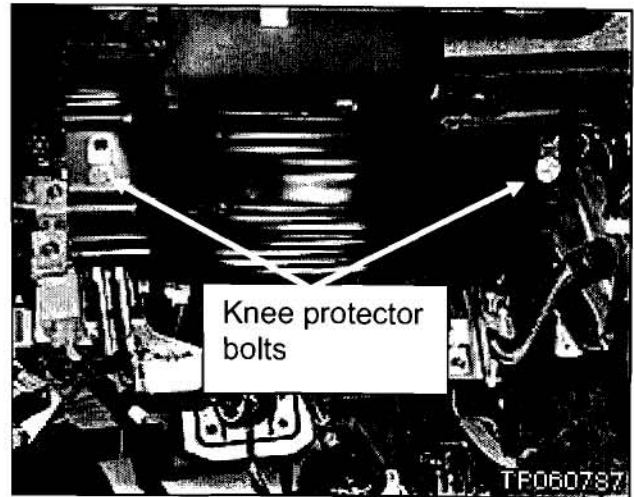
Figure 11

13. Remove the 2 knee protector bolts and remove the knee protector.

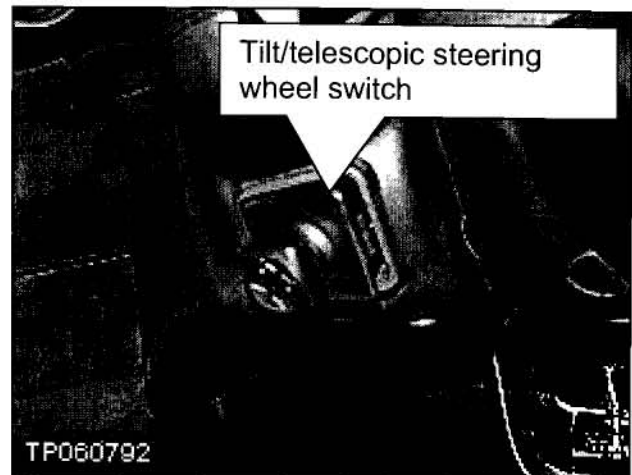
Figure 12

14. If equipped; remove the tilt/telescopic steering wheel switch.

- Use a plastic trim tool to remove—snap out—the switch, then
- Disconnect its electrical connector.

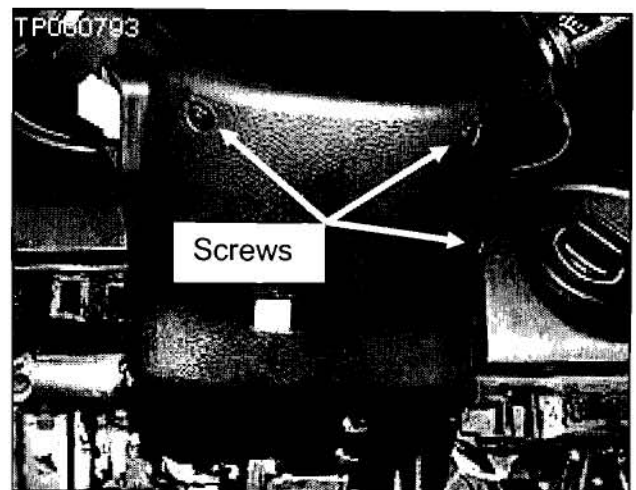
Figure 13

15. Remove the lower steering column cover:

- a. Remove the 3 screws on the lower cover.
- b. Pull straight down on the cover to remove it.

**NOTE:** Do not pry between the upper and lower cover.

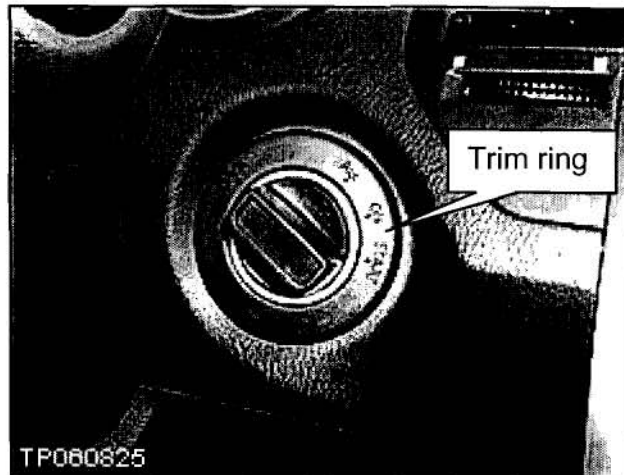
Figure 14

16. Remove the trim ring from around the ignition knob.

- Use a plastic trim tool.
- Pull it straight out (towards the driver seat).

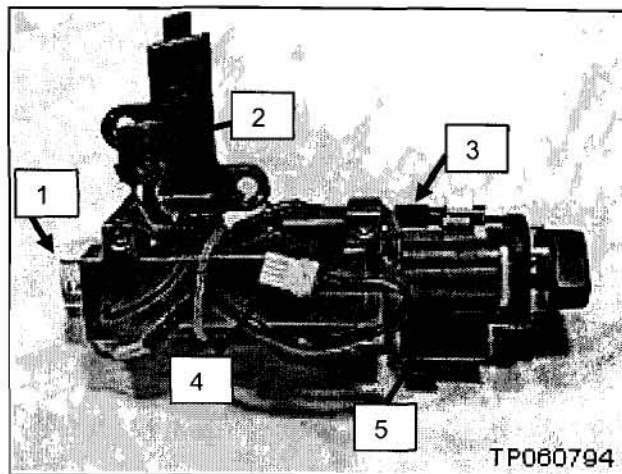
Figure 15

17. Disconnect the 5 electrical connectors from the lock cylinder assembly.

- For easier identification of the connectors, the lock cylinder is shown removed from the vehicle.
- It may be easier to disconnect #3 (lock knob illumination) as you remove the lock cylinder in step 19.

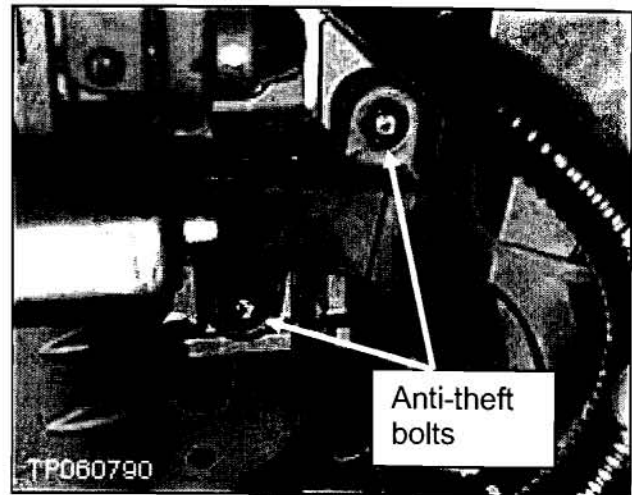
Figure 16

19. Remove the 2 anti-theft bolts from the lock cylinder and remove the lock cylinder from the steering column.

**NOTE:** A sharp punch and hammer can be used to loosen the bolts by tapping the bolt heads counterclockwise.

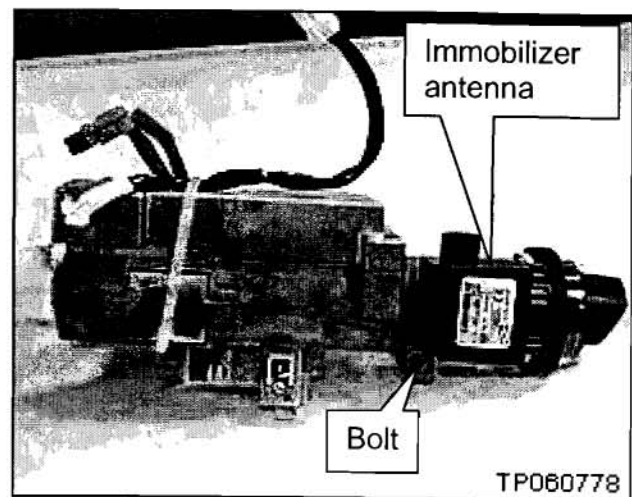
Figure 17

20. Remove the immobilizer antenna:

a. Remove the bolt.

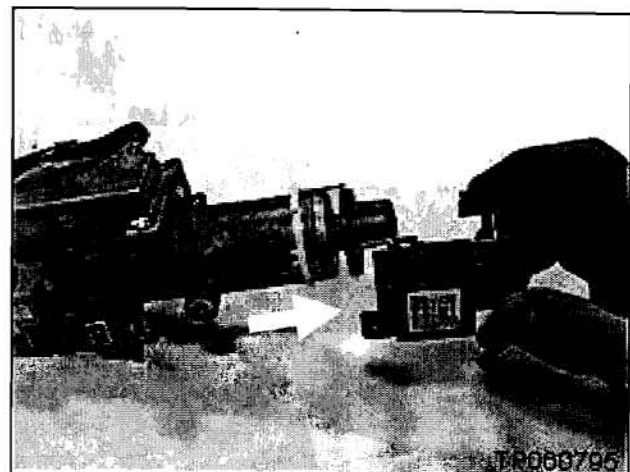
Figure 18

b. Remove the antenna (slide it off) and set it aside.

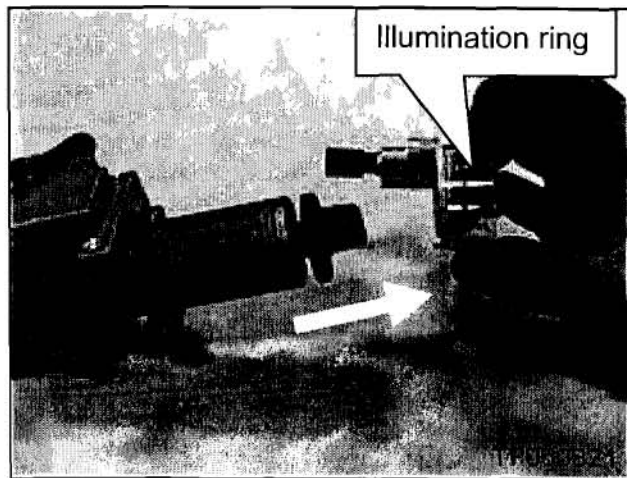
Figure 19

21. Remove the illumination ring (slide it off) and set it aside.

**NOTE:** The old ignition knob will not be reused.

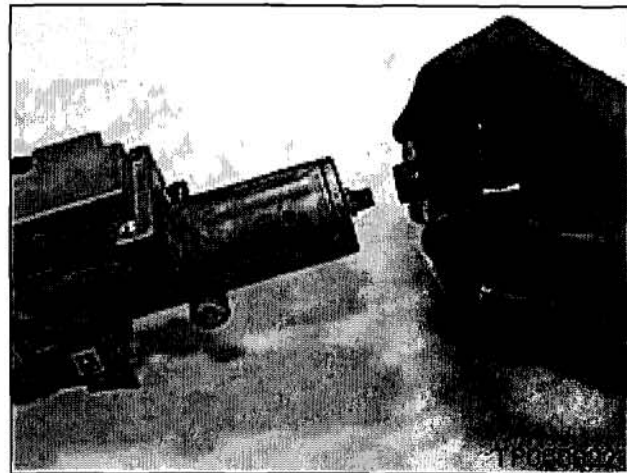
Figure 20

22. Install the new ignition knob on the new lock cylinder.

- Make sure to use the right color.
- The knob goes on only one way.
- Push it on until it snaps in place.

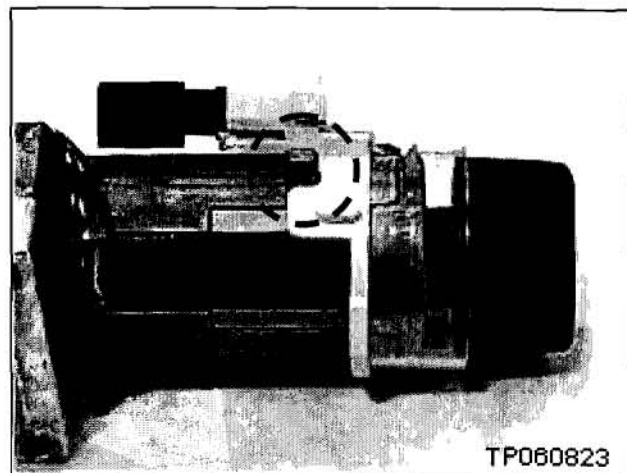
Figure 21

23. Install the illumination ring on the new lock cylinder:

- Make sure the slot is aligned with the tab shown in Figure 21.

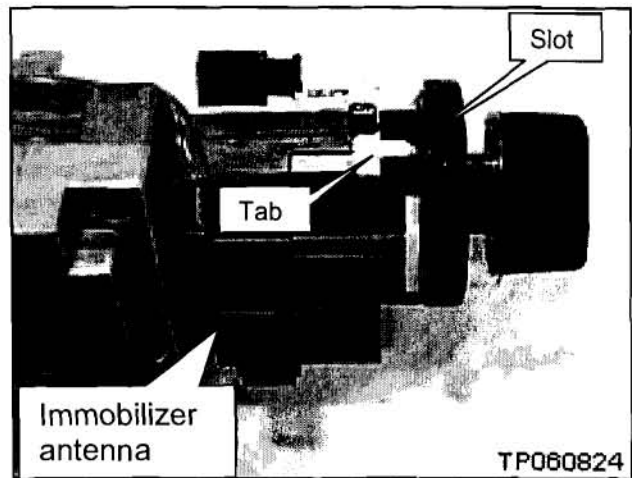
Figure 22

24. Install the immobilizer antenna on the new lock cylinder:

- Make sure the slot is aligned with the tab as shown in Figure 22.

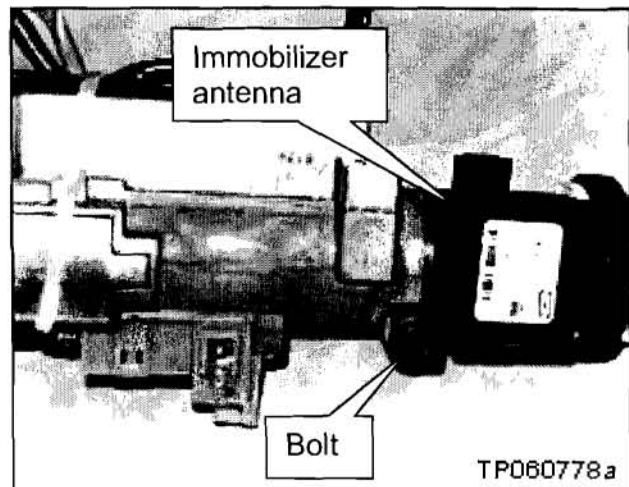
Figure 23

- Install the antenna mounting bolt.

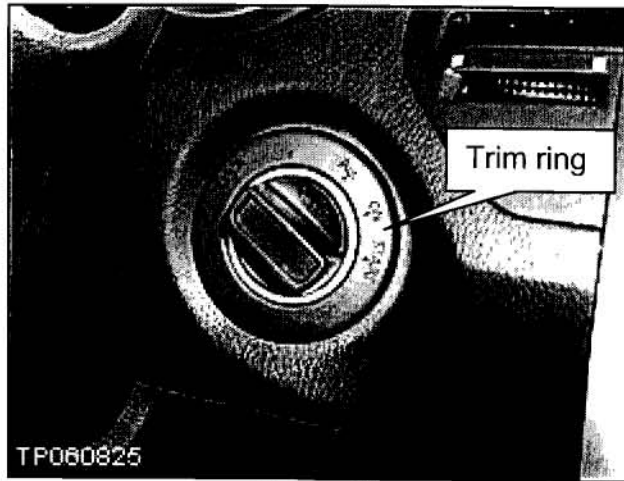
Figure 24

27. Install the trim ring around the ignition knob.

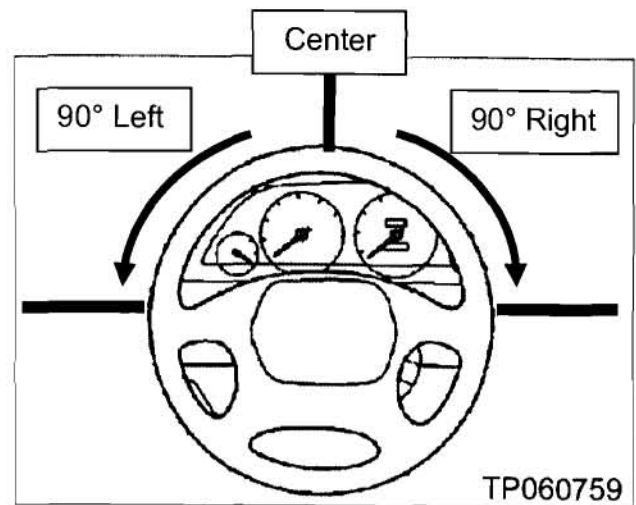
Figure 27

34. Turn the steering wheel 90 degrees to the left and then back to center.

35. Turn the steering wheel 90 degrees to the right and then back to center.

- The steering wheel should not lock when turning left and right.

- If the steering wheel locks:
  - a. Turn ignition knob to ON.
  - b. Place shift selector in Park.
  - c. Turn ignition knob to LOCK.
  - d. Loosen the anti-theft bolts.
  - e. Reposition the key cylinder assembly.
  - f. Then re-snug the bolts—do not break OFF the bolt heads yet.
  - g. Repeat steps 29 through 35.
