# **SAFETY RECALL**

## **CAMPER MOUNT REPLACEMENT**

| <b>Subject:</b><br><br><b>SAFETY RECALL</b> Required Front Camper Mount Inspection and Replacement | <b>Bulletin No:</b> 0008 rev C |
| | <b>Issued:</b> 12/28/2006 |

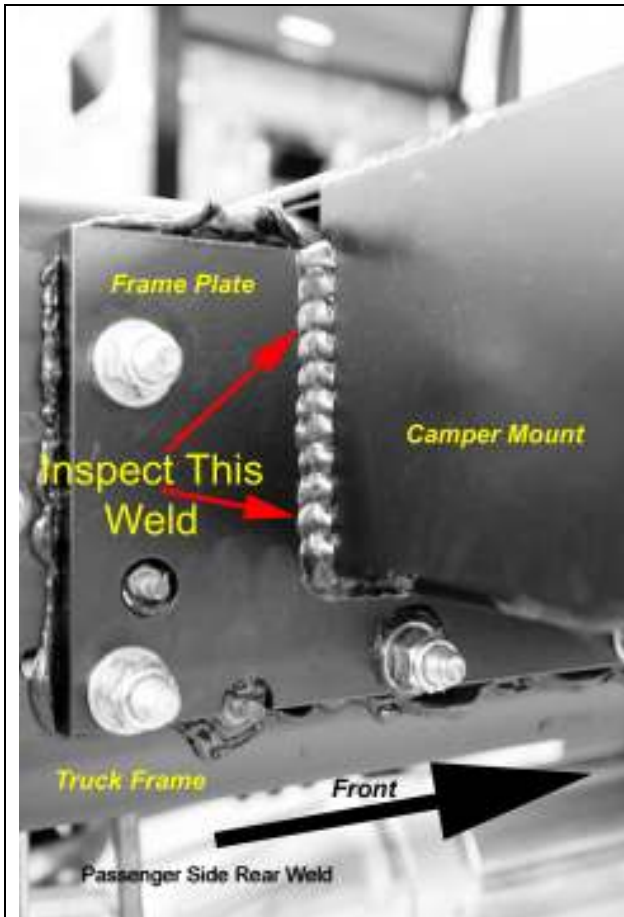
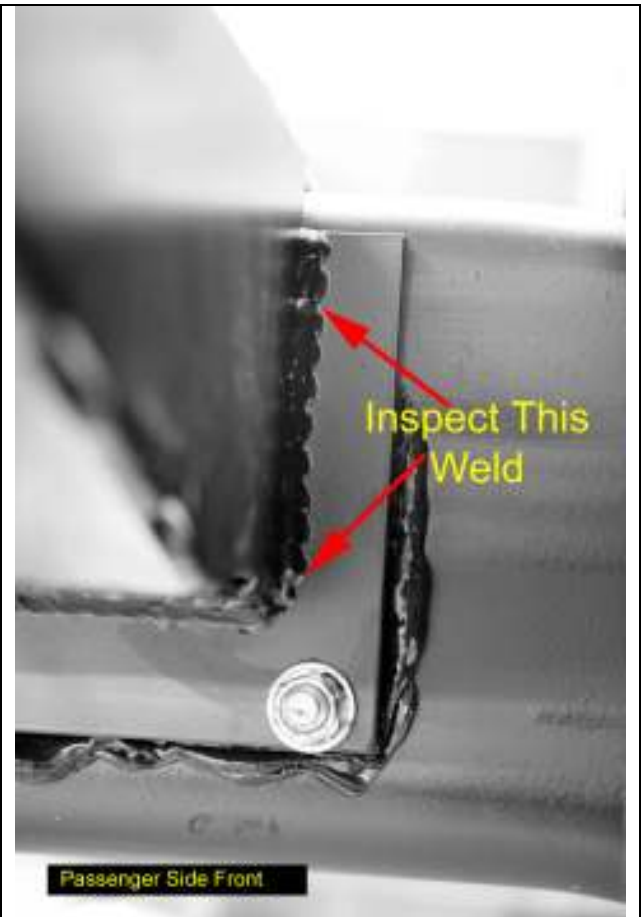
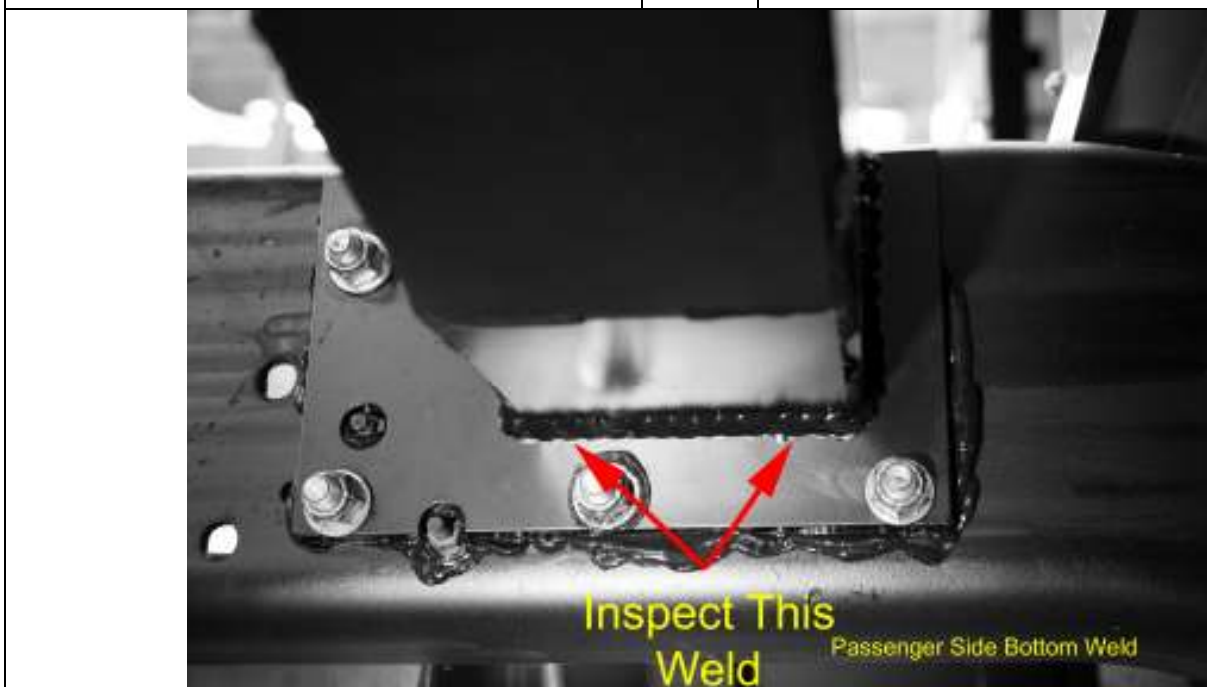
## Passenger Side

Camper mount before camper has been installed. These photos show revision D mounts with a continuous weld bead. Your mounts will be stitch welded.

All revision B or C front camper mounts will need to be replaced with current revision mounts as soon as feasibly possible to ensure driver safety. Each circumstance will be addressed and the repair method handled individually.

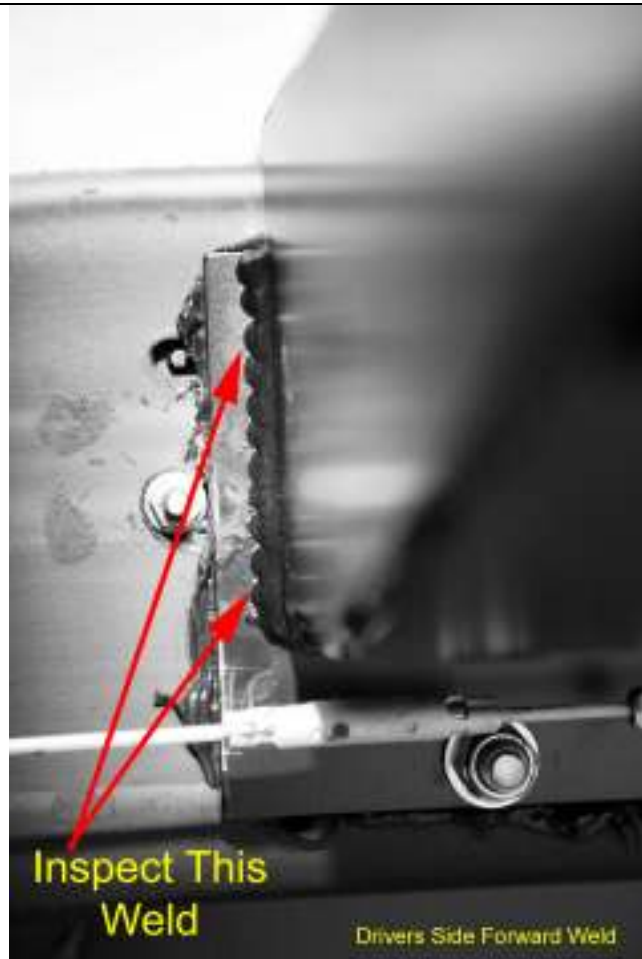
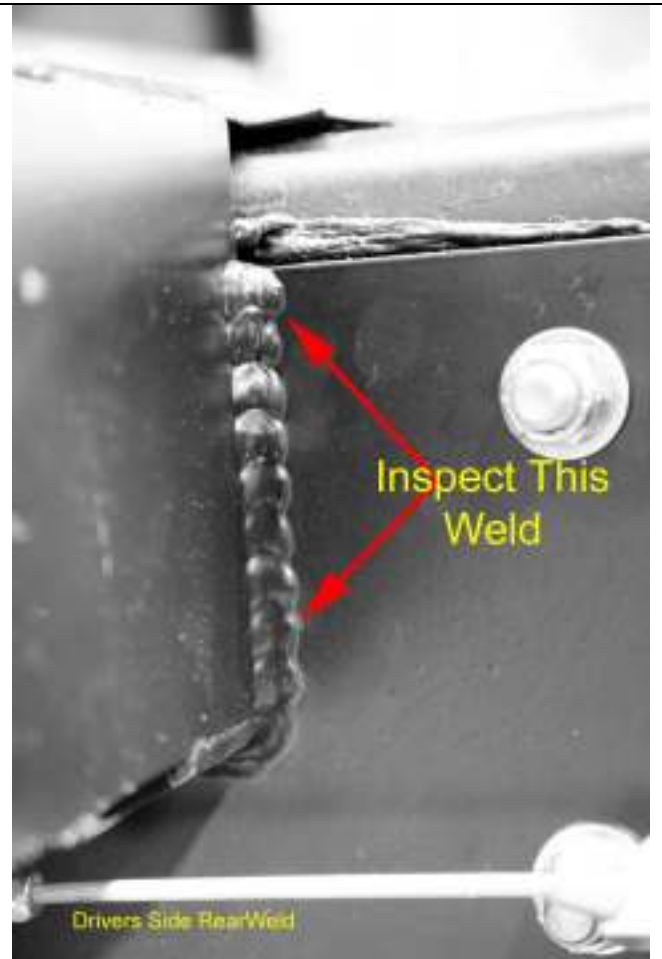
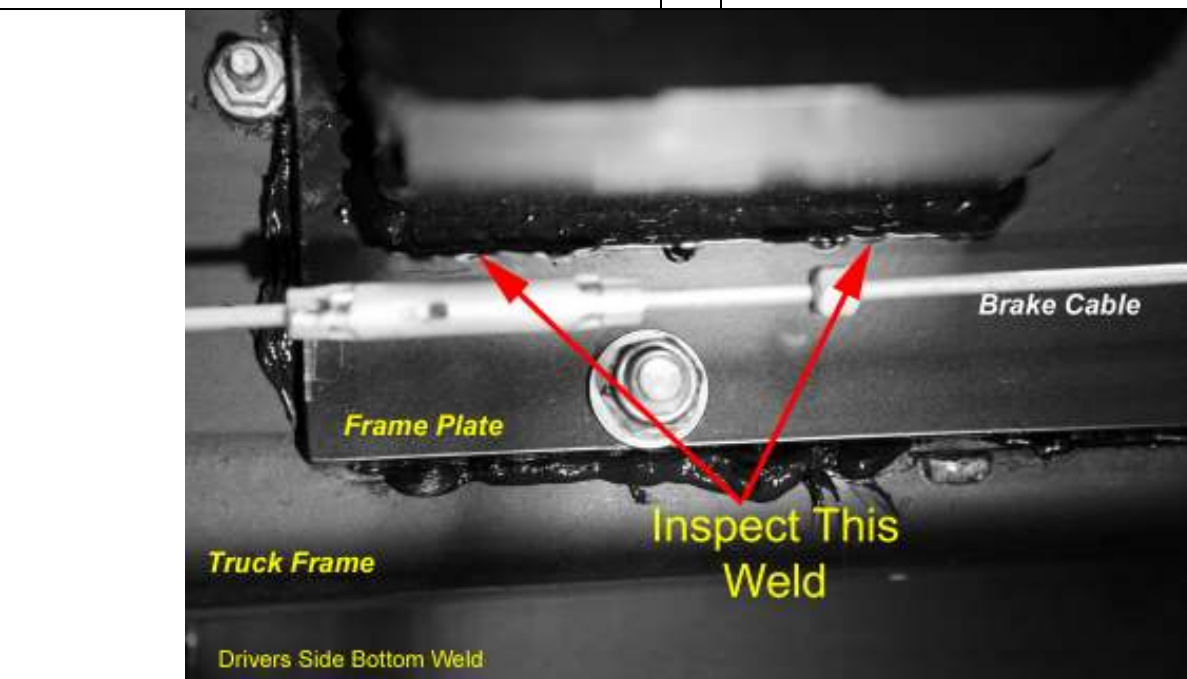
## Driver Side

Camper mount before camper has been installed. These photos show revision D mounts with a continuous weld bead. Your mounts will be stitch welded.

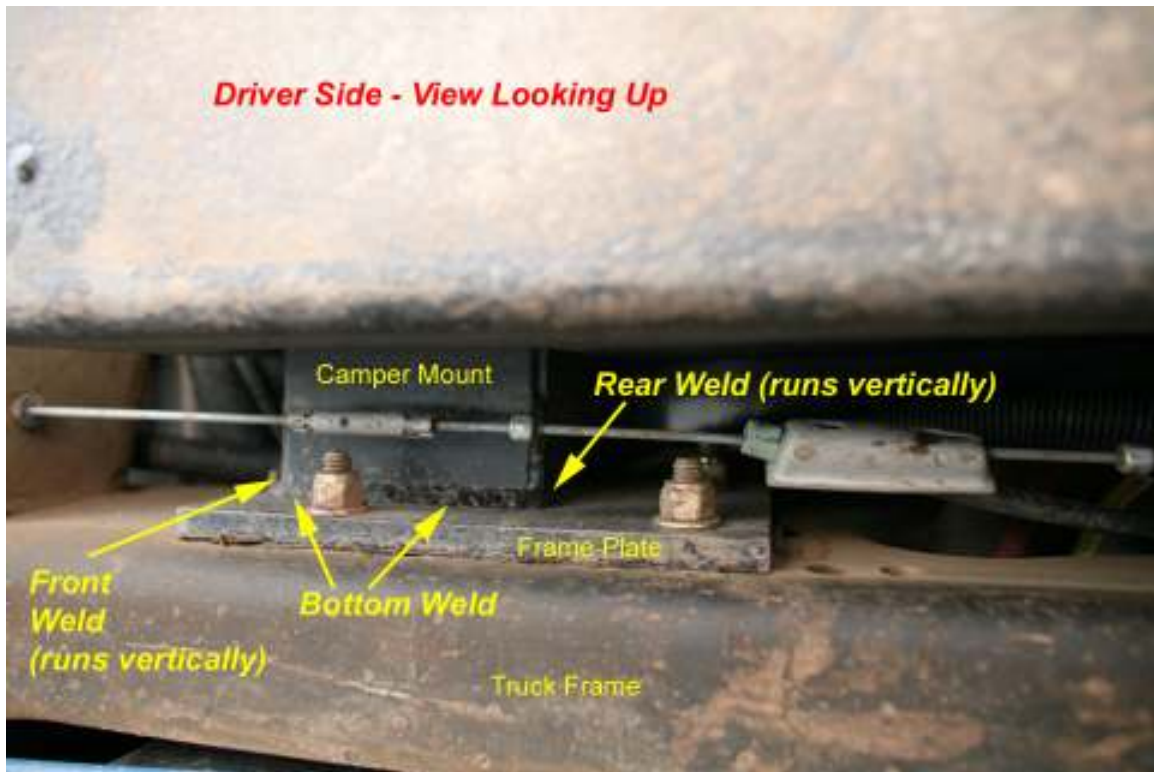
## Camper mount after camper has been installed
