**SUBJECT: Campaign #103 -TV STRAP BOLTS**

Winnebago Industries, Inc. has decided a safety defect which relates to motor vehicle safety may exist where incorrect fasteners were used to secure the television located in the front overhead area of the motor home. The television may become loose and possibly fall from its position which has the potential to impact the driver or passengers, resulting in personal injury and/or vehicle and property damage.

## INSTRUCTIONS TO PERFORM CAMPAIGN 103 TELEVISION STRAP BOLTS

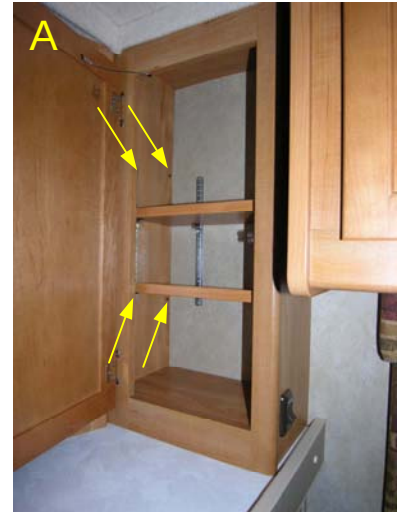
1. Remove the shelves in the cabinet to the right of the television. Unscrew the left side panel in the cabinet. (Photo A)

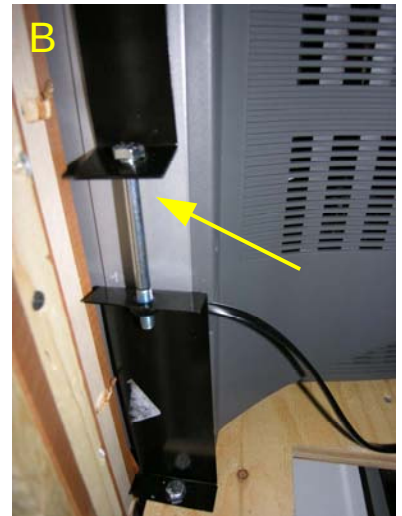
2. Inspect the bolt holding the straps together on the right side of the television. You may want to use a mirror and flashlight to easily see the bolt. (Photo B)

4. Remove the bolt holding the straps together on the right side of the television. (Photo B)
5. Remove the television from the cabinet and set aside.
6. Make note of which hole the strap is bolted to on the left side. There are two attachment locations. Remove both straps from the cabinet.

14. Fasten the straps together with the new 4" bolt. (Photo B)
  - a. Hold the lower strap so it will not turn and cause harm to the television casing.
  - b. While tightening the bolt, ensure the strap is tight, but not to the point of causing damage to the television.

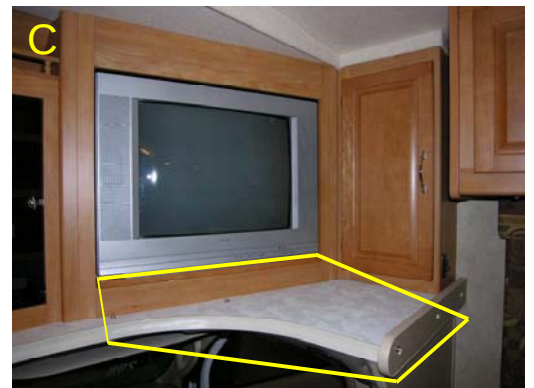
- b. If this bolt does not have blue thread lock compound, you will need to replace all three bolts securing the strap. Continue to Step 3.
3. Protect the bottom edge of the television cabinet and surrounding areas with masking tape and carpet squares, or equivalent. (Photo C)

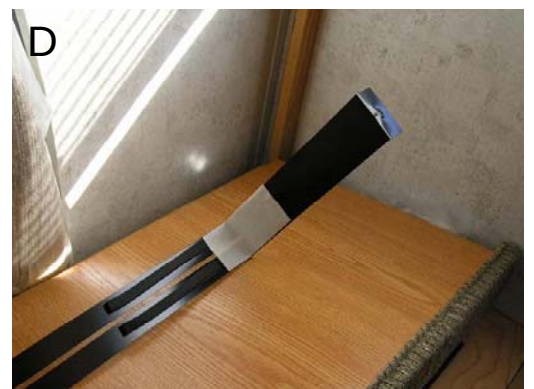
7. Cut the 12" piece of adhesive into two 6" pieces. Remove paper from one side and place adhesive in the corners of the strap. If there is foam tape in the way, cut away the interfering sections. A typical strap has been shown in the picture. (Photo D)

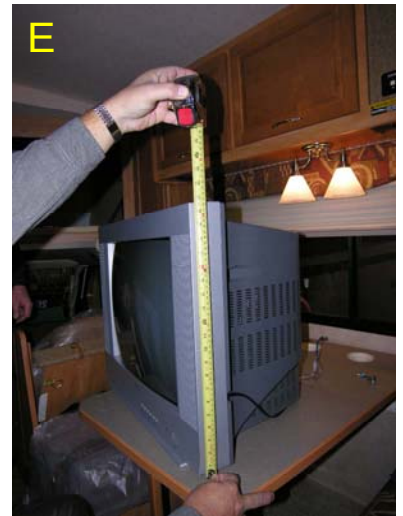
9. Measure the television from the base to the top to ensure proper height for the left strap. (Photo E)
10. Reinstall the left side of the strap with the new 3" bolt. Position it so the top inside corner of the strap is the same height as the television. (Photo F) Make sure to bolt it through the original hole to ensure proper fit.
