RECALL CAMPAIGN BULLETIN

NTB07-009

VOLUNTARY RECALL CAMPAIGN 2004 – 2006 TITAN REAR DOOR HARNESS

CAMPAIGN I.D. # R0616
 NHTSA #: 06V-459
 APPLIED VEHICLES: 2004 – 2006 Titan (A60) King Cab only
 APPLIED VINs: 2004: 1N6*A06A*4N 500006 - 593463
 1N6*A06B*4N 500000 - 593471
 2005: 1N6*A06A*5N 500002 - 580219
 1N6*A06B*5N 500007 - 580226
 2006: 1N6*A06A*6N 500003 - 576810
 1N6*A06B*6N 500000 - 576805

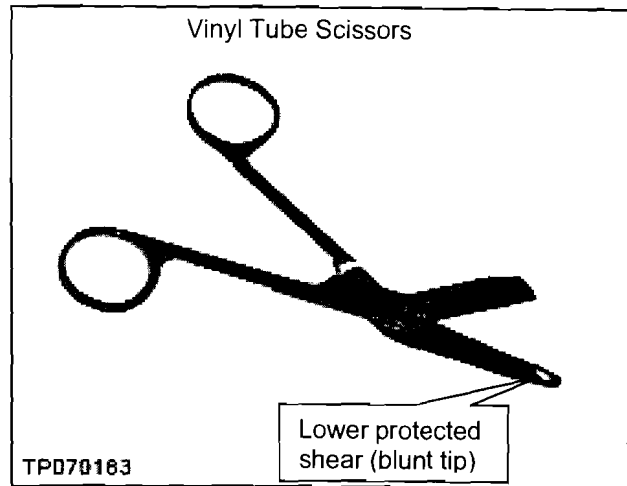
- Each dealer was shipped one pair of Vinyl Tube Scissors.
- Use these scissors when removing the wiring harness vinyl tubing during the installation of the Update Kit.

CAUTION: It is very important that you use the Vinyl Tube Scissors when removing the wiring harness vinyl tubing. Failure to use the Vinyl Tube Scissors for this procedure could cause damage to the electrical wiring and may affect vehicle electrical system functions.

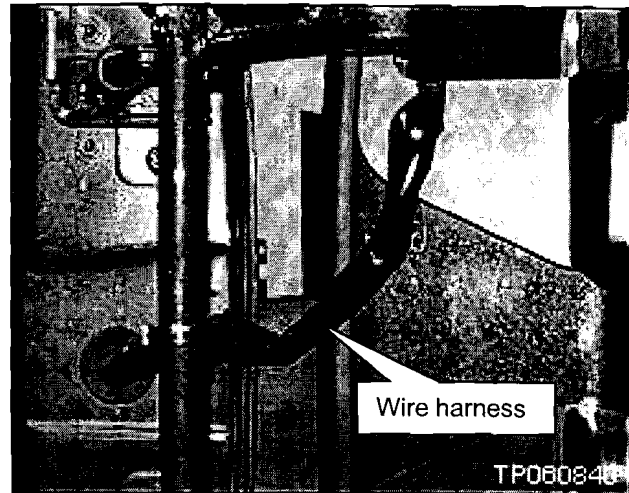
Figure A1

1. Open the rear door and locate the harness in the door hinge area.

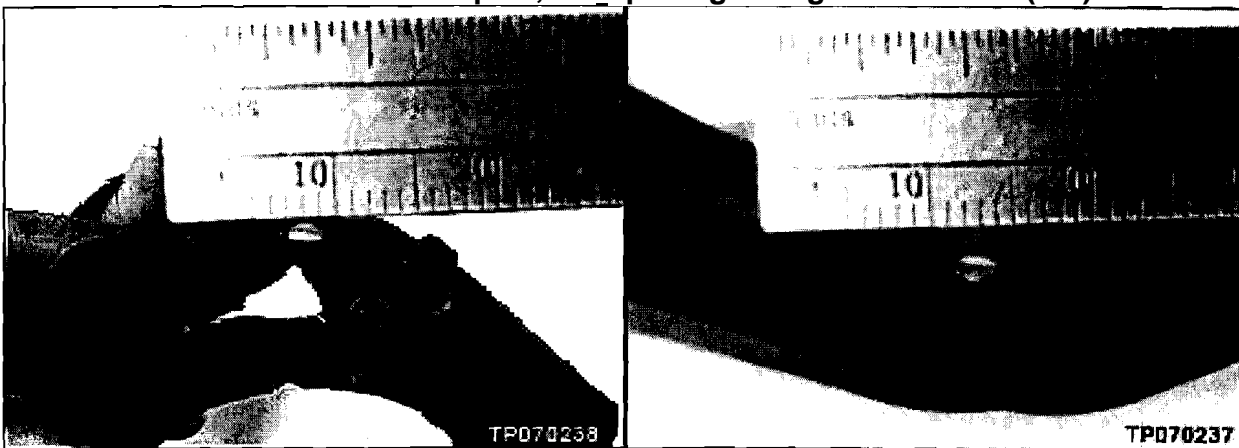
Figure A2

2. Inspect the wire harness vinyl tube:
 - Inspect the entire visible area.
 - Look for worn areas, tears, and/or slits

In both of these examples, the opening is larger than 2 mm (NG)

3. Any areas where you can see the wires inside the vinyl tube, measure the size of the opening.
 - OK; no opening in the vinyl tube or opening is 2 mm or smaller; replace the vinyl tube with the corrugated tube – Update Kit (see page 7).
 - NG; opening in the vinyl tube is larger than 2 mm: Replace the wire harness (see page 14).

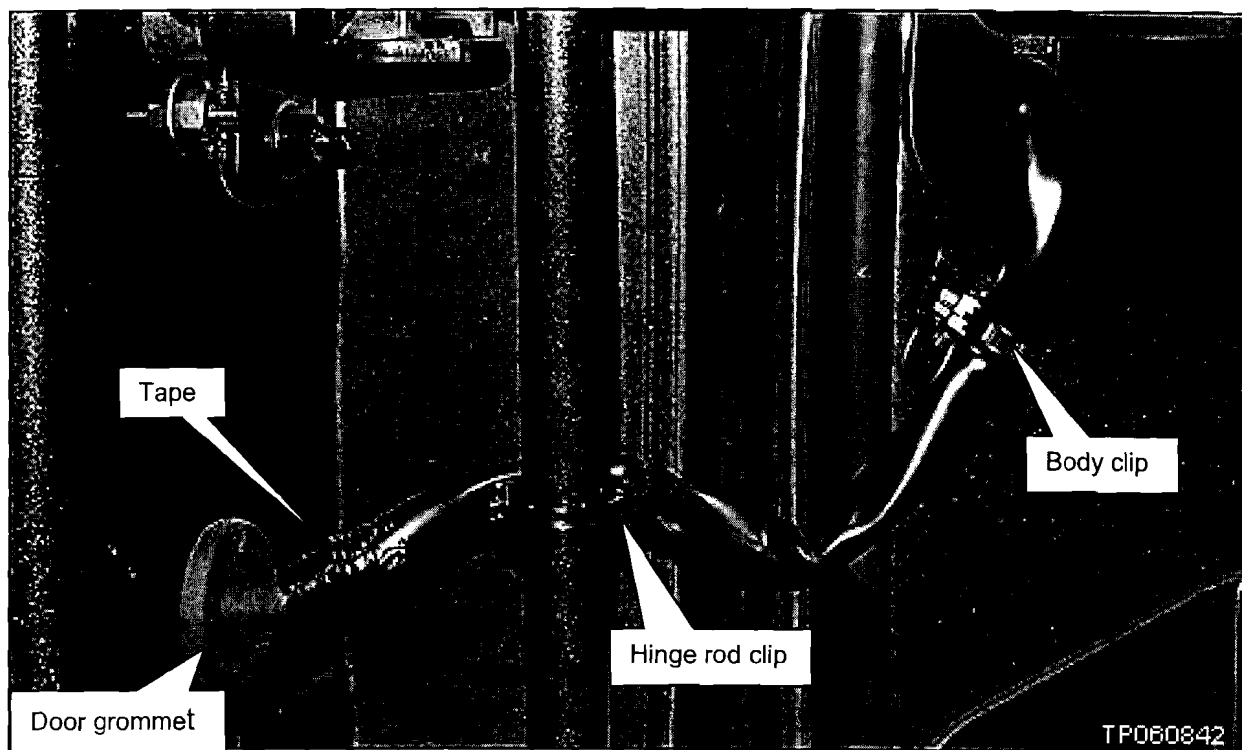
1. Remove the body clip from the body (see Figure B1).
2. Remove the hinge rod clip from the hinge rod (see Figure B1).
3. Cut both clips off of the harness.

4. Remove the tape that is holding the door grommet to the vinyl tube (see Figure B1).

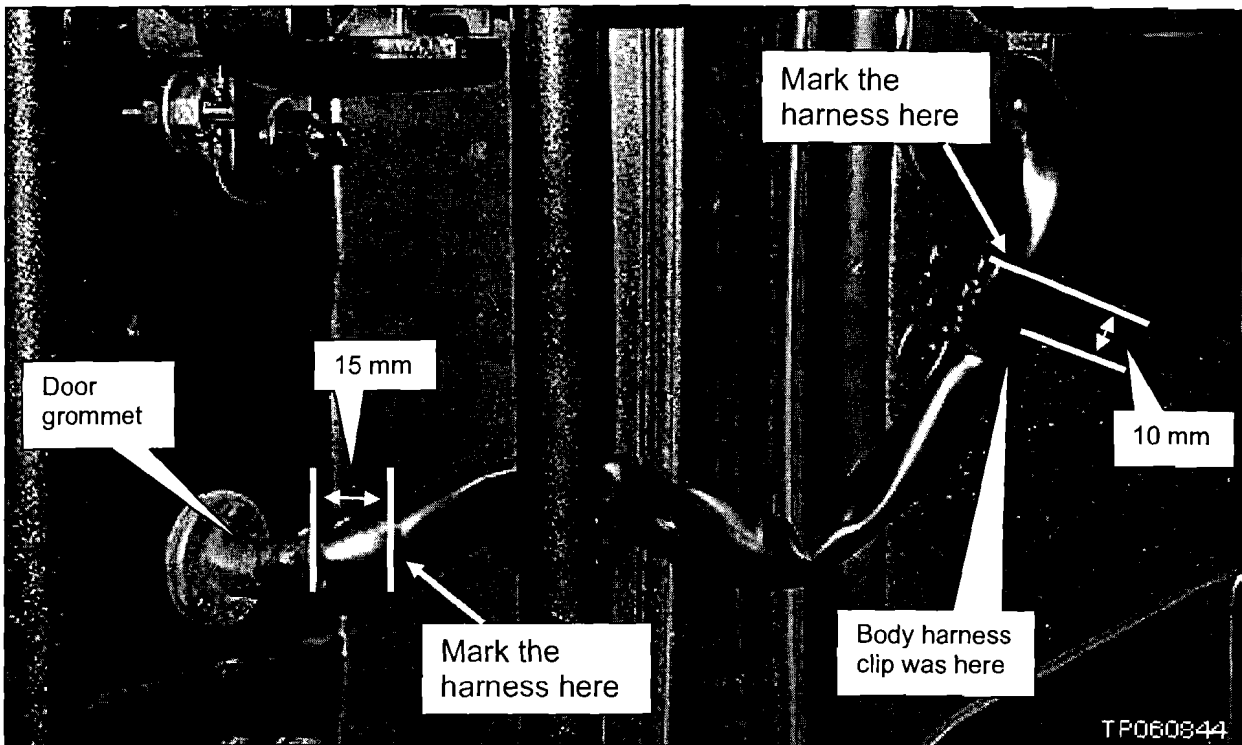
Figure B2

5. Mark the harness vinyl tube 10 mm above the spot where the body harness clip was located (see Figure 62).
6. Mark the harness vinyl tube 15 mm from the door grommet (see Figure 62)

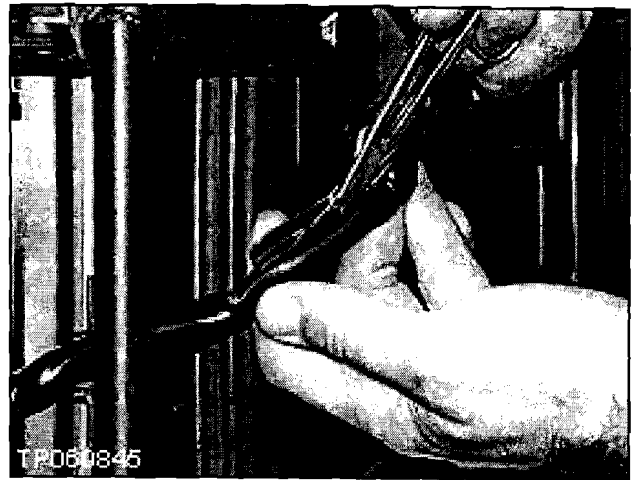
Figure B3

Using the Vinyl Tube Scissors, **carefully** cut off the vinyl tube between the marks you made in steps 5 and 6.

- **DO NOT** use a razorblade.
- Keep the lower (protected — blunt end) shear of the scissors towards the wires inside the vinyl tube.
- Don't damage the wires inside the vinyl tube.

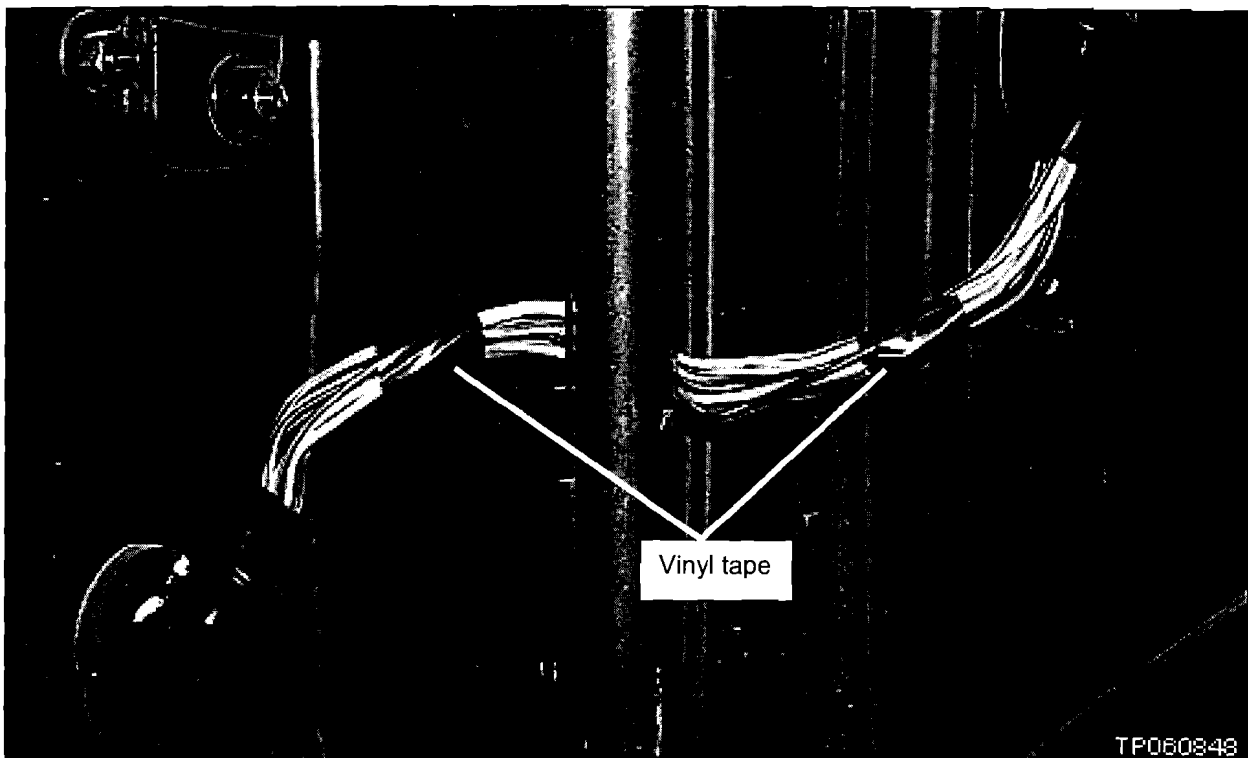
Figure B4

8. Once the vinyl tube is cut off, put vinyl tape on the harness in two spots as shown in Figure B4.

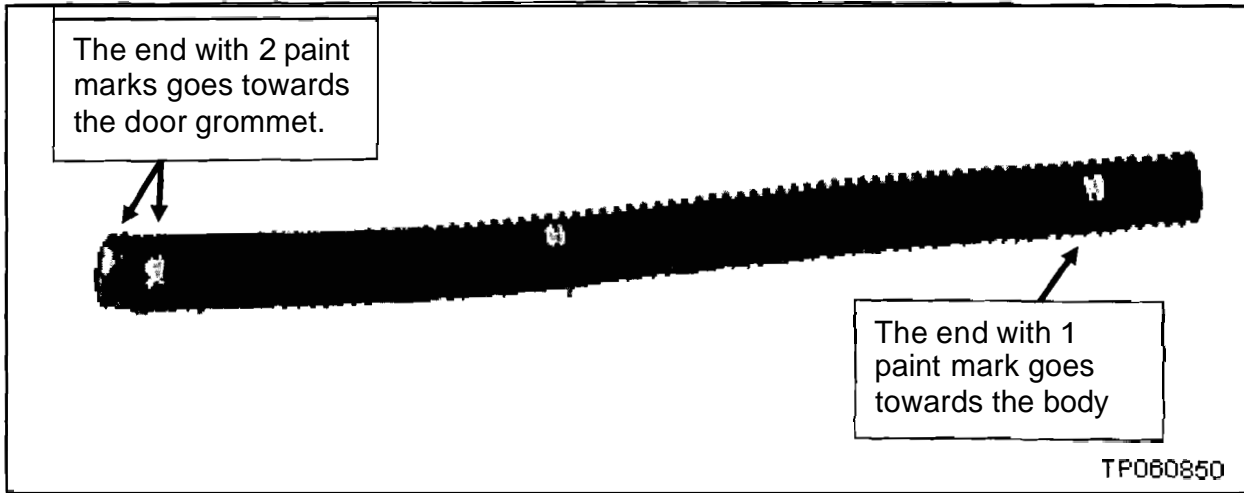
Figure B5

9. Install the corrugated tube over the harness.

The corrugated tube will replace the vinyl tube that you cut off.

- Install the corrugated tube in the direction shown in Figure B5.

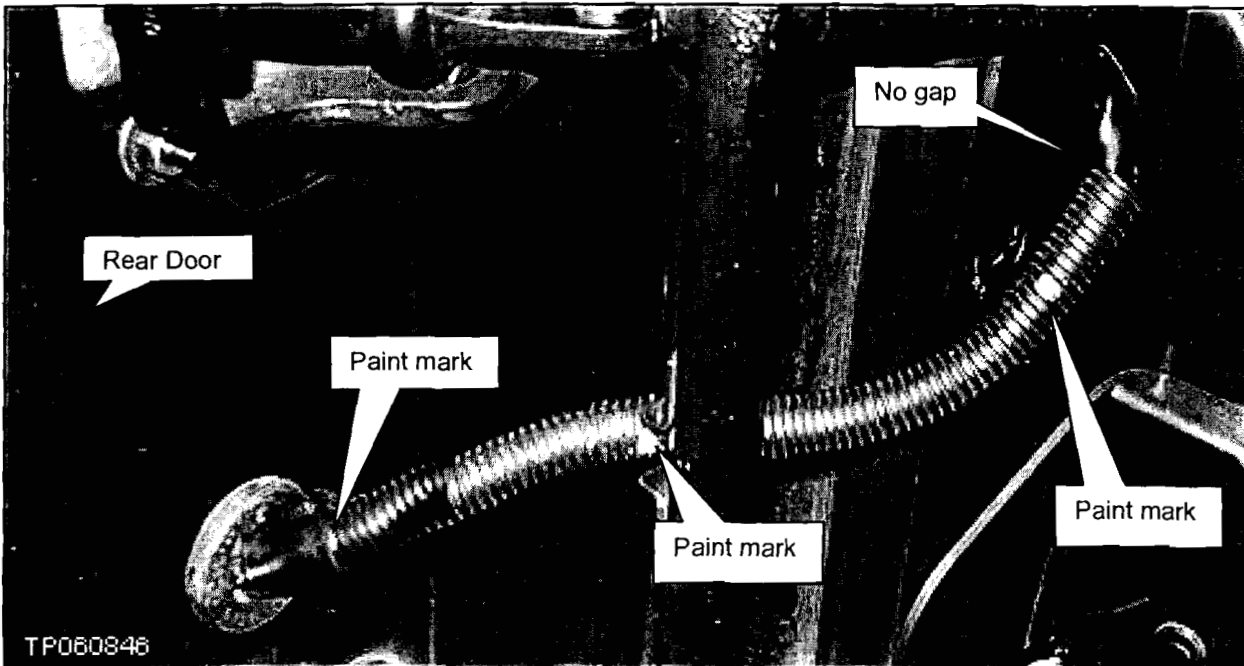
Figure B6

- Slide the corrugated tube inside the door grommet about 10 mm. The second paint mark should just be visible (see Figure B6). You may need to roll the grommet back and then forward over the tube.
- At the body end, the corrugated tube should meet the vinyl tube with no gap.
- The paint marks must be facing away from the door/body as shown in Figure B6.

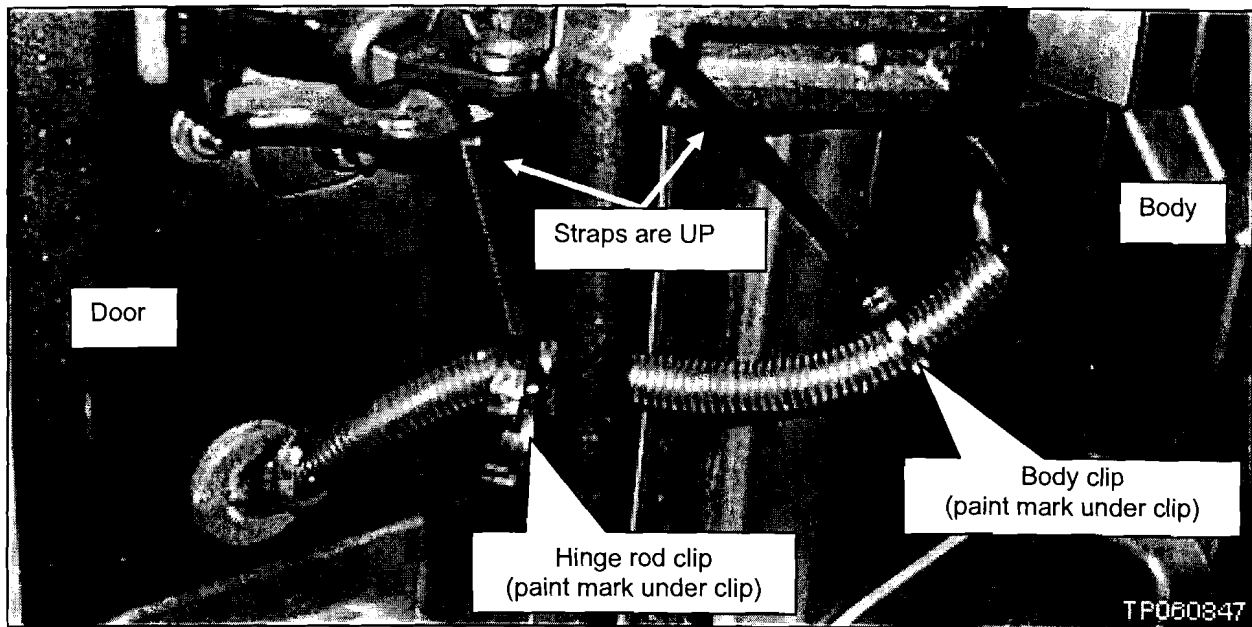
Figure B7

10. Install the new body clip over the paint mark on the body-side (see Figure B7).

- Feed the strap through the buckle so the strap is UP as shown in Figure B7.

11. Install the new hinge rod clip over the center paint mark (see Figure B7).

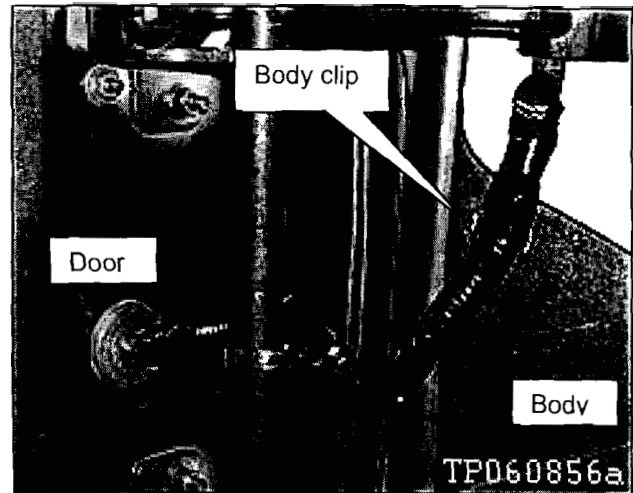
Figure B10

16. Attach the new body clip to the body.

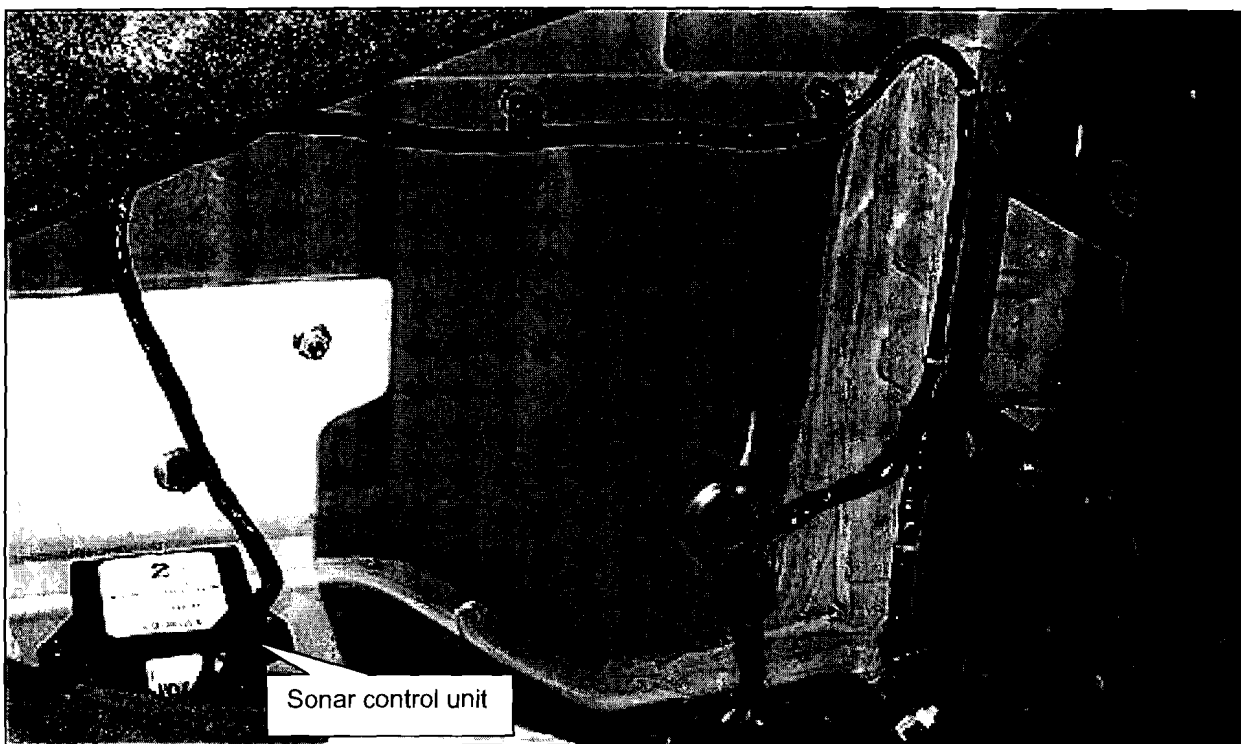
Figure C46

41. Lift the carpet on the rear cabin wall.

42. Disconnect the control unit(s).

43. Take the harness loose from the rear cabin wall.

NOTE: The vehicle you are working on may have a differential lock control unit (not shown) mounted near the sonar control unit.

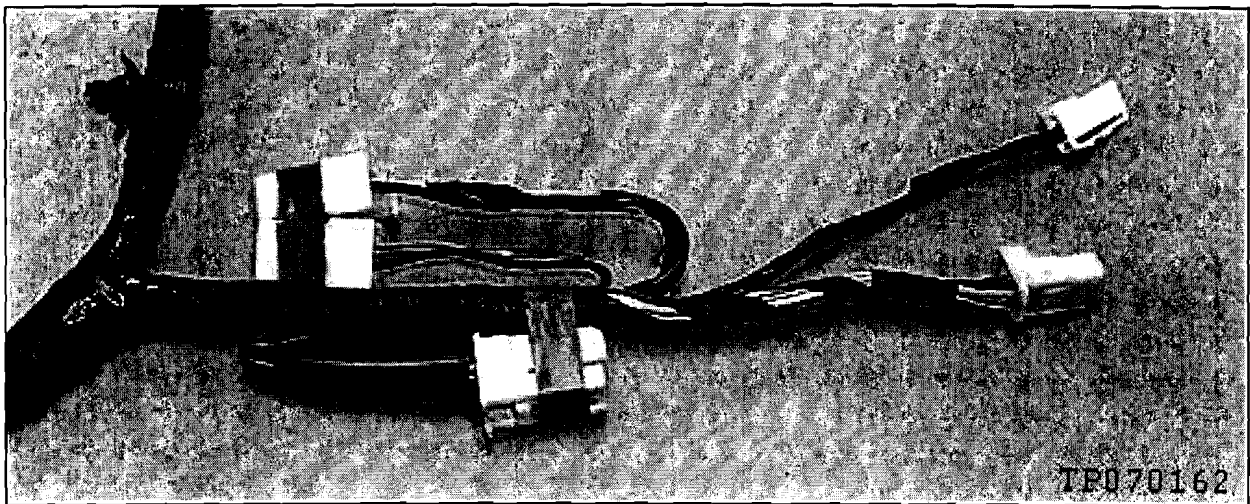
Figure C47

- During installation of the new harness you will find some connectors taped to the harness as shown in the figure below.
- Some of the connectors will be for options that the vehicle you are working on does not have.
- Un-tape the connectors that are needed. Leave the connectors you don't need taped to the harness.

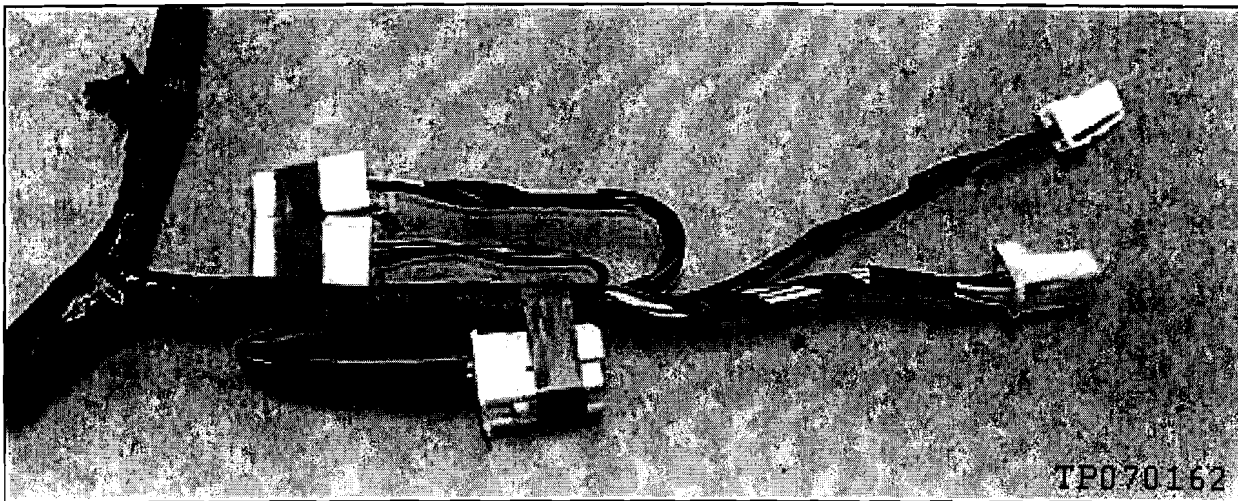
Figure D21

- During installation of the new harness you will find some connectors taped to the harness as shown.
- Some of the connectors will be for options that the vehicle you are working on does not have.
- Un-tape the connectors that are needed. Leave the connectors that are not needed taped to the harness.
