RECALL CAMPAIGN BULLETIN

NTB07-009a

VOLUNTARY RECALL CAMPAIGN 2004 – 2006 TITAN REAR DOOR HARNESS

CAMPAIGN I.D. # R0616
NHTSA #: 06V-459
APPLIED VEHICLES: 2004 – 2006 Titan (A60) King Cab only

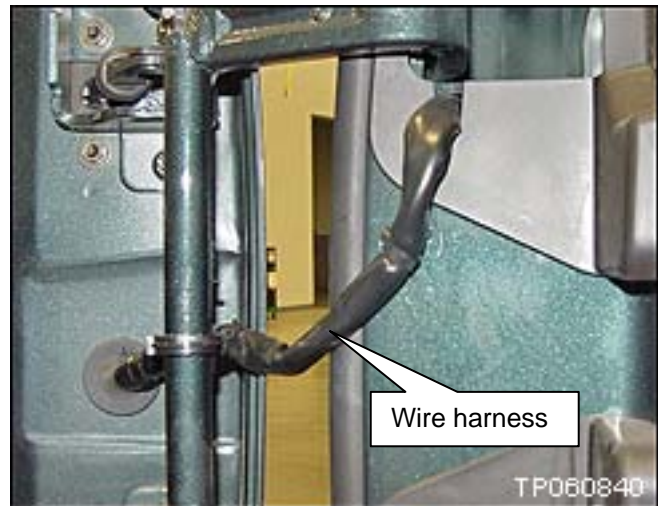
Figure A1

1. Open the rear door and locate the harness in the door hinge area.

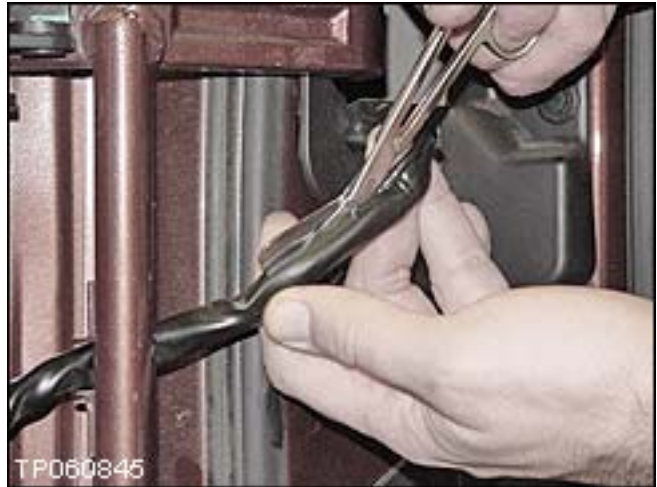
Figure B3

- Using the Vinyl Tube Scissors, **carefully** cut off the vinyl tube between the marks you made in steps 5 and 6.

- **DO NOT use a razorblade.**
- Keep the lower (protected—blunt end) shear of the scissors towards the wires inside the vinyl tube.
- Don't damage the wires inside the vinyl tube.

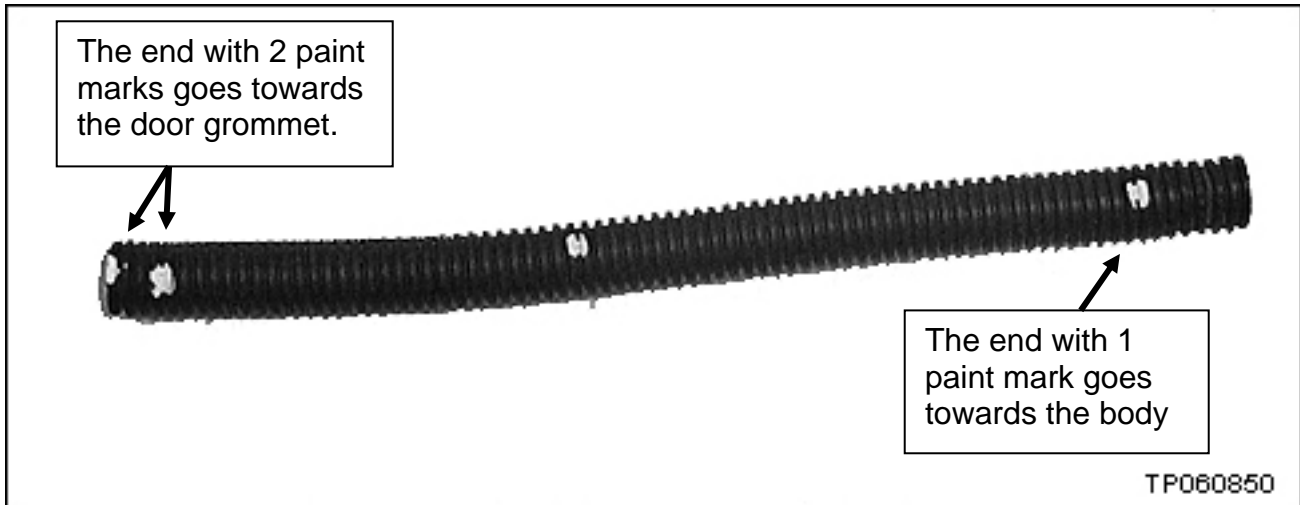
Figure B5

- The corrugated tube will replace the vinyl tube that you cut off.
- Install the corrugated tube in the direction shown in Figure B5.

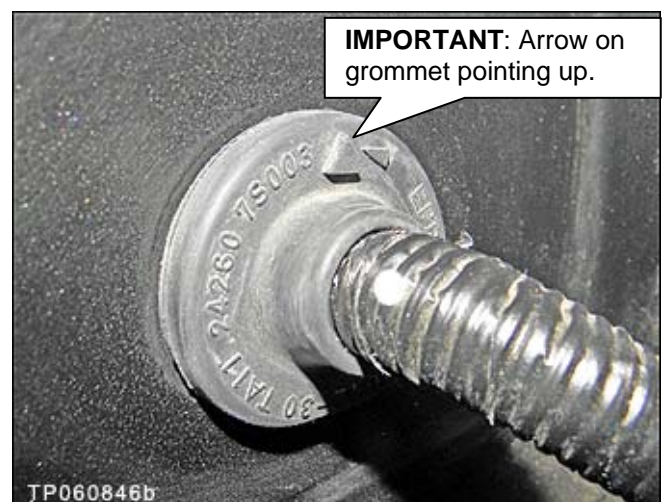
Figure B8

13. IMPORTANT: Make sure the arrow on the grommet is pointing UP, as shown in Figure B7 and B8

IMPORTANT: Before taping, make sure the arrow on the grommet is pointing UP, as shown in Figure B7 and B8 on the previous page.

19. Make sure the arrow on the grommet is pointing UP (Figures B7 and B8, page 11).
