# Recall Action Notice Service Bulletin 378 December 2006

**Affected Model** ..... **Sprint ST (1050cc) and Sprint ST (1050cc) ABS**

**Subject** ..... **Drag Link to Drop Link Bolt, sleeve and nut**

# Recall Action Notice Service Bulletin 379 December 2006

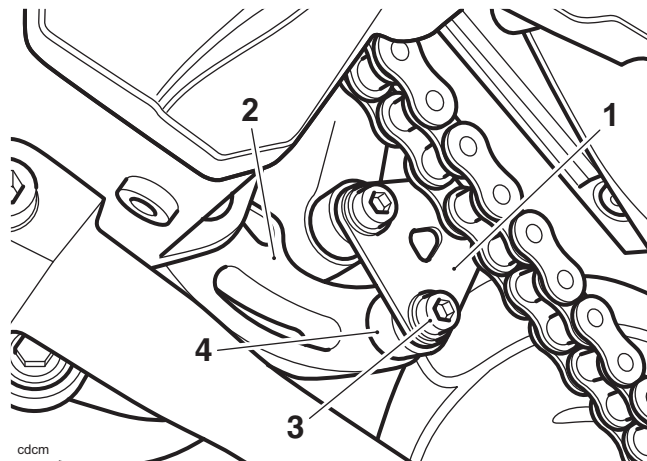
In-service quality feedback has identified a potential problem with the drag link to drop link bolt (part number T3330335), which could result in the bolt becoming bent or fractured.

1. **Drop link**
2. **Drag link**
3. **Drag link to drop link bolt**
4. **Spacer (left hand shown)**

1. Raise and support the rear of the motorcycle beneath the frame or engine. Position a block to support the rear wheel.
2. Remove the nut and bolt securing the drag link to the drop link. Collect the washer from under the bolt head and retain for re-use.

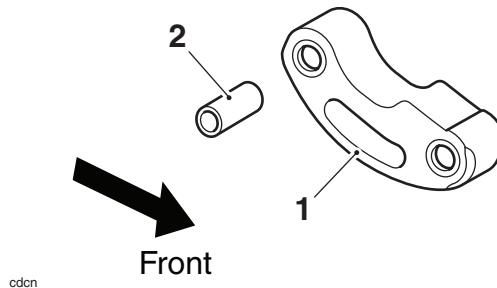
1. Drag link (shown removed from the motorcycle for clarity)
2. Bearing sleeve

4. Remove the bearing sleeve from the drag link.

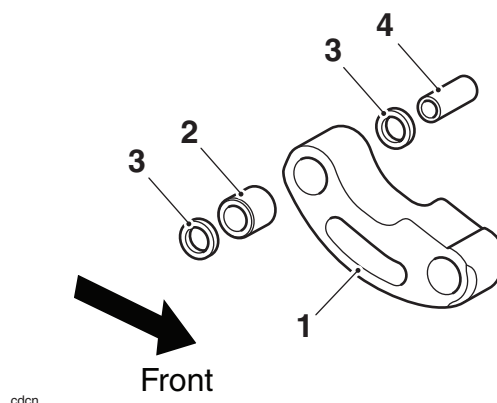
1. Drag link
2. Rear bearing
3. Seals
4. Bearing sleeve

1. Remove the drag link as follows:
  - Remove the bolt and nut (discard the nut) securing the drag link to the frame.
  - Detach the drag link from the frame.
2. Remove the two rear drag link seals.

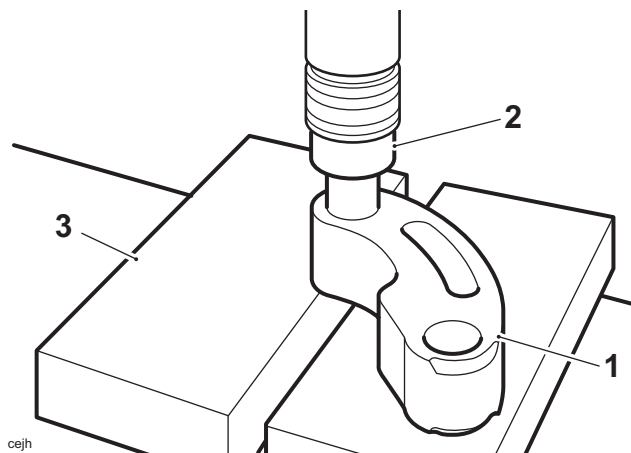
1. Drag link
2. Tool T3880253
3. Press bars

3. Transfer the drag link to a press, and using service tool T3880253, press out the rear bearing through the drag link as shown below. Collect the bearing as it is released, and remove the tool from the drag link.

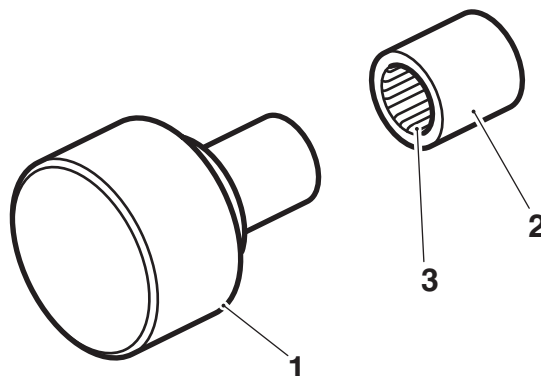
1. Tool T3880254
2. Bearing (shown with marked side facing the service tool)
3. Bearing markings

The bearing must be installed with the marked side of the bearing facing towards service tool T3880254. Failure to follow this instruction will result in damage to the bearing.

4. Position the new bearing to service tool T3880254, with the marked side of the bearing facing towards the tool.

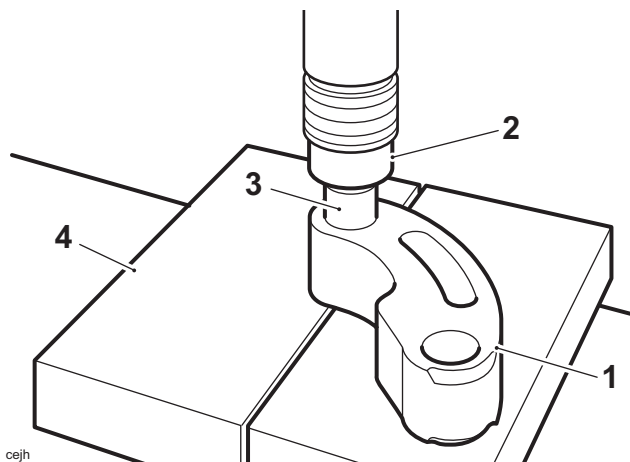
1. Drag link
2. Tool T3880254
3. Bearing
4. Press bars

5. Position the service tool and bearing to the press as shown below, and press in the new bearing until the tool contacts the drag link.

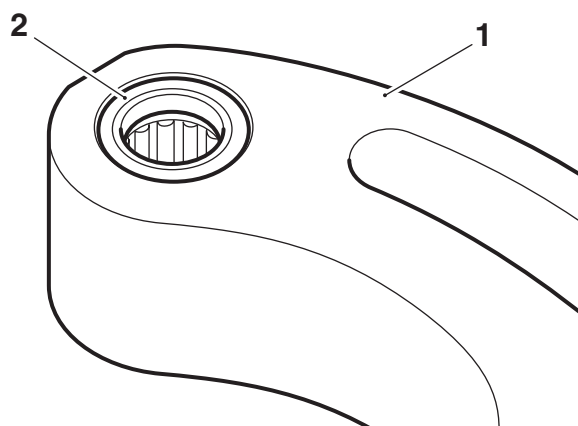
1. Drag link
2. Seal (flush with surface of drag link)

6. Install two new seals, with the marked side of the seal facing outwards, until they are flush with the surface of the drag link.

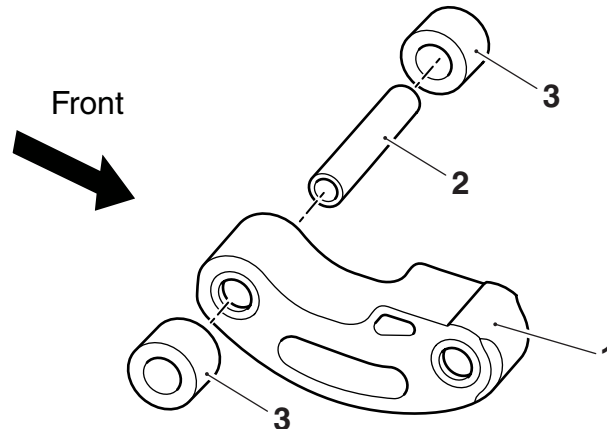
1. **Drag link (shown with the bearing and seals assembled)**
  2. **Bearing sleeve**
  3. **Spacers**
4. Lubricate the exposed outer surface of the bearing sleeve with grease to NLGI 2 specification (we recommend Mobil grease HP222).

1. Lubricate the rear bearing with grease to NLGI 2 specification (we recommend Mobil grease HP222).
2. Lubricate the rear seal's knife-edges with grease to NLGI 2 specification (we recommend Mobil grease HP222).
3. Install the new, longer bearing sleeve (part number T2050102) to the drag link, ensuring it protrudes evenly through either side of the drag link.

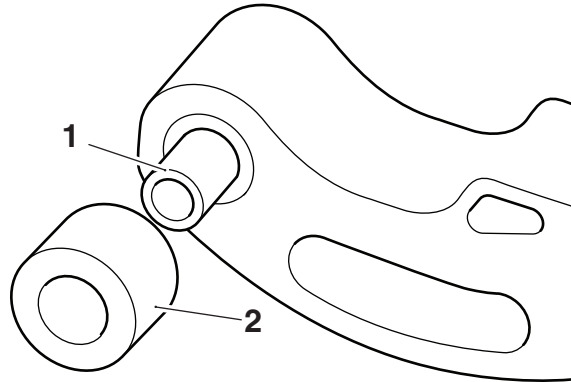
1. New bearing sleeve
2. Spacer (Right hand shown)

5. Fit the two spacers (part number T2050103) to the outside of the bearing sleeve (one on each side) as shown below.

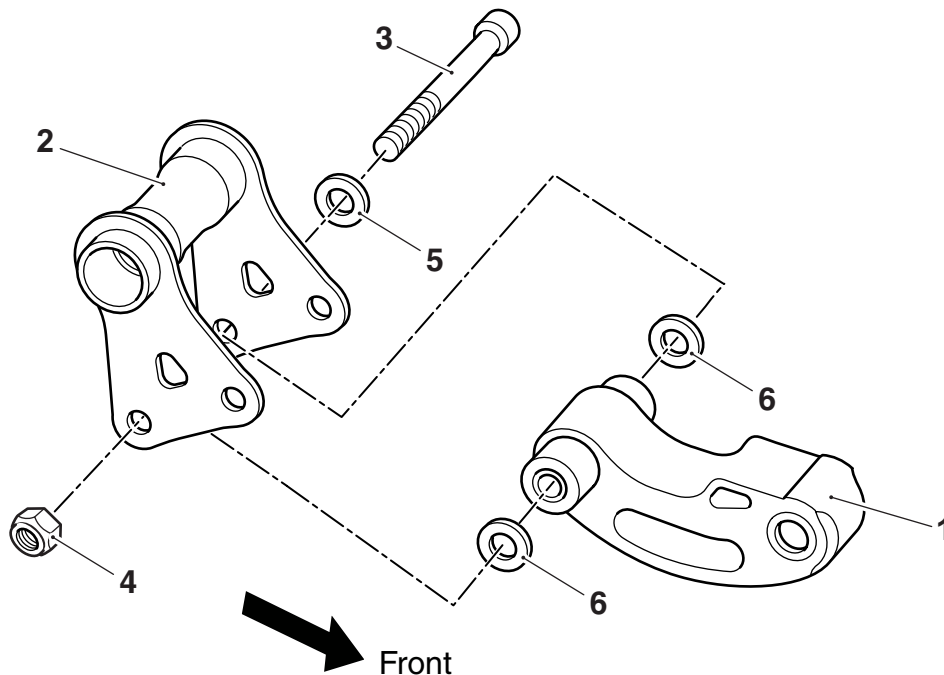
1. Drag link (shown with the bearing sleeve and spacers assembled)
2. Drop link
3. Drag link to drop link bolt
4. Nut
5. Hardened washer (removed from original bolt)
6. New hardened washers

6. Align the drag link to the drop link and fit a new hardened washer to each end of the bearing sleeve, between the side plates of the drop link.

7. Fit the hardened washer (removed from the original bolt) to the new bolt (part number T3330335).

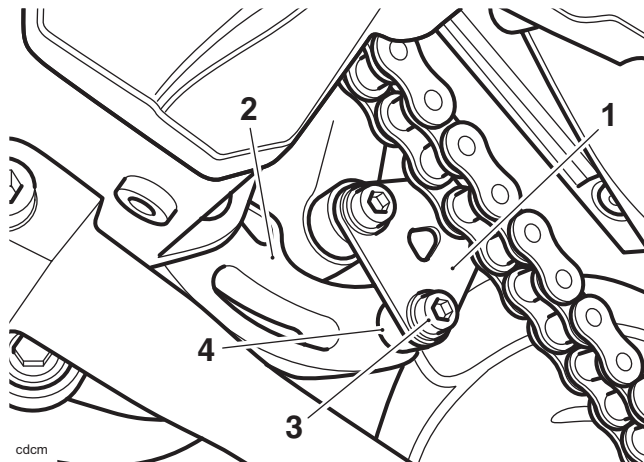
1. Drop link
2. Drag link
3. Drag link to drop link bolt
4. Spacer (left hand shown)

8. Install the new drag link to drop link bolt (part number T3330335) from the left hand side, fit a new nut (part number T3350005) and tighten to **48 Nm**.

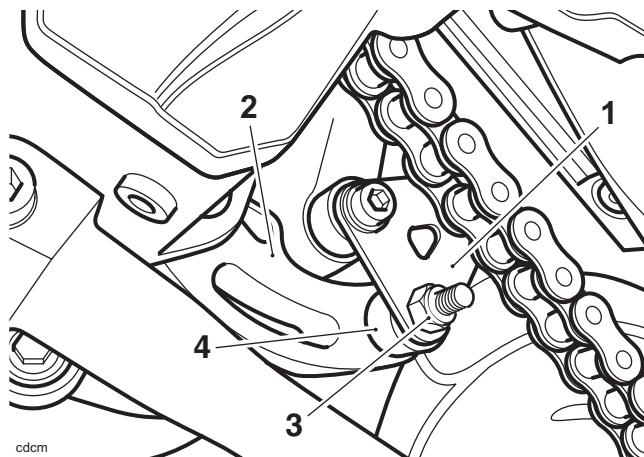
- The bolt will have been installed from the right hand side, and will require removal of the intermediate exhaust pipe in order to remove it.

1. Drop link
2. Drag link
3. Drag link to drop link bolt/nut
4. Spacer (left hand shown)

15. Remove the intermediate pipe.
16. Remove the nut and bolt securing the drag link to the drop link from the right hand side. Collect the washer from under the bolt head and retain for re-use.

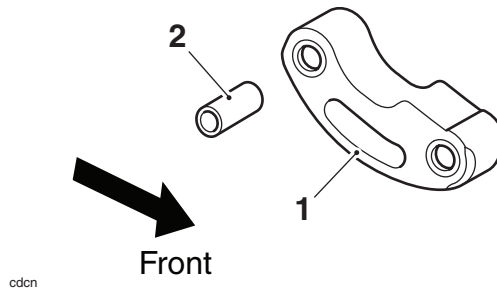
1. Drag link (shown removed from the motorcycle for clarity)
2. Bearing sleeve

18. Remove the bearing sleeve from the drag link.

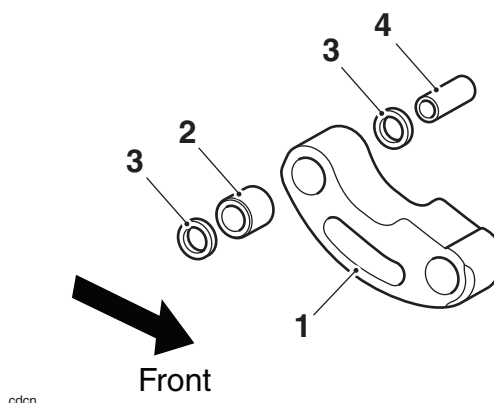
1. Drag link
2. Rear bearing
3. Seals
4. Bearing sleeve

1. Remove the drag link as follows:
  - Remove the bolt and nut (discard the nut) securing the drag link to the frame.
  - Detach the drag link from the frame.
2. Remove the two rear drag link seals.

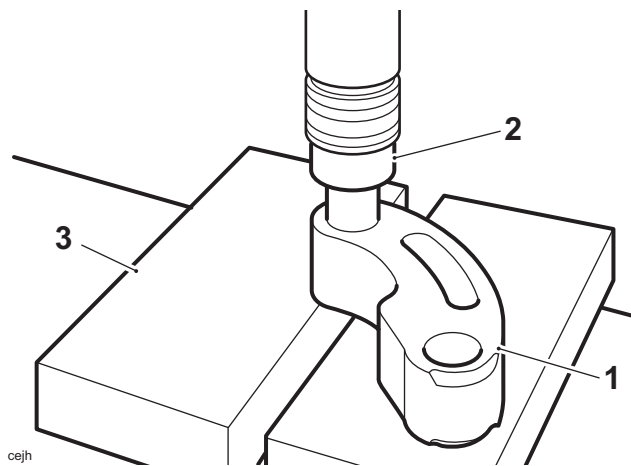
1. Drag link
2. Tool T3880253
3. Press bars

3. Transfer the drag link to a press, and using service tool T3880253, press out the rear bearing through the drag link as shown below. Collect the bearing as it is released, and remove the tool from the drag link.

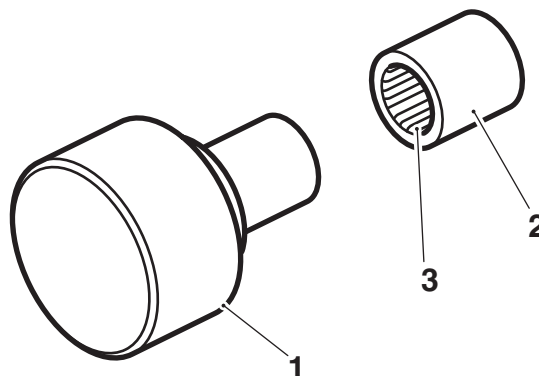
1. Tool T3880254
2. Bearing (shown with marked side facing the service tool)
3. Bearing markings

The bearing must be installed with the marked side of the bearing facing towards service tool T3880254. Failure to follow this instruction will result in damage to the bearing.

4. Position the new bearing to service tool T3880254, with the marked side of the bearing facing towards the tool.

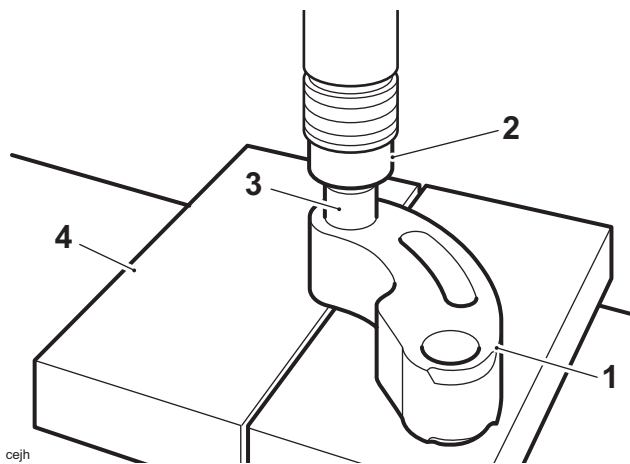
1. Drag link
2. Tool T3880254
3. Bearing
4. Press bars

5. Position the service tool and bearing to the press as shown below, and press in the new bearing until the tool contacts the drag link.

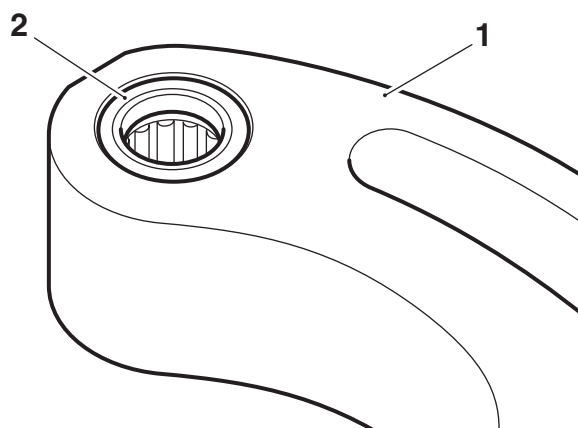
1. Drag link
2. Seal (flush with surface of drag link)

6. Install two new seals, with the marked side of the seal facing outwards, until they are flush with the surface of the drag link.

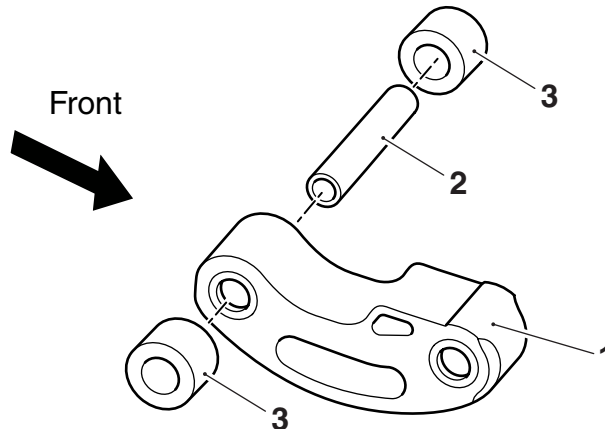
1. **Drag link (shown with the bearing and seals assembled)**
  2. **Bearing sleeve**
  3. **Spacers**
4. Lubricate the exposed outer surface of the bearing sleeve with grease to NLGI 2 specification (we recommend Mobil grease HP222).

1. Lubricate the rear bearing with grease to NLGI 2 specification (we recommend Mobil grease HP222).
2. Lubricate the rear seal's knife-edges with grease to NLGI 2 specification (we recommend Mobil grease HP222).
3. Install the new, longer bearing sleeve (part number T2050102) to the drag link, ensuring it protrudes evenly through either side of the drag link.

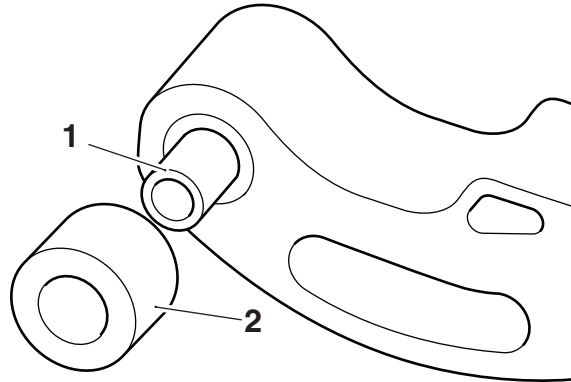
**1. New bearing sleeve**

**2. Spacer**

5. Fit the two spacers (part number T2050103) to the outside of the bearing sleeve (one on each side) as shown below.

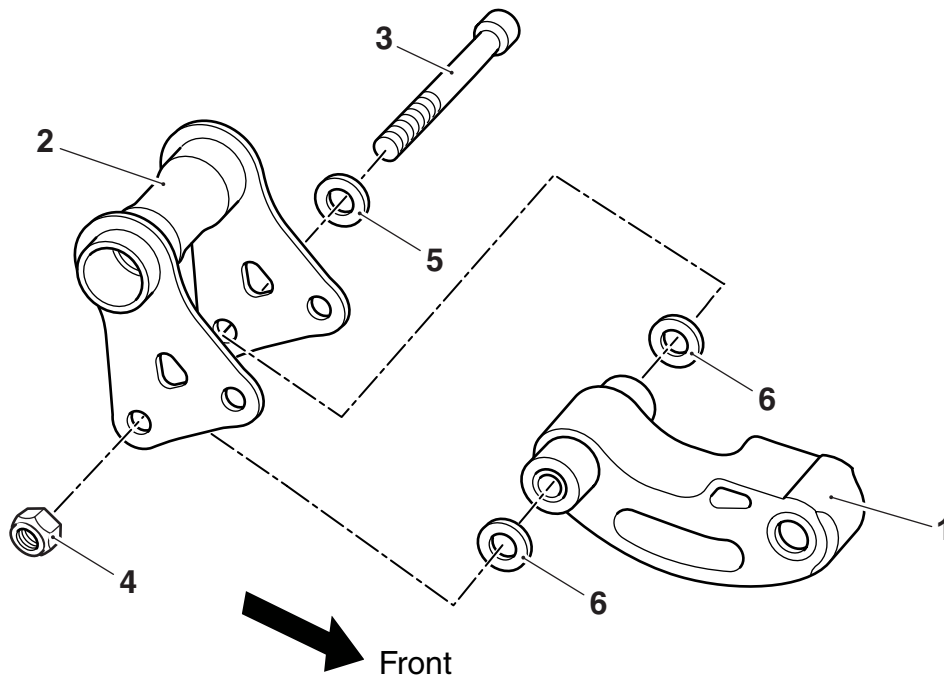
**1. Drag link (shown with the bearing sleeve and spacers assembled)**

**2. Drop link**

6. Align the drag link to the drop link and fit a hardened washer to each end of the bearing sleeve, between the side plates of the drop link.

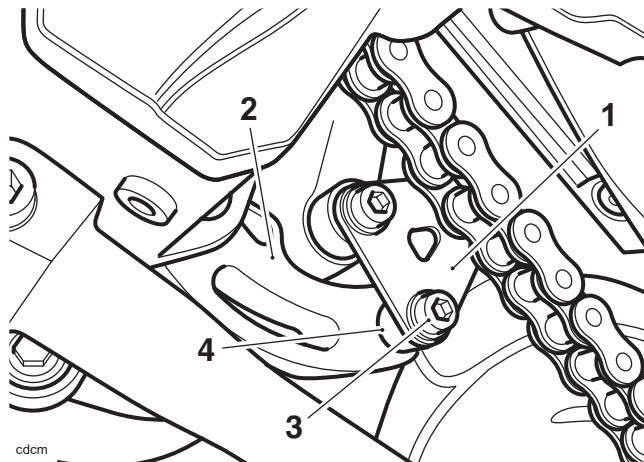
1. Drop link
2. Drag link
3. Drag link to drop link bolt
4. Spacer (left hand shown)

8. Install the new drag link to drop link bolt (part number T3330335) from the left hand side, fit a new nut (part number T3350005) and tighten to **48 Nm**.
