<i>Recall Bulletin</i>	<i>RCL-07-001</i>
	<i>DNA</i>

Subject: Fuel Pump - Fuel Sending Unit Wiring Cables

Models: ST3 - ST3ABS MY 2006

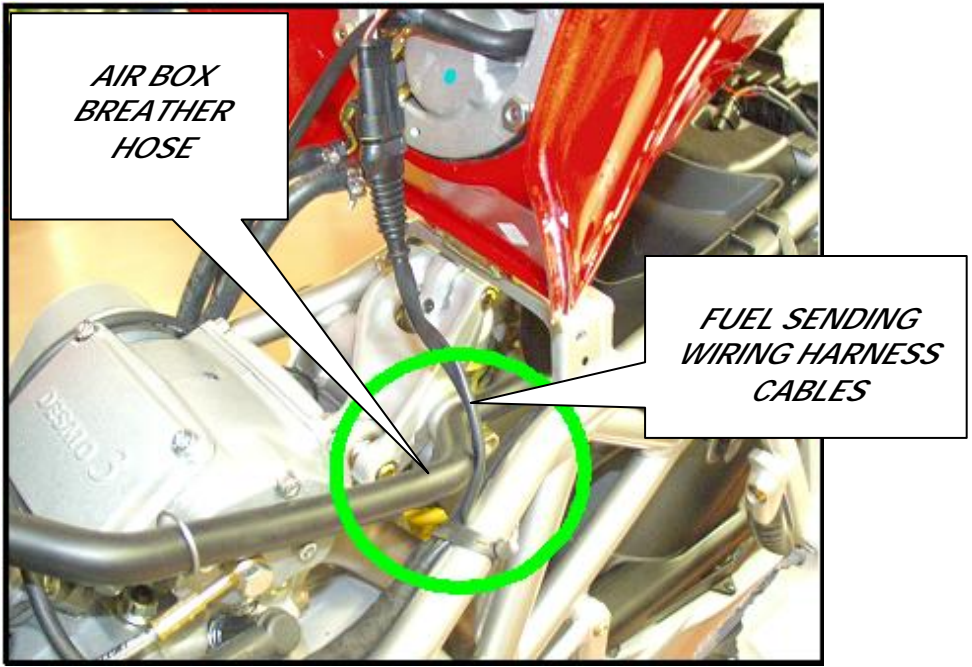
PICTURE 1

Lift the fuel tank and check that fuel pump cable is routed outside of the air box breather hose as shown below.

Lift the fuel tank and check that the fuel sending unit wiring cables are routed outside the air box breather hose as illustrated in the instructions attachment.

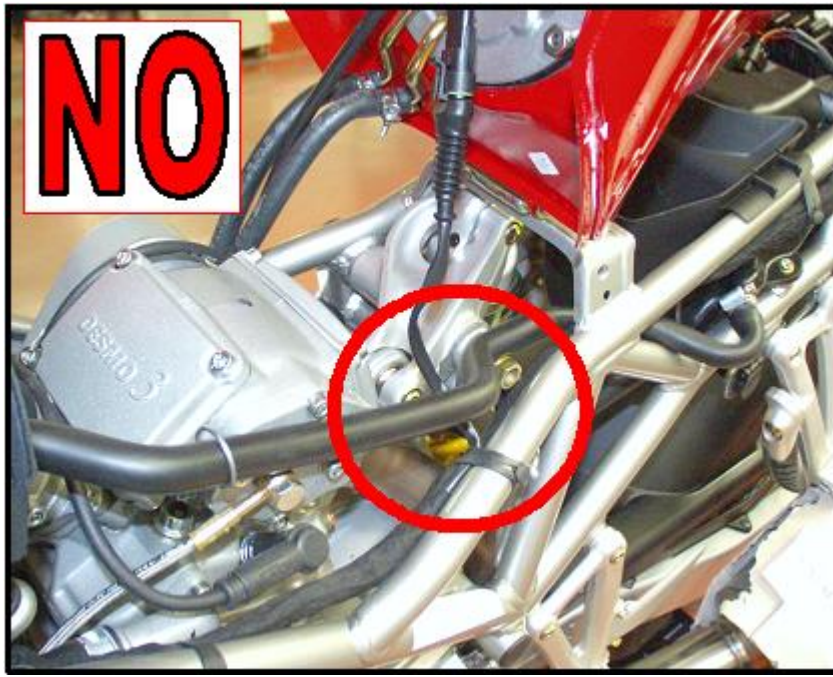
PICTURE 2

Ducati Motor Holding S.P.A. has determined that it is possible that the fuel sending unit wiring cables installed during production could be routed incorrectly possibly coming in contact with the exhaust pipe. This condition will burn the cables insulation and cause a possible electrical short circuit stopping the fuel pump and consequently stopping the engine. If the engine stopped while the motorcycle was being driven, it could increase the risk of a crash.

Picture (2) below shows *incorrect* cable routing that shall be rectified and set as shown in picture (1) above. It is necessary to reposition it because the cable could touch the vertical cylinder exhaust pipe.
