RE: NHTSA Campaign Number 07V-163

SUBJECT: Campaign #105 – Exterior Drawer Secondary Catch

INSTRUCTIONS TO PERFORM CAMPAIGN 105

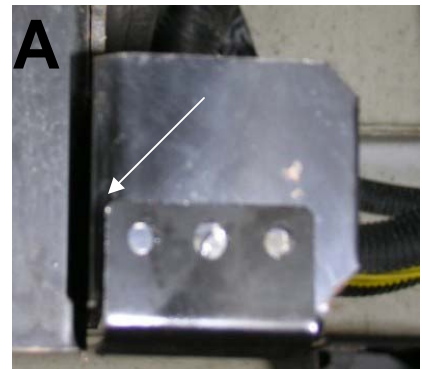
1. Turn the outside knobs and open the slideout storage drawer. Inspect the areas of intended work to assure that nothing has been damaged.
2. Clean the surface of the metal support.
3. Remove the backing of the adhesive tape on the return flange.
4. Place the return flange (provided) on the metal support, positioning it toward the rear edge as shown in Photo A.

NOTE: It is important to offset the installation of the return flange in order to avoid interference with the operation of the slideout drawer latch/pawl.

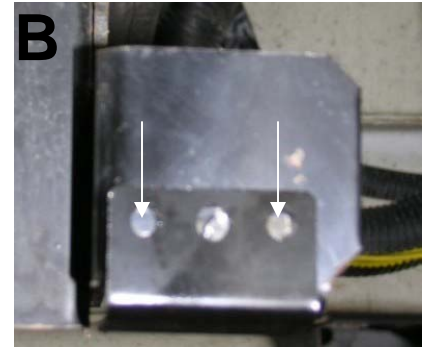
5. Drill (2) holes and install rivets in locations shown on Photo B.
6. Clean the interior of the drawer area where the secondary catch will be installed.
7. Holding the secondary catch (provided), position the catch allowing it to pass the return flange while closing the drawer, but catching the return flange when opening the drawer. Remove the backing to the two-sided adhesive and place in position. Shown in Photo C.

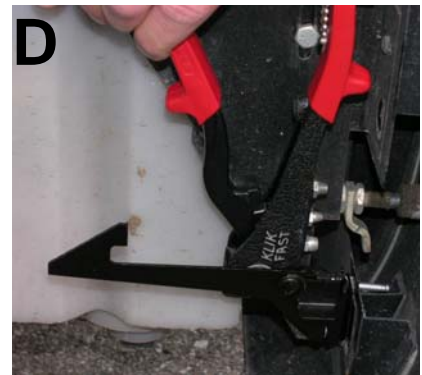
8. With the adhesive tape holding the secondary catch in place, drill (2) rivet holes using a 3/16 drill bit and install the rivets (provided). Shown in Photo D.

NOTICE
Care must be taken when drilling holes to ensure you do not pass through metal and damage the exterior drawer skin.

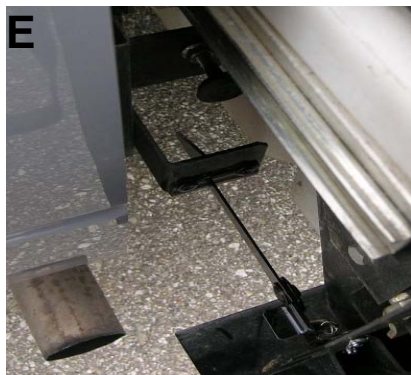
9. Check your installed secondary catch and return flange to ensure proper operation when opening and closing the slideout drawer. Shown in Photo E.
