Safety Defect and Noncompliance Report Guide for Equipment  
**PART 573 Defect and Noncompliance Report<sup>4</sup>**

## SERVICE BULLETIN

**DATE:** 2-2007 **BULLETIN NO:** 02-036A

**TITLE:** 200457 STEERING STOP GROUP

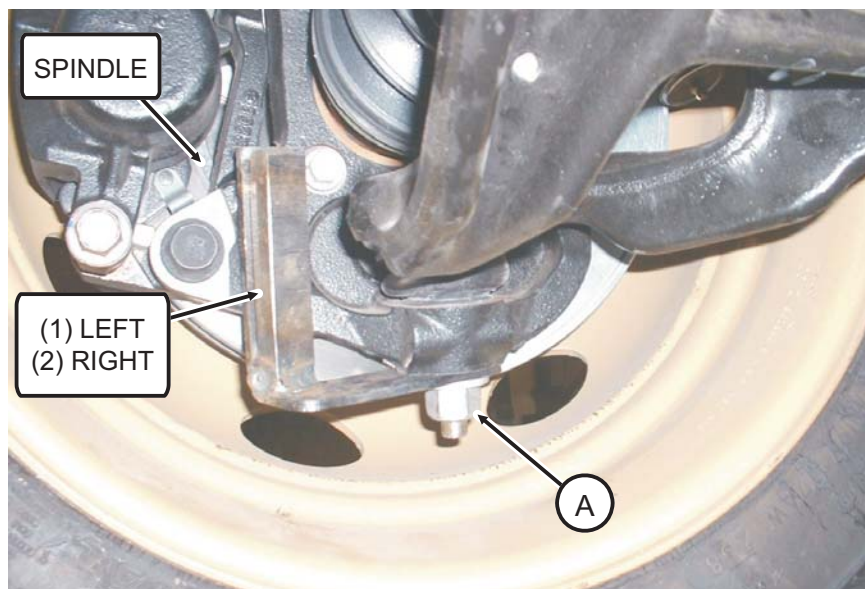
FIGURE 1  
STEERING STOP REPLACEMENT

1. Raise the front of the vehicle high enough so both of the front wheels are off of the ground. Remove both vehicle front wheels.
2. Visually inspect the vehicle components and tires for damage, wear, nicks, gouges, rubbing, cut or frayed wires, etc. Replace any damaged or worn component as necessary.
3. Remove lower ball joint nut (A) to remove the existing steering stop (not illustrated).
4. Install the new steering stop (1 or 2) over the stud so the stop plate is towards the rear of the vehicle. Re-install lower ball joint nut (A) Push the steering stop (1 or 2) firmly against the spindle and torque nut (A) to 94 lb-ft (128 N-m).
5. Repeat Steps 3 and 4 for the other side of the vehicle.

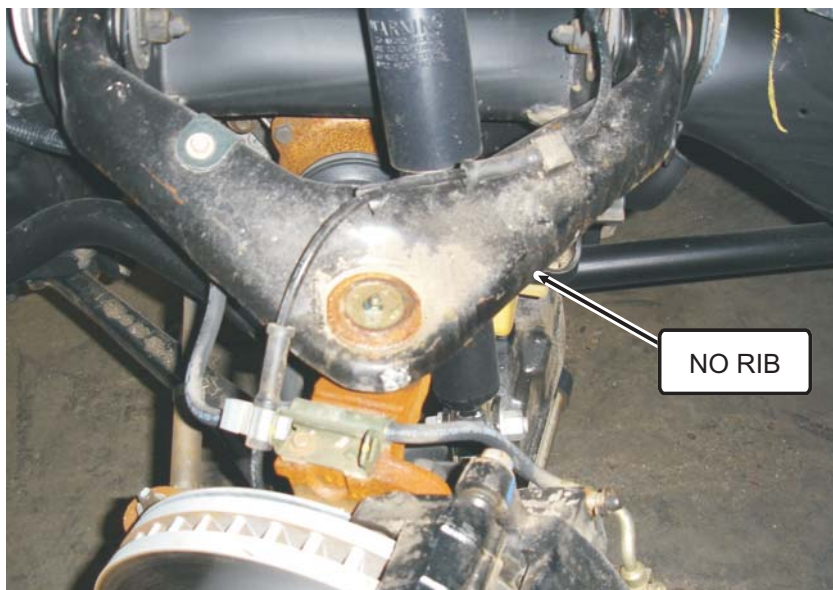
FIGURE 2  
UPPER CONTROL ARM WITHOUT RIB

1. Determine if a control arm guard plate is or is not needed.
  - a. If the control arm on the vehicle does not have a rib, as shown in Figure 2, a guard plate is needed. Go to 3.1 Installing Control Arm Guard Plate.
  - b. If the control arm on the vehicle has a rib, as shown in Figure 3, a guard plate is not required. Go to 4.0 Anti-Lock Brake Sensor Wire Relocation.

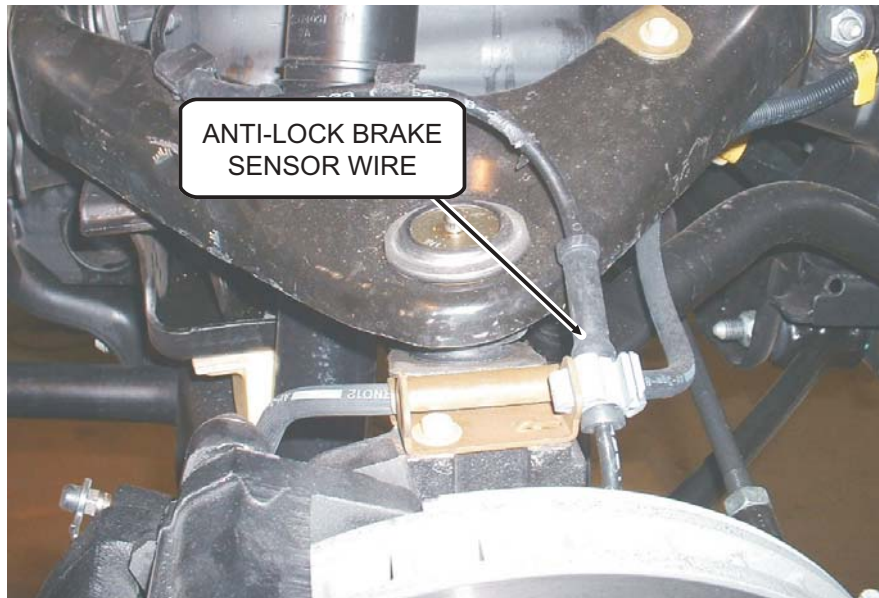
FIGURE 5  
ANTI-LOCK BRAKE SENSOR WIRE IN ORIGINAL LOCATION

3. Relocate the anti-lock brake sensor wire from its original mounting location as shown in Figure 5 to its new mounting location as shown in Figure 6 re-using all of the original factory mounting clips. Secure the sensor wire to the upper control arm using ty-raps as necessary.
- 4 Repeat Steps 2 and 3 for the other side of the vehicle.

**SUMMARY:** Reports have been received that front wheels on 2001 to present Chevrolet 2500HD vehicles were found to have rubbed on the upper control arms when turning hard left or right, and particularly when bouncing on uneven ground. As a result, the anti-lock brake sensor wires have been cut. Therefore, we recommend to inspect the vehicle's front tires, wheels, upper control arms and anti-lock brake sensor wires for damage, wear, nicks, gouges, rubbing, cut or frayed wires, etc.

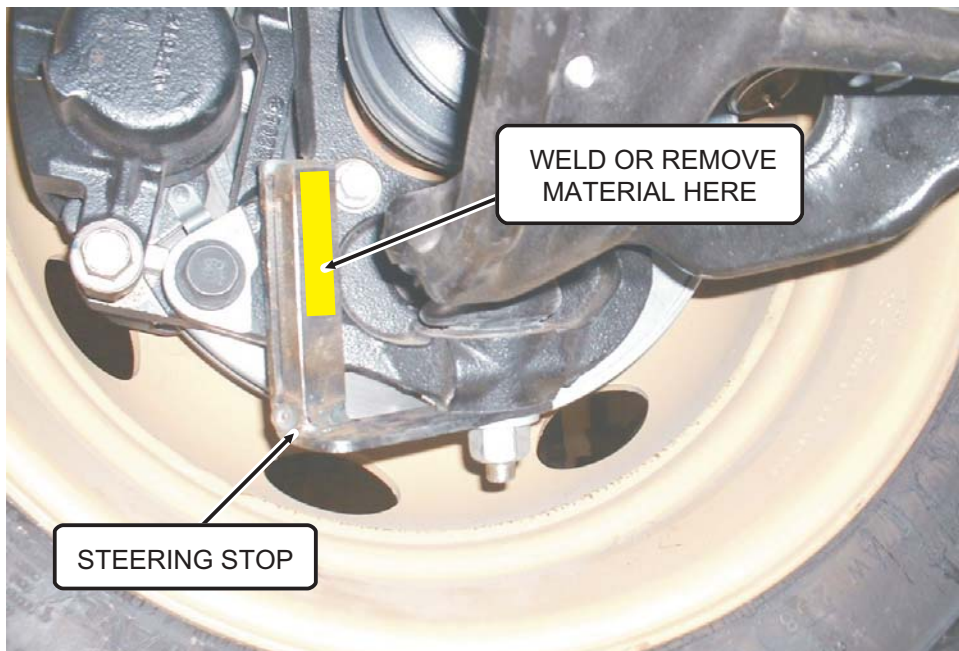
FIGURE 7  
STEERING STOP MODIFICATION

3. Thoroughly clean the contact area of the steering stop surface of all dirt, grease, rust, etc. where material (not supplied) will be welded to.
4. If there was less than 3/8 - 1/2 inch (9.5 - 12.7 mm) of clearance or any contact at all, weld a 1 inch wide piece of suitable material to the steering stop surface in the area shown for the thickness needed and length required. Repeat the Wheel and Tire Clearance Inspection procedure. See 5.0 Wheel and Tire Clearance Inspection.

5. If there was more than 1/2 inch (12.2 mm) of clearance, use a grinder to remove material from the steering stop surface in the area shown. Do not remove more than 1/16 inch (1.6 mm) material before rechecking the vehicle wheel clearance. Repeat the Wheel and Tire Clearance Inspection procedure. See 5.0 Wheel and Tire Clearance Inspection.

3. Lower the front of the vehicle to the ground. Turn the vehicle front wheels both hard left and hard right. Check the vehicle's front wheels (tires and rims) for contact with any components (upper control arm, brake lines, anti-lock brake sensor wire, etc.) of the vehicle in both directions. There must be a minimum of 3/8 - 1/2 inch (9.5 - 12.7 mm) clearance between the vehicle front wheel rim and any of the above listed components.

4. If there is 3/8 - 1/2 inch (9.5 - 12.7 mm) of clearance, the clearance is acceptable.
5. If there is less than 3/8 - 1/2 inch (9.5 - 12.7 mm) of clearance or any contact at all, the steering stops must be modified. Go to 6.0 Steering Stop Modification.

6. If there is more than 1/2 inch (12.7 mm) of clearance, the steering stops can be modified to help decrease the turning radius of the vehicle. Go to 6.0 Steering Stop Modification.
