Safety Defect and Noncompliance Report Guide for Vehicles
PART 573 Defect and Noncompliance Report³

07V-474
(22 Pages)

Make(s): DUCATI Model Years Involved: 2008 Model(s): HYPERMOTARD

HYPERMOTARD Battery Fastener Safety Recall Campaign Instructions

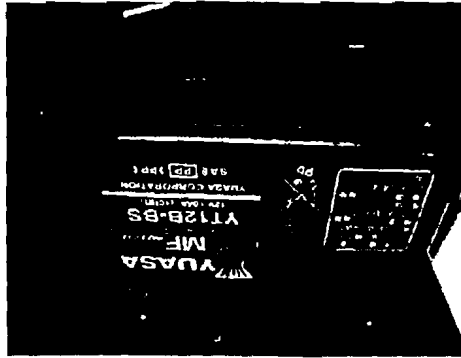
Attach the new Velcro strips supplied in the kit part number 69924041A on the battery bottom and the fuel tank surface allocating the battery. (See pictures below)

Remove the double lock Velcro strips located under the battery bottom and the fuel tank battery box surface. Clean both surfaces using solvent.

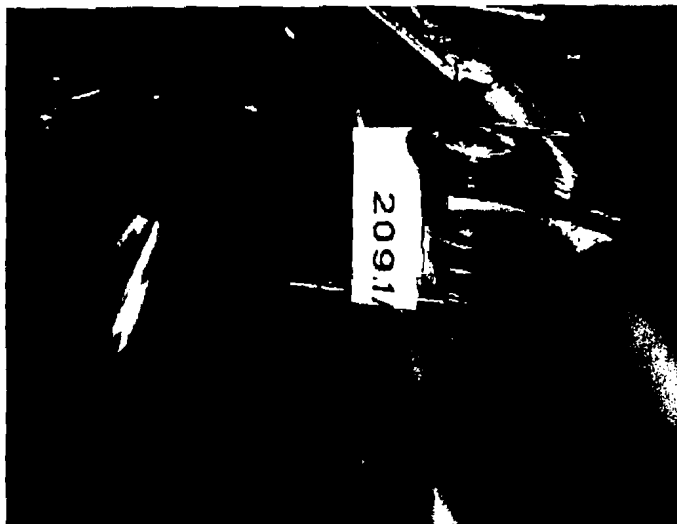
Install the mounting bracket, the 5 mm spacers, the 1 mm washer and the M 5 nut ensuring that the mounting bracket contacts the battery top surface and prevents its vertical movement. The required number of spacers and washer may vary according to the clearance between the affected parts. Tighten nut to 3 Nm. (See picture below)
