Re: Champion Bus  
Defect and Non-Compliance Report

**Subject:** NHTSA Threshold Warning Signal Recall (Recall Number 06E-094)

# Service Bulletin 34273

Instructions for Braun Corporation "Public and Private Use" Dual Parallel Arm Lift Threshold Sensitivity Evaluation and NHTSA Compliance Applicable for NL, NCL and NVL Series Lifts

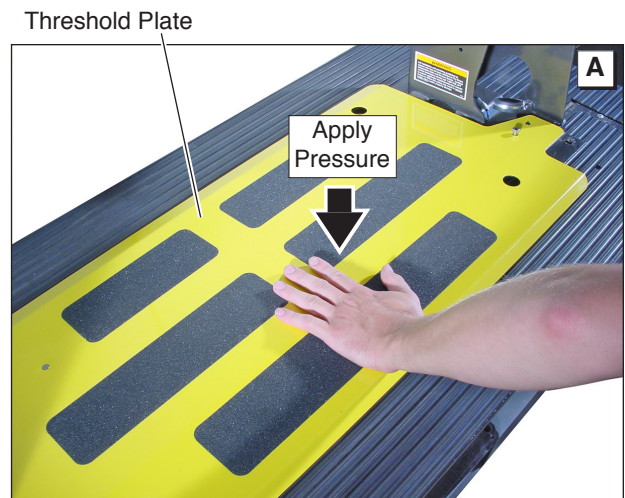
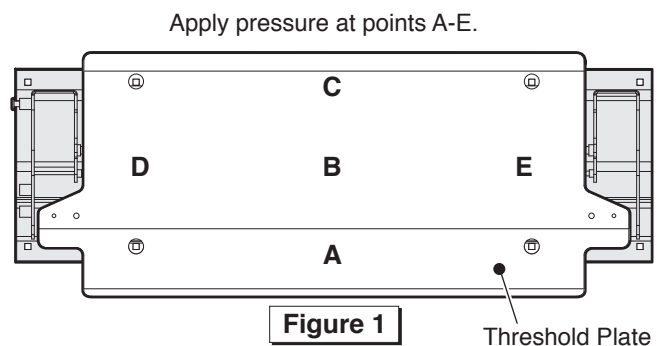
1. Turn Lift Power switch ON. Deploy the lift platform fully to the ground.
2. Apply hand pressure on the center of the threshold plate as shown in Photo A. The visual and/or audible threshold warning\* should be activated when you push down.

Repeat the sensitivity test procedure at positions A-E shown in Figure 1.

3. If the threshold alarm is activated at all positions, no further procedures are required. The lift threshold sensitivity meets NHTSA FMVSS 403/404 requirements.

If the threshold alarm is not activated at all positions, perform the retrofit procedures detailed on pages 2 and 3 of this bulletin. Repeat the sensitivity test procedures following the retrofit. If the lift still does not meet the requirement, contact a Braun Corporation Product Support representatives at 1-800-THE LIFT®.

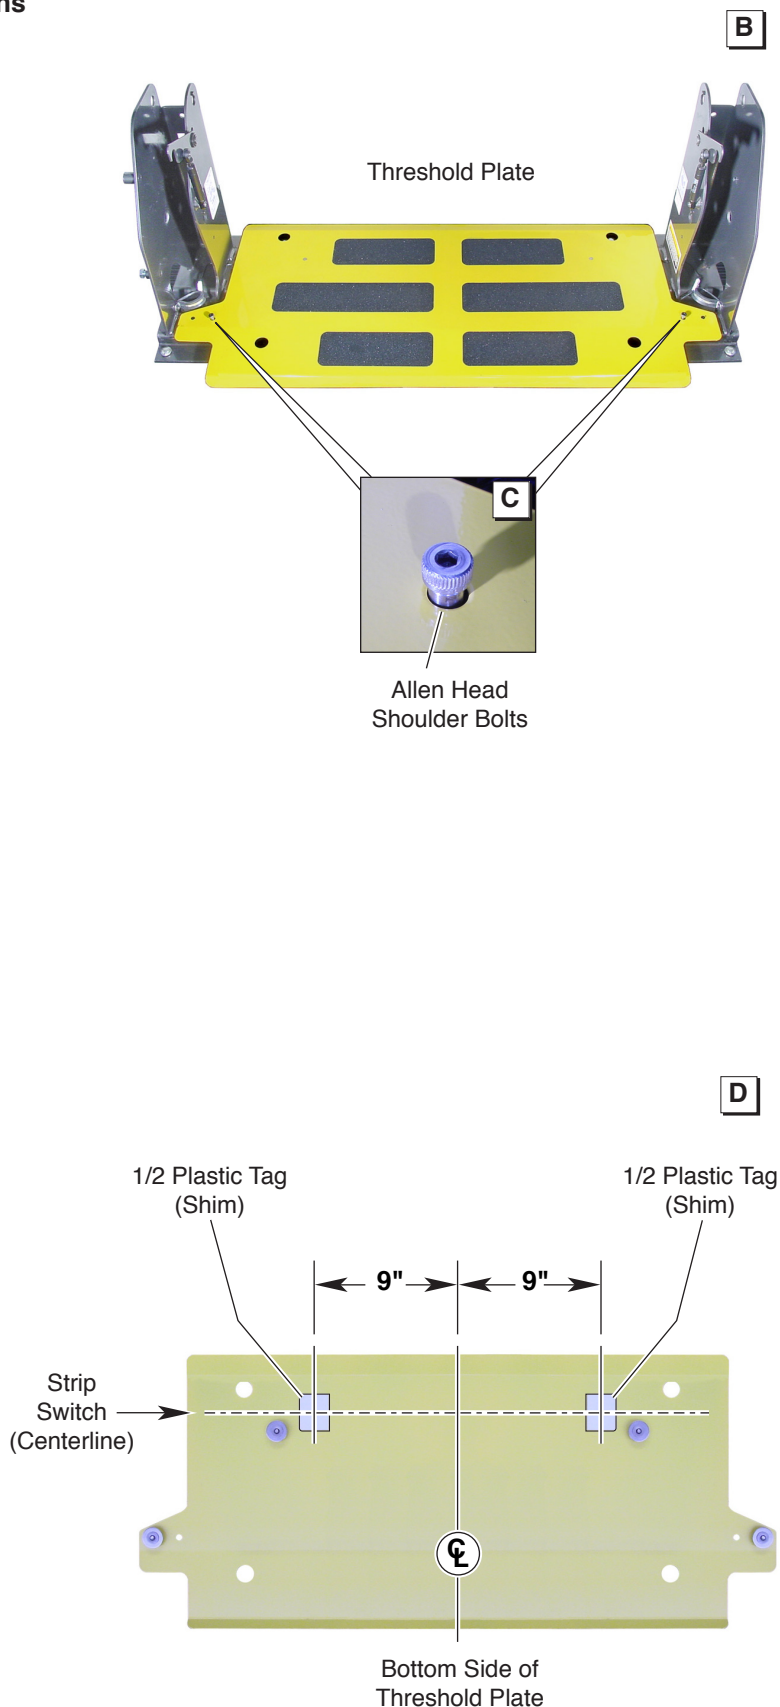
1. Turn Lift Power switch ON. Deploy the lift platform fully to the ground.
2. Remove the threshold plate. Loosen and remove two Allen head shoulder bolts securing the plate (see Photos B and C). Keep bolts. Slide the plate outward and lift to remove it (four keeper standoffs engage key-hole slots). See Photos E, F and G.
3. An adhesive-backed plastic tag is supplied to serve as an alarm activation shim (minimal thickness required to activate the highly sensitive alarm strip switches). Cut the plastic tag in two halves. The plastic tags (shims) will be affixed to the bottom side of the threshold plate (positioned as shown and detailed below).

Turn threshold plate over. See Photo D. The strip switches typically leave an impression (mark) on the yellow plate from use. Use the impression of the inboard strip switch as a centerline for shim positioning (or measure to establish position).

Position each shim 9" from the center of the threshold plate (see Photo D). Align the tags with the strip switch centerline. Clean the surface as detailed below and affix the adhesive-backed tag to the plate (**press firmly**).

**Note:** Clean the surface with isopropyl alcohol before affixing the tag. Use a clean cloth or paper towels. Do not use oily shop rags. Wipe surface free of residue with dry portion of cleaning cloth.

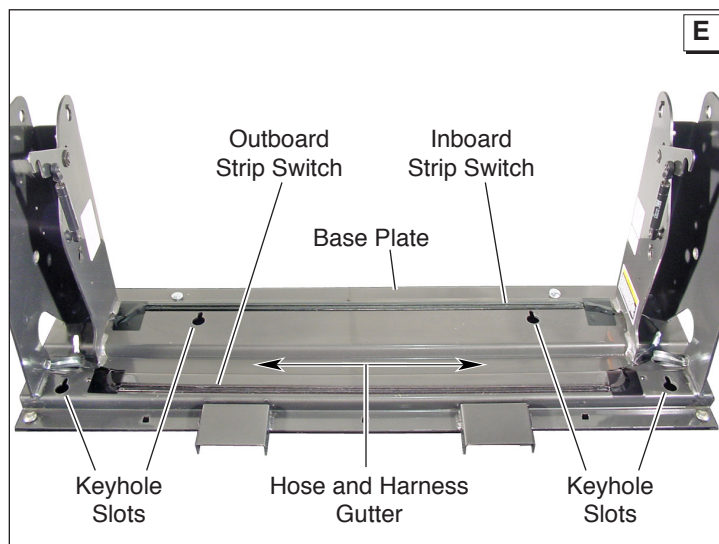
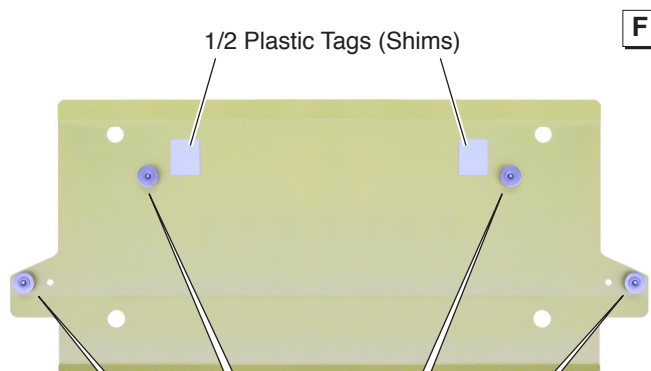
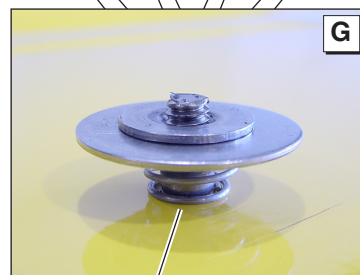
Keeper Standoffs  
(Engagement Studs)

4. Reposition the threshold plate (with shim). Align the keeper standoffs (studs) on the bottom of the threshold plate with the base plate keyhole slots. See Photos E, F and G. Insert studs and **carefully** slide the plate inward (engage slots fully).

**Ensure** all hoses and wiring harnesses routed through the base plate gutter are positioned fully in the gutter and not located anywhere they could potentially interfere with activation of the tape switches. See Photo E.

**Note:** Spraying a light mist of glass cleaner (or other) to the strip switches will aid in the plate sliding easier into position. See Photos E, F and G.

**Ensure** all four keeper standoffs engage the base plate keyhole slots.

5. Reinstall the two Allen head shoulder bolts previously securing the plate (see Photo B and C). Tighten bolts securely.
6. Repeat the sensitivity test procedures outlined on page 1.
