Re: Eldorado National - California  
Defect and Non-Compliance Report

**Subject:** NHTSA Threshold Warning Signal Recall (Recall Number 06E-094)

# Service Bulletin 34273

Instructions for Braun Corporation "Public and Private Use" Dual Parallel Arm Lift Threshold Sensitivity Evaluation and NHTSA Compliance Applicable for NL, NCL and NVL Series Lifts

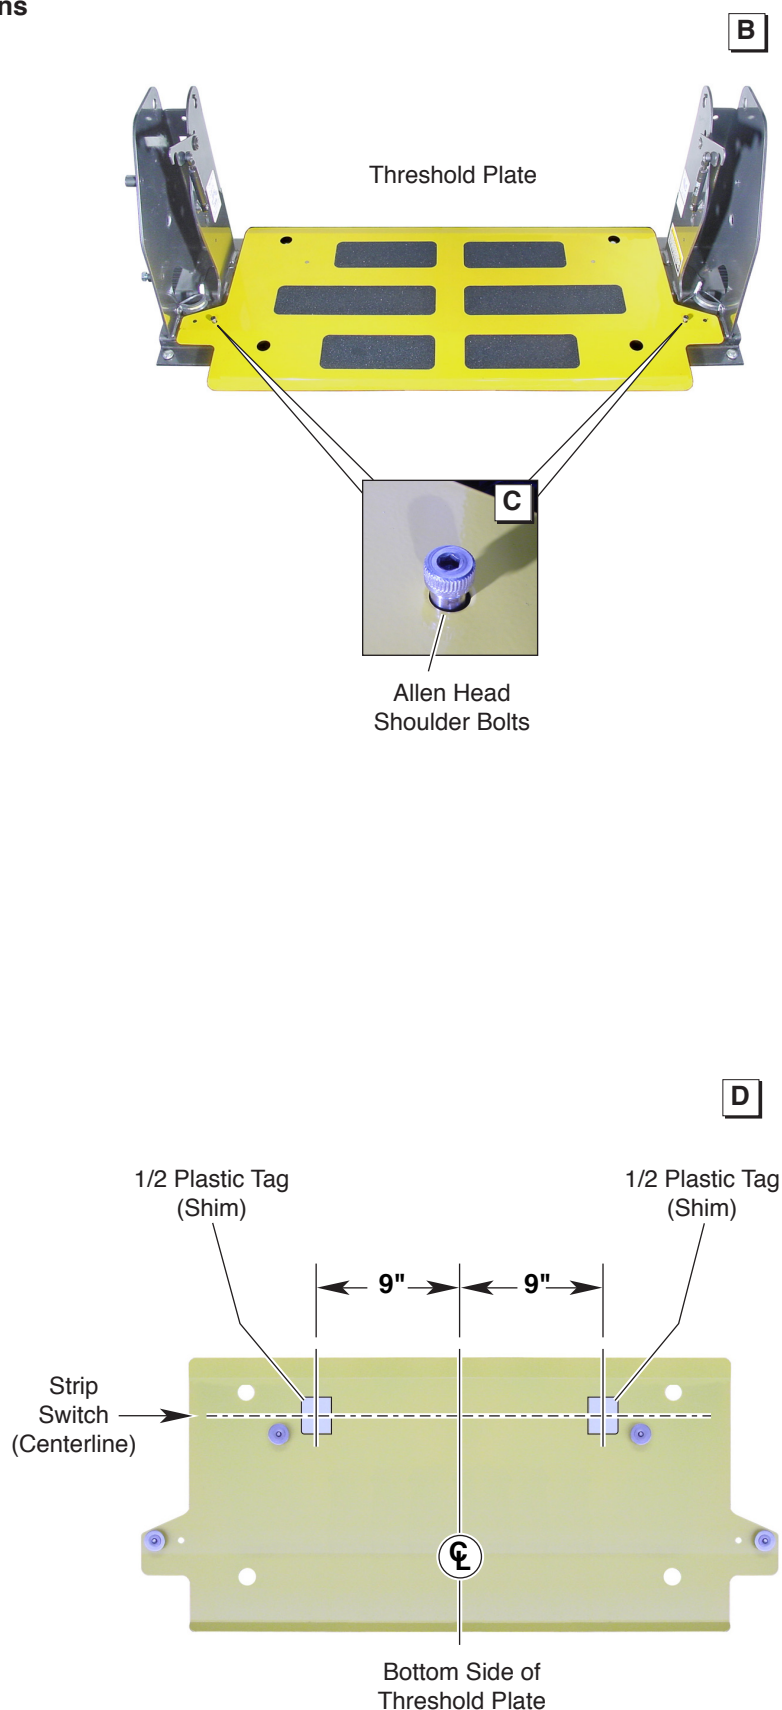
1. Turn Lift Power switch ON. Deploy the lift platform fully to the ground.
2. Remove the threshold plate. Loosen and remove two Allen head shoulder bolts securing the plate (see Photos B and C). Keep bolts. Slide the plate outward and lift to remove it (four keeper standoffs engage key-hole slots). See Photos E, F and G.
3. An adhesive-backed plastic tag is supplied to serve as an alarm activation shim (minimal thickness required to activate the highly sensitive alarm strip switches). Cut the plastic tag in two halves. The plastic tags (shims) will be affixed to the bottom side of the threshold plate (positioned as shown and detailed below).

Turn threshold plate over. See Photo D. The strip switches typically leave an impression (mark) on the yellow plate from use. Use the impression of the inboard strip switch as a centerline for shim positioning (or measure to establish position).

Position each shim 9" from the center of the threshold plate (see Photo D). Align the tags with the strip switch centerline. Clean the surface as detailed below and affix the adhesive-backed tag to the plate (**press firmly**).

**Note:** Clean the surface with isopropyl alcohol before affixing the tag. Use a clean cloth or paper towels. Do not use oily shop rags. Wipe surface free of residue with dry portion of cleaning cloth.

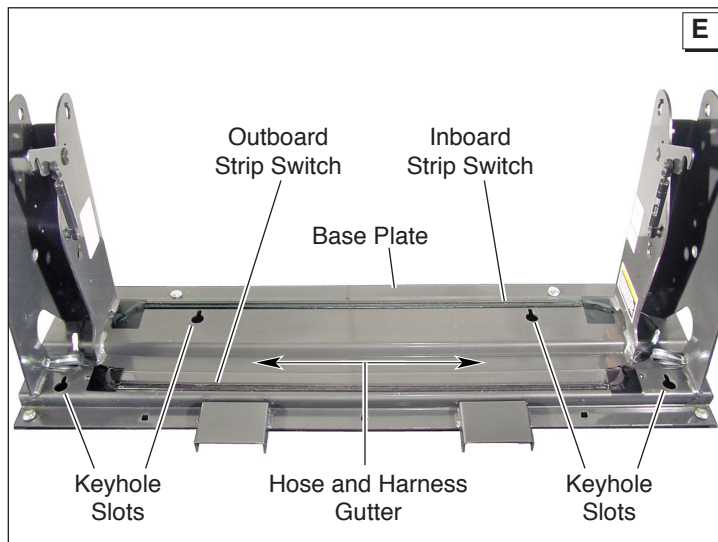
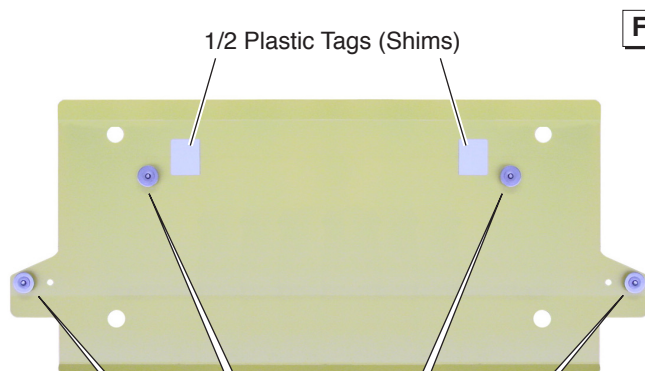
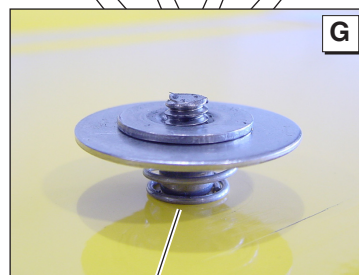
Keeper Standoffs  
(Engagement Studs)

4. Reposition the threshold plate (with shim). Align the keeper standoffs (studs) on the bottom of the threshold plate with the base plate keyhole slots. See Photos E, F and G. Insert studs and **carefully** slide the plate inward (engage slots fully).

**Ensure** all hoses and wiring harnesses routed through the base plate gutter are positioned fully in the gutter and not located anywhere they could potentially interfere with activation of the tape switches. See Photo E.

**Note:** Spraying a light mist of glass cleaner (or other) to the strip switches will aid in the plate sliding easier into position. See Photos E, F and G.

**Ensure** all four keeper standoffs engage the base plate keyhole slots.

5. Reinstall the two Allen head shoulder bolts previously securing the plate (see Photo B and C). Tighten bolts securely.
6. Repeat the sensitivity test procedures outlined on page 1.
