## SERVICE ADVISORY # 07- 096

### Challenger / Everest Kitchen Slide LP Gas Line

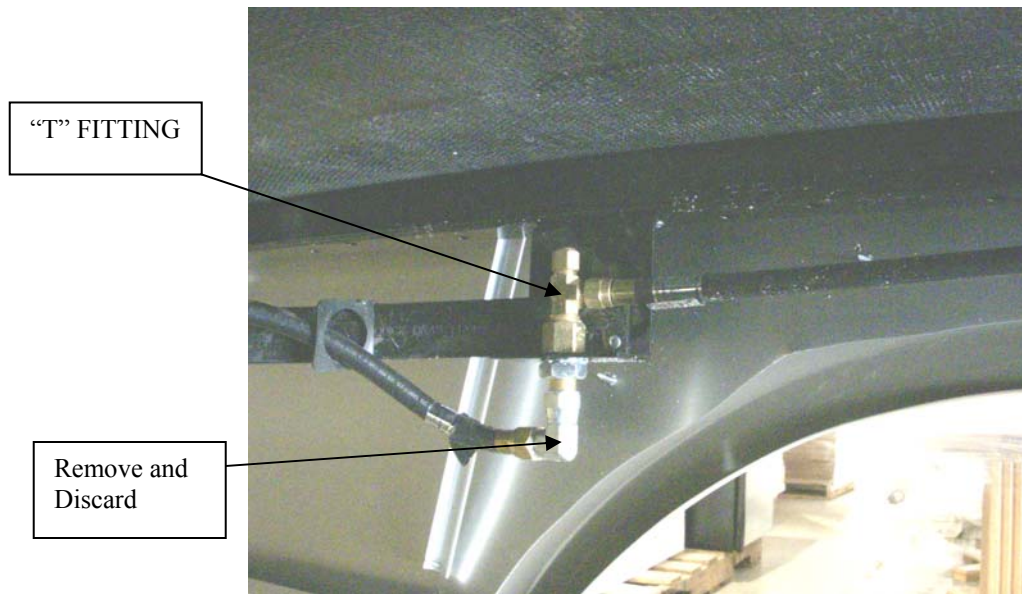
Fig 1

**Keystone RV Company is conducting a voluntary RECALL notification campaign in accordance with the National Traffic and Motor Vehicle Safety Act. It has been determined that on some vehicles the LP line may come in contact with the tire. This causes an increased risk of property damage and fire. The following instructions explain how to correct the problem.**

- Step 4.** Disassemble the LP fittings located at the rear of the slide room. Remove and discard the 90 degree elbow located between the flex hose and bulkhead fitting. Remove the cap from the "T" fitting. Remove the flex hose from the "T" fitting. Remove the "T" fitting and Bulk head assy. Refer to figure 1.
- Step 5.** Fasten the supplied 90 degree bracket (KRV# 102220) to the slide out room bar with (2) 1/4" x 1" hex head self tapping screws, approximately 6 inches in front of the existing mounting bracket, (closer to the front of the coach) as shown in figure 2.
- Step 6.** Install the bulkhead fitting into the new bracket and reattach the flex hoses and flare cap as shown in figure 2.
