Recall Information Bulletin

No: C1002210 **Issued:** 8/9/2007

Re: 4M50 Idler Gear Shaft Flange

Safety Recall C1002210 - 4M50 Idler Gear Shaft Flange

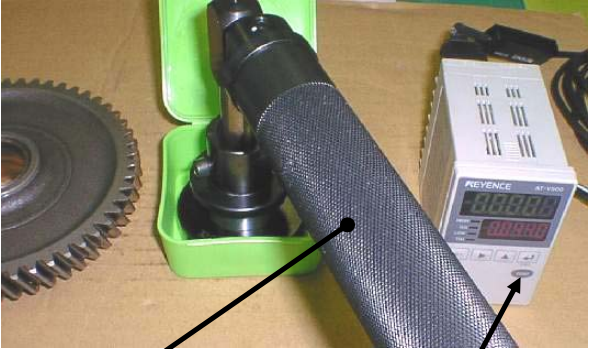
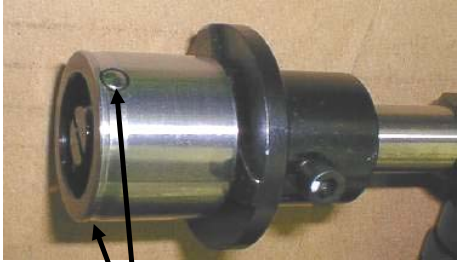
- **Before performing calibration, place the storage case on a flat surface and place the calibration ring in the storage case. Then fully insert the measuring gauge downward into the calibration ring, the gauge sensor must contact the calibration ring securely to ensure proper calibration.**

Measuring gauge

Button for ZERO setting

Storage case

Calibration ring

Detail for gauge sensor

**Gauge sensor
two sensors in opposite side**

1. Switch "ON" to turn on the controller.
2. Remove the protective cap for the gauge.
While inserting the gauge into the calibration ring, push the ZERO button to set zero.
Zero setting requires pushing the ZERO button one time.

Confirm that 0.000 is displayed on the measurement screen of the controller after pushing the ZERO button.

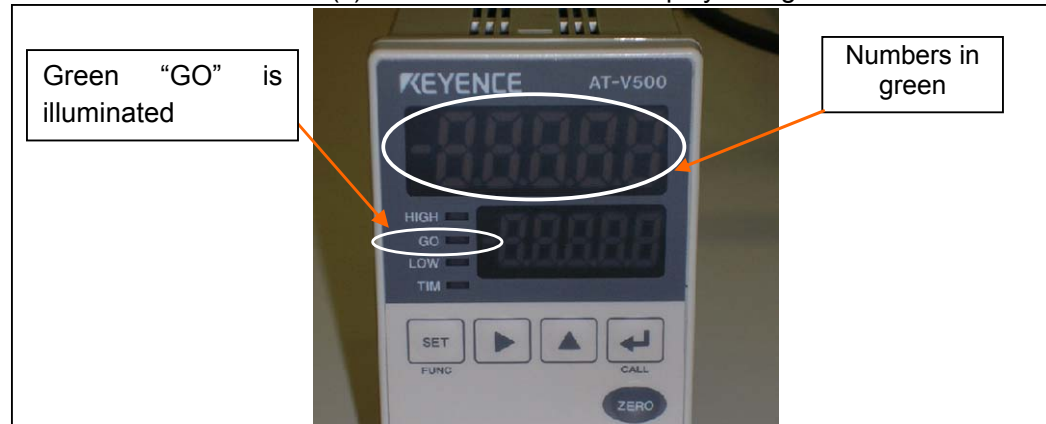
a. I/D of the head idler gear bushing is $\phi 32.043\text{mm}/1.262''$ or below. Number(s) on the measurement display is in green and "GO" is illuminated.

→ OK

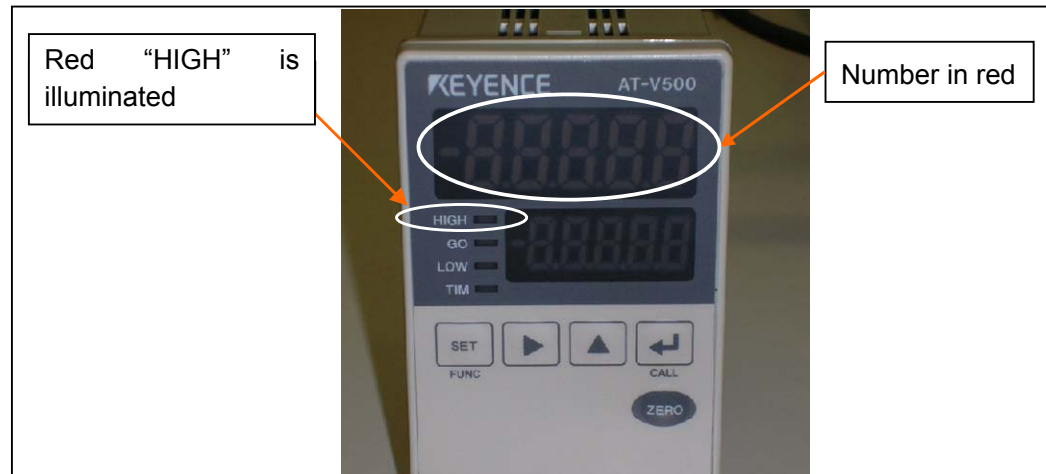
b. I/D of the head idler gear bushing is over $\phi 32.044\text{mm}/1.262''$. Number(s) on the measurement display is in red and "HIGH" is illuminated.

→ NG :Replace the cylinder head idler gear, shaft and shaft bolt.

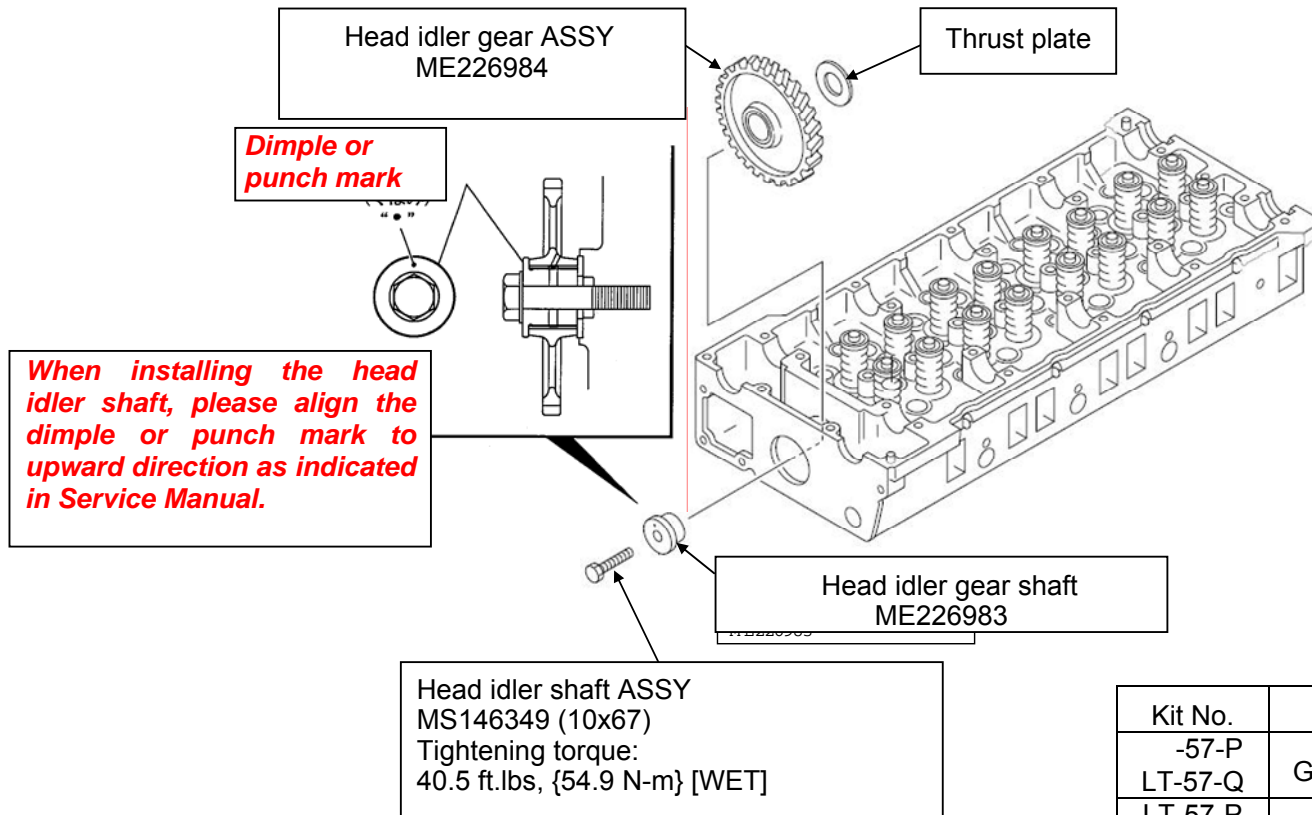
NOTE: When removing the head idler gear, be sure not to drop the thrust plate by pressing it against the cylinder head.

Description of work	Tightening torque for the head idler shaft bolt
Inspection only (re-use of existing gear)	29.6 ft.lbs, {40.2 N m } [WET]
Replace gears	40.5 ft.lbs, {54.9N m } [WET]

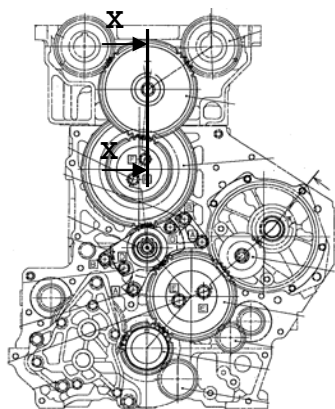
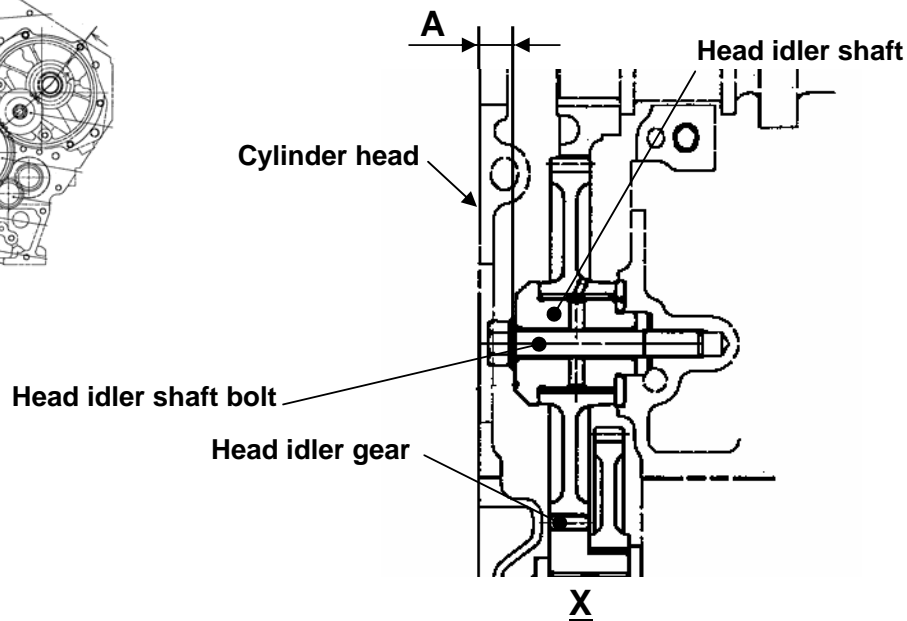
Measuring before removal and reassembling head idler shaft

Be sure to measure below distance before removal and reassembling of the head idler shaft

Distance "A" : From end surface of a cylinder head to end surface of a head idler shaft

1) Existing head idler shaft (Thin flange): 0.71" (18 mm)

2) New head idler shaft: 0.51" (13mm)

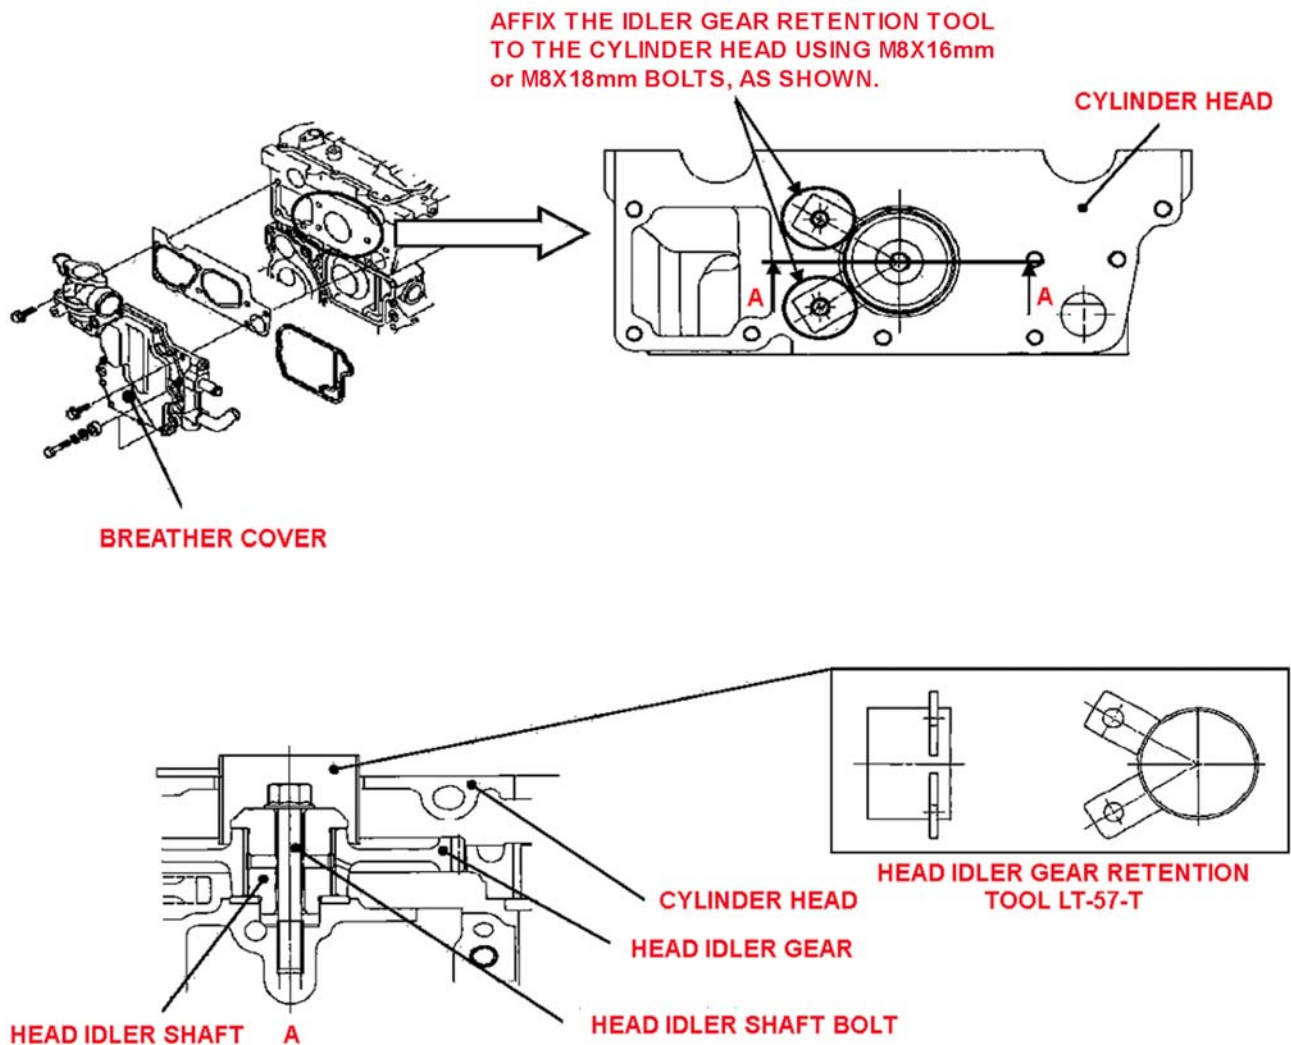
An Idler Gear Retention Tool (LT-57-T) will be provided to each Dealer in order to prevent the thrust plate from dropping out during idler shaft removal and installation. Please review the tool installation instructions below to properly affix the retention tool.
