SUBJECT: Campaign #105 – Exterior Drawer Secondary Catch

INSTRUCTION TO PERFORM CAMPAIGN #105

INSTRUCTIONS TO PERFORM CAMPAIGN 105

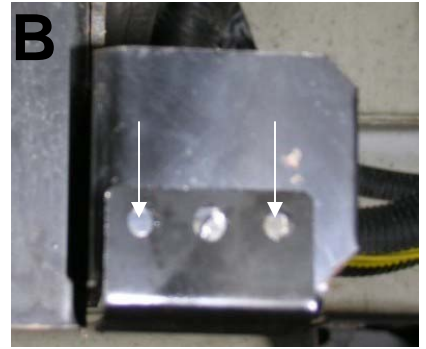
5. Drill (2) holes and install rivets in locations shown on Photo B.
6. Clean the interior of the drawer area where the secondary catch will be installed.
7. Holding the secondary catch (provided), position the catch allowing it to pass the return flange while closing the drawer, but catching the return flange when opening the drawer. Remove the backing to the two-sided adhesive and place in position. Shown in Photo C.

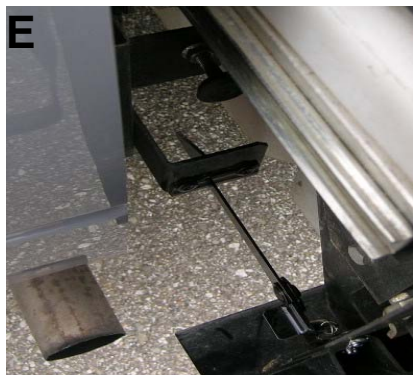
9. Check your installed secondary catch and return flange to ensure proper operation when opening and closing the slideout drawer. Shown in Photo E.
