VEHICLE SAFETY DEFECT NOTIFICATION – Brake Line Routing on 2004-2006 VMI Ford Freestar Conversions

Recall DOC4241

Title	Ford Freestar Hydraulic Brake Line Routing		
Assembly Area	N/A	Engineer	Bruce Blocksom
Model	Freestar	Station #	Field

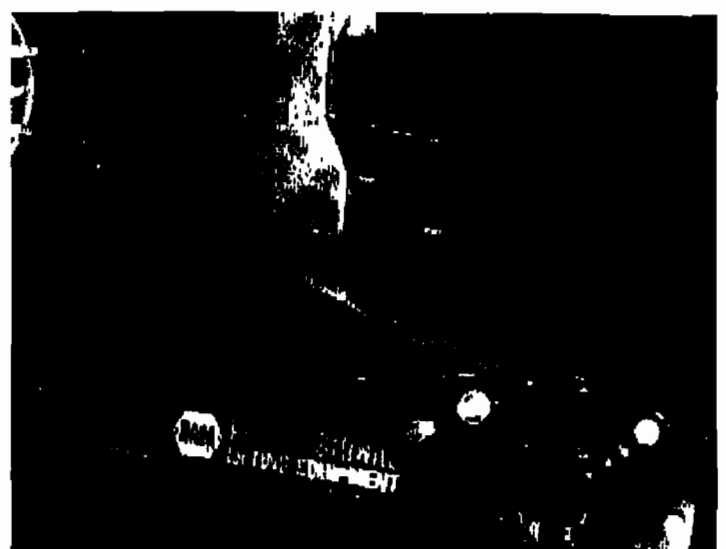
- 2) Lower the hydraulic floor jack just enough so the weight of the driver side front is supported by the jack stand. **LEAVE THE HYDRAULIC FLOOR JACK IN PLACE UNDER THE JACK PAD.** Remove the driver side front wheel.

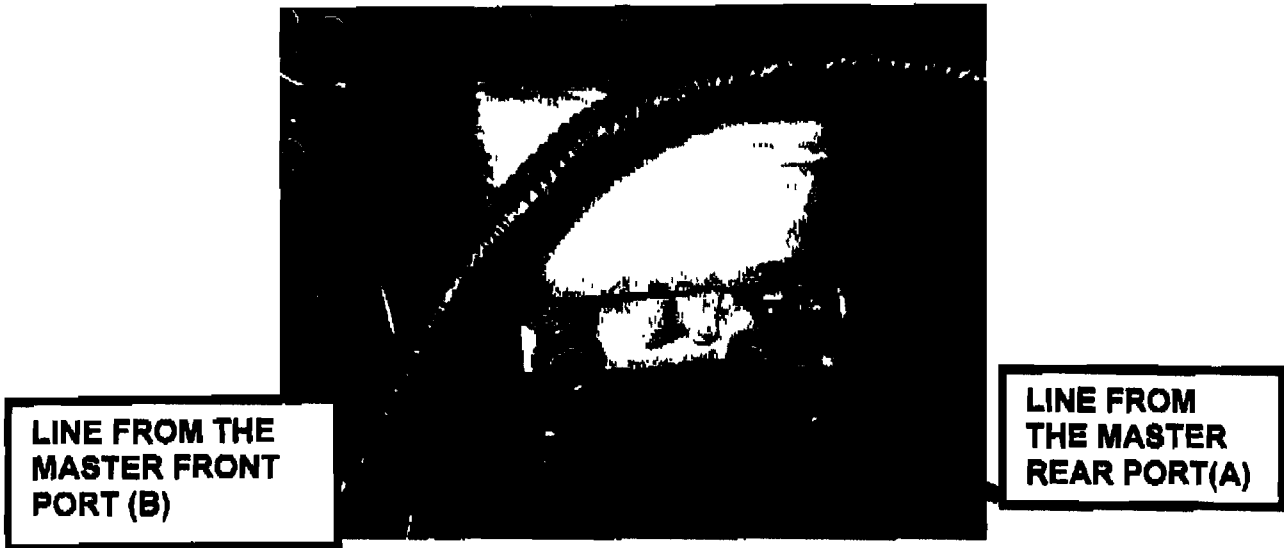
NOTE: IF THE HYDRAULIC LINES NEED TO BE REPLACED, THEY MUST BE INSTALLED TO THE CORRECT PORT OF THE ABS PUMP FROM THE MASTER CYLINDER OTHERWISE THE ABS WILL NOT FUNCTION PROPERLY. (Note: Remove and Replace one (1) Brake Line at a Time).

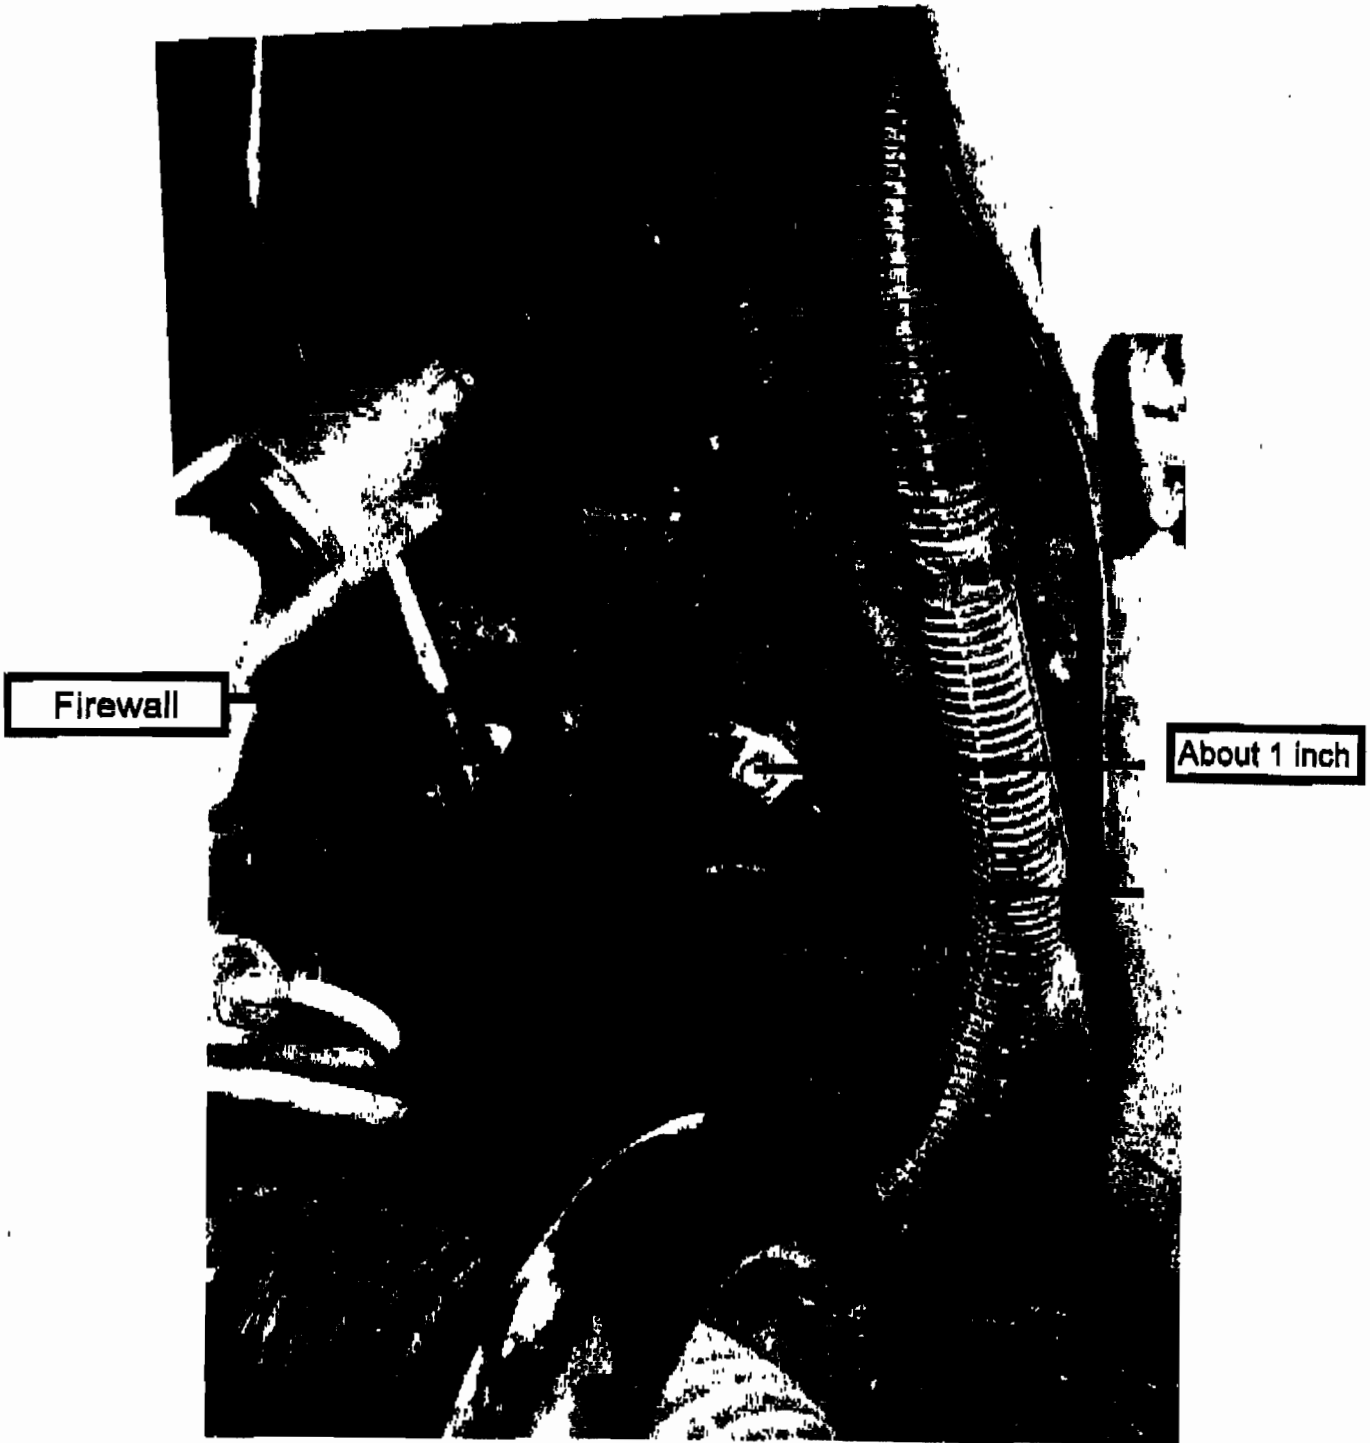
Route the replacement brake lines from the master cylinder to the driver side of the steering wheel shaft and against the firewall. Secure with TWO plastic lined clamps and one sheet metal screw. NOTE location of sheet metal screw (about 1 in above edge of sheet metal).

Connect lines to the proper ports of the ABS pump (Note: Remove and Replace one (1) Brake Line at a Time).
