SERVICE PROCEDURE

**G-07506
May 2007**

SUBJECT: SAFETY RECALL (U.S.)

**DAVCO® FUEL PRO® 382 PRE-HEATER on certain
7000, 8000, 9000 and ProStar™ Models built
12/1/2006 thru 2/21/2007**

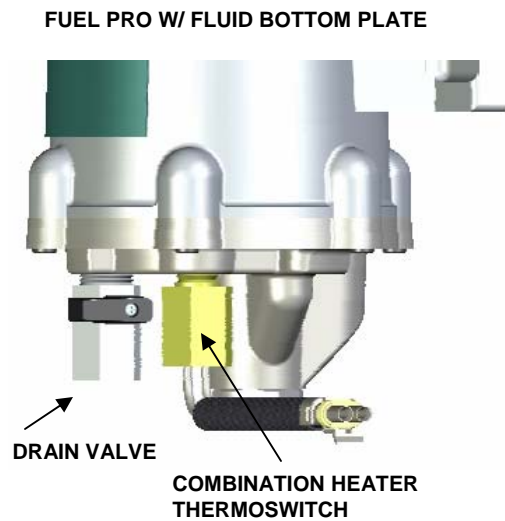
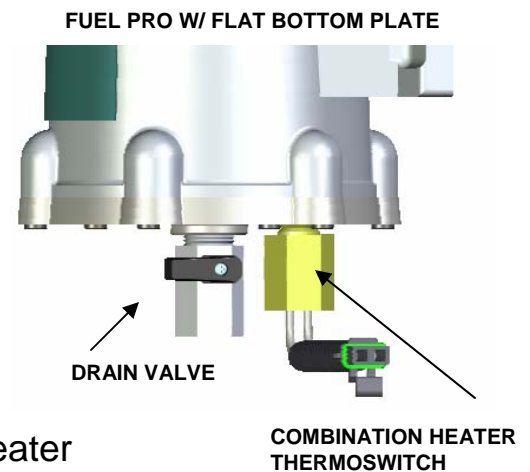
1. Remove vent cap on the cover of the Fuel Pro.
2. Drain the Fuel Pro completely into a clean container. Keep the fuel for reuse later.
3. Disconnect heater harness connector.
4. Place a drain pan under the Fuel Pro. Using a 1" box end wrench remove the combination heater thermoswitch.

1. Apply thread sealant to new combination heater thermoswitch.
2. Install and tighten to 15 ft-lb.
3. Reconnect the heater harness.
4. Using fuel drained during the removal procedure, refill the Fuel Pro and install the vent cap and tighten by hand only.
