# Technical Bulletin

TSB No. TS 05 07167

**SUBJECT: SAFETY RECALL CAMPAIGN "MU" REPLACEMENT OF M/T GEARSHIFT CABLE CLIP**

**MODEL(S): AERIO(RH420 AND RH423) MANUAL TRANSMISSION ONLY**

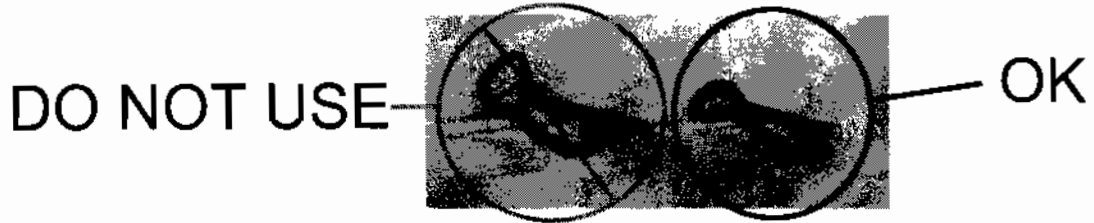
Part Numbers	Description	QTY	Notes
09385-08004	Clip	1	See picture

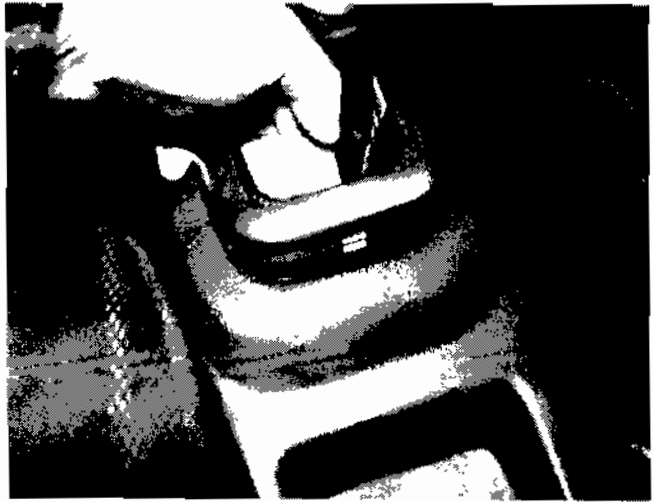
4. Remove the gearshift lever garnish by lifting from the inside of the garnish ring. Raise the garnish ring up but do not remove the boot from the shifter.

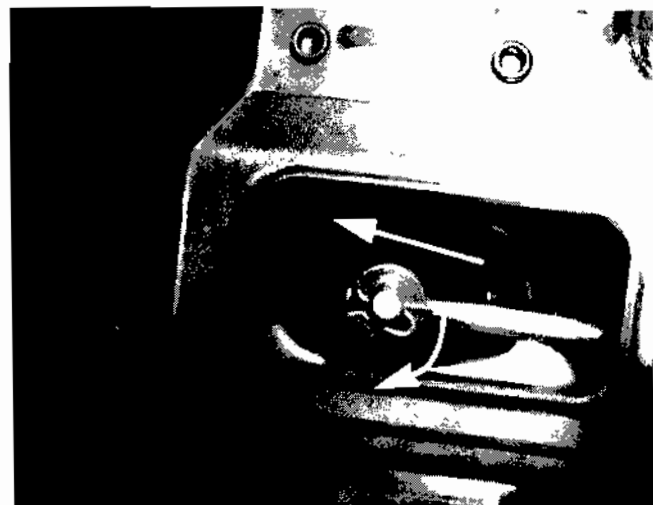
- Bend the hooked end of the clip down to remove the old clip from the shifter link.
- Install the new clip in the same position.
- Re-assemble the console by reversing these instructions.

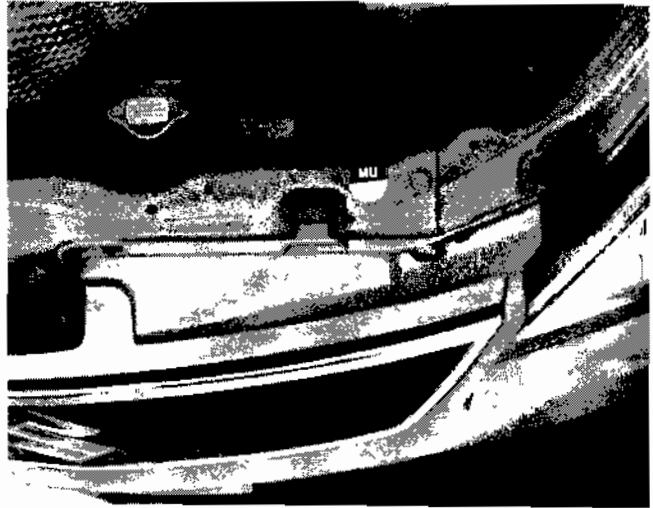
12. Place campaign sticker "MU" on core support.
13. Discard old clip.
