PREVOST

**SAFETY
RECALL**

Sr07-11

DATE : September-2007	SECTION : 12
SUBJECT : BENDIX SR-7 SPRING BRAKE MODULATING VALVE – INTERNAL CHECK VALVE RETROFIT

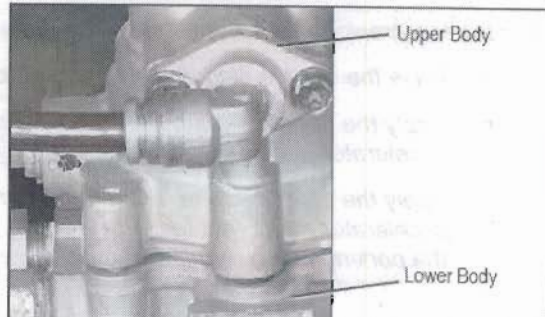
5. Align the valve lower body with the upper body. Push the body halves together.
6. Insert two of the four screws (finger tight) into the lower body mounting holes closest to the supply port first. This will help with alignment. One extra screw is included in this kit in the event one is lost during installation.
