Technical Bulletin

Section Title: Body, Cab & Accessories
 TSB No. TS 11 10177R2

SUBJECT: SAFETY RECALL CAMPAIGN “NB” LOW BEAM HEADLIGHT AND DAYTIME RUNNING LIGHT (DRL) SPLICE PACK REPAIR
MODEL(S): FORENZA SEDAN/WAGON, RENO (RQ420)
YEAR: 2004~2006
REVISION: THE VIN RANGE AND PARTS INFO HAS BEEN UPDATED
AFFECTED VIN(S): ALL 2004, 2005, AND CERTAIN 2006 MY UP TO ~6K369480
NOTE: VIN numbers are not fully inclusive. Not all VIN’s within the above range are included. If the vehicle owner does not present the Owner Notification Letter, with the printed VIN, check vehicle history in Suzuki Connect to verify if the VIN is affected and included or not.

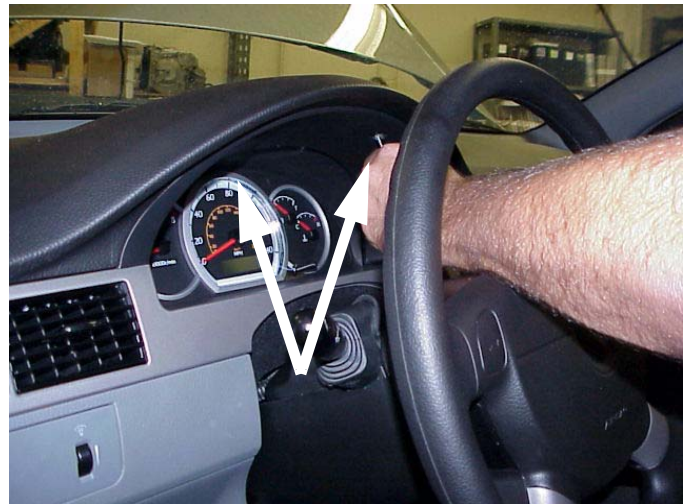
1. Disconnect the battery negative cable. Tilt wheel to the max down position. Remove instrument cluster bezel by removing the two screws.

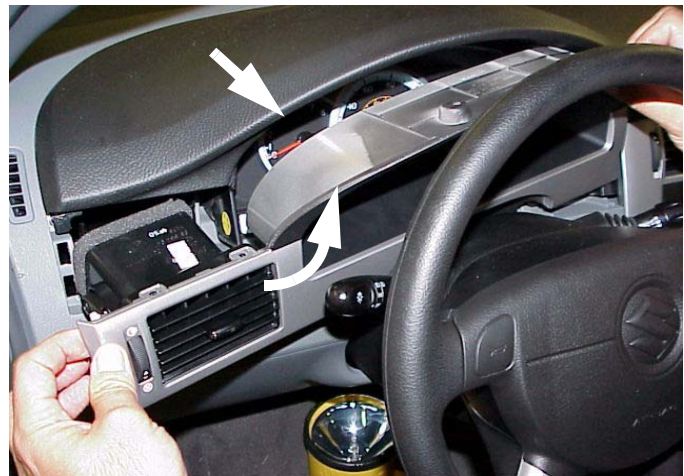
2. The bezel is secured along the bottom with clips. Some force is required to release clips. Remove the bezel by sliding towards you and tilting up behind steering wheel.

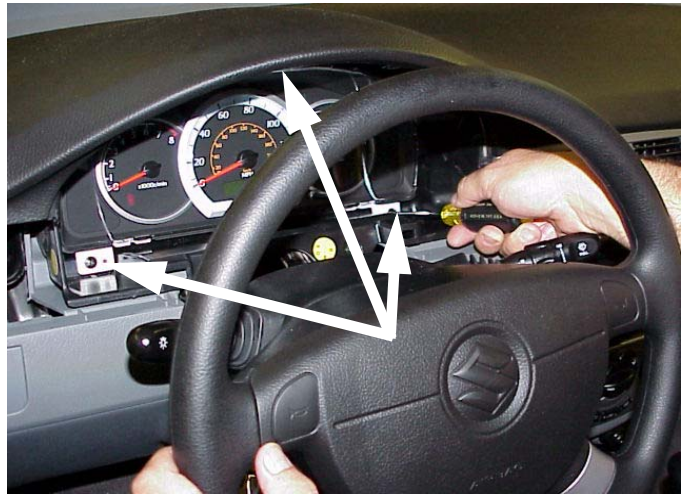
3. Remove the three instrument cluster screws.

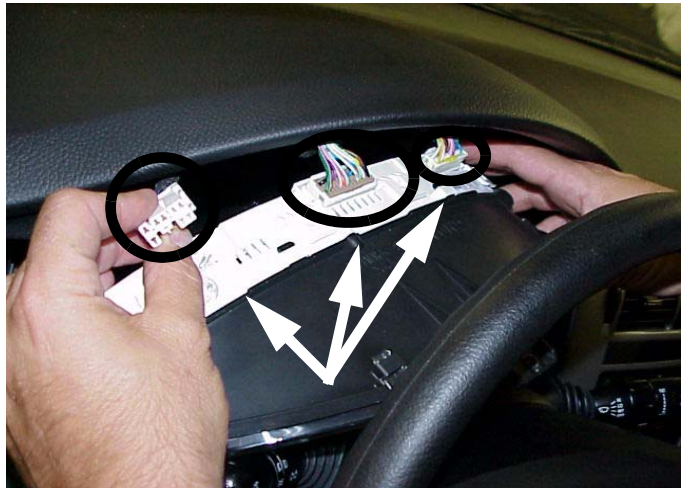
4. Slide instrument cluster forward enough to remove the three electrical connectors. Then remove and set the instrument cluster aside.

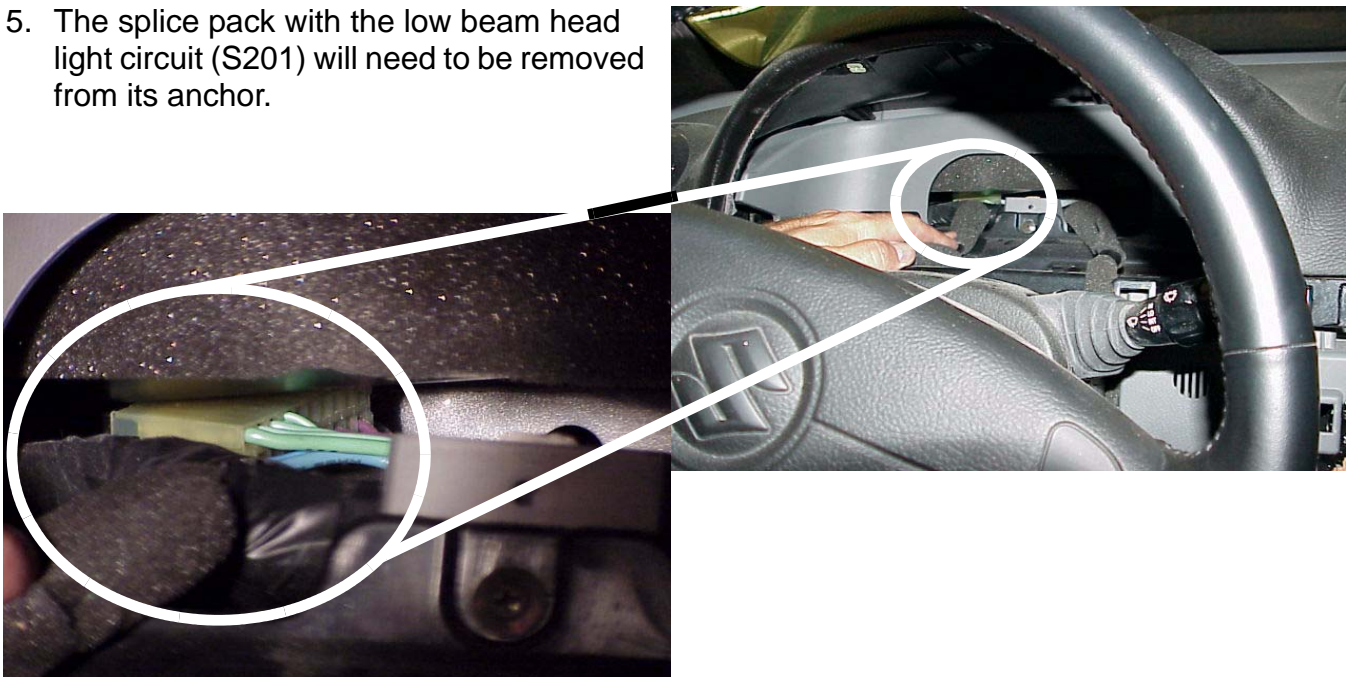
CONDITION: Possible high resistance in the S201 splice pack may cause low beam headlights and DRL to not operate.

CAUSE: Affected vehicles were produced with splice packs which may have high resistance at the headlight lamp splice. It is possible for this high resistance to generate enough heat to melt the splice pack eventually causing the circuit for the low beam headlights and DRL to open. The low beam and DRL may not function if the circuit opens. A burning smell may also be present from the instrument cluster area.

5. The splice pack with the low beam head light circuit (S201) will need to be removed from its anchor.

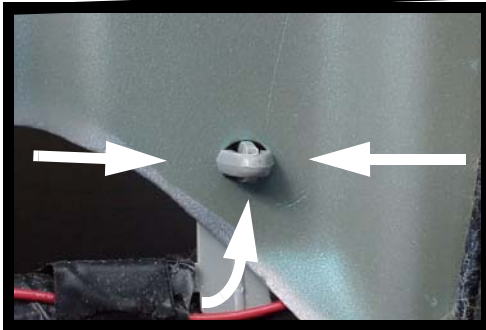
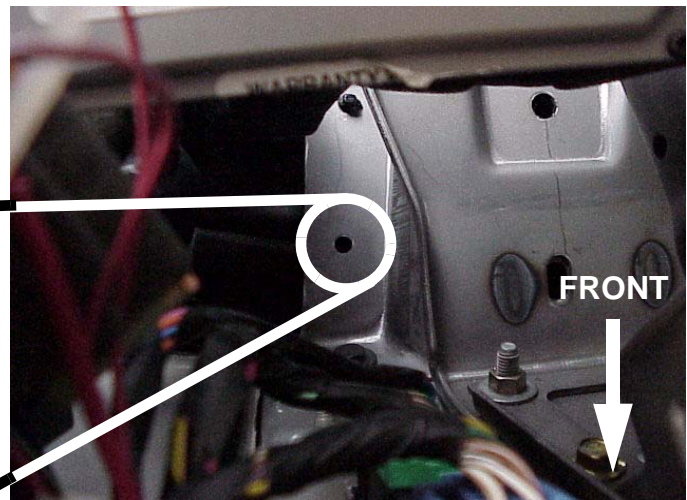
6. Under the dash to the left of the steering column directly under the splice pack, release the anchor of the splice pack by squeezing the anchor catches. Then, push the anchor through the hole.

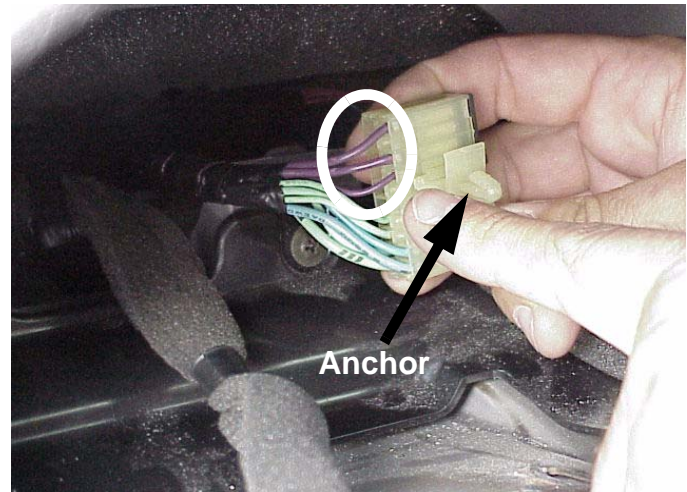
7. Back up at the instrument panel opening, pull the splice pack out from in between the A/C duct and dash support structure. Inspect the splice pack for the three violet wires shown. If present continue to step 8. If they have been cut off, a repair attempt has been made which will have to be removed and then repaired as described starting with step 8.

With the splice pack anchor facing you as shown, the three violet wires will be on top.

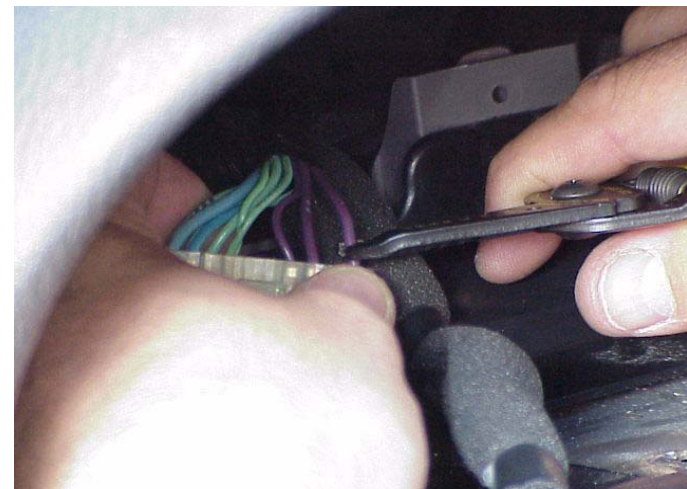
8. Cut the three violet wires just behind any heat damage if it exists. If a repair has already been attempted remove the repair by cutting the wires as close to the repair as possible.

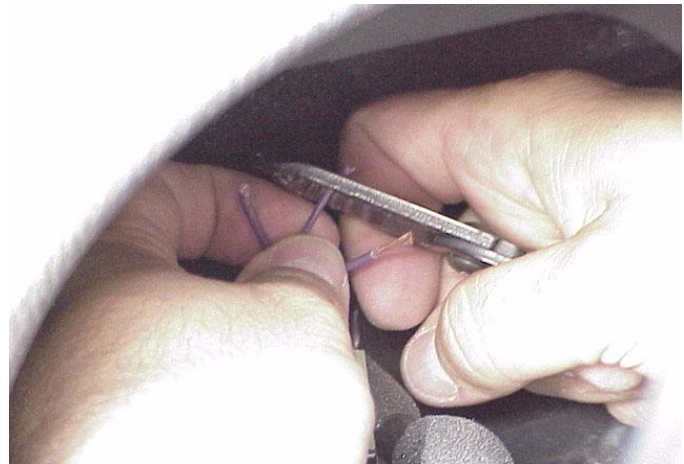
9. Strip about half an inch of insulation off the end of each violet wire and twist the stripped ends together. (It may be necessary to remove some of the harness wrap to expose enough of the violet wires to work with.)

Hands must be clean of any grease when preparing wires for connection. Any grease or foreign matter on the wires will prevent solder from adhering to the copper wire strands.

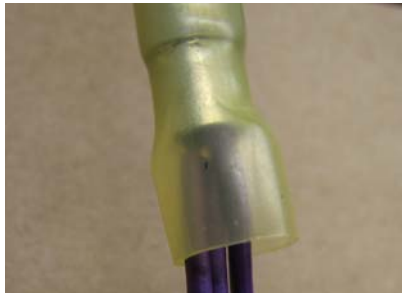
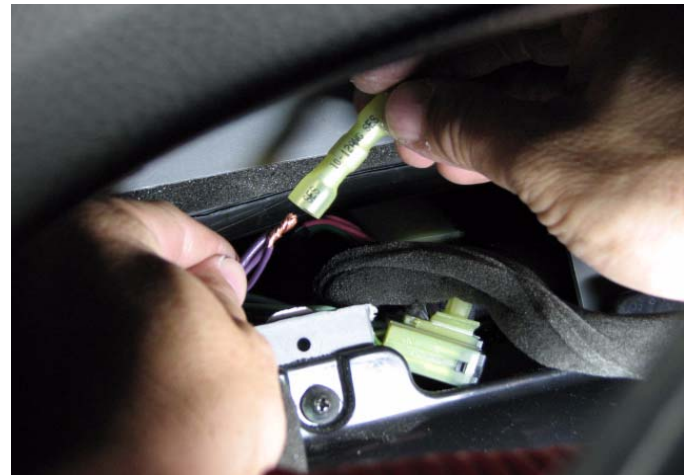
10. Insert the twisted wire end fully into the specified crimp connector. The exposed copper wire should be completely inserted in the metal barrel of the crimp connector. The wire insulation should be inside of the clear area of the connector touching the barrel.

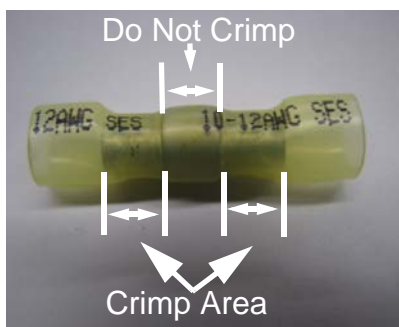
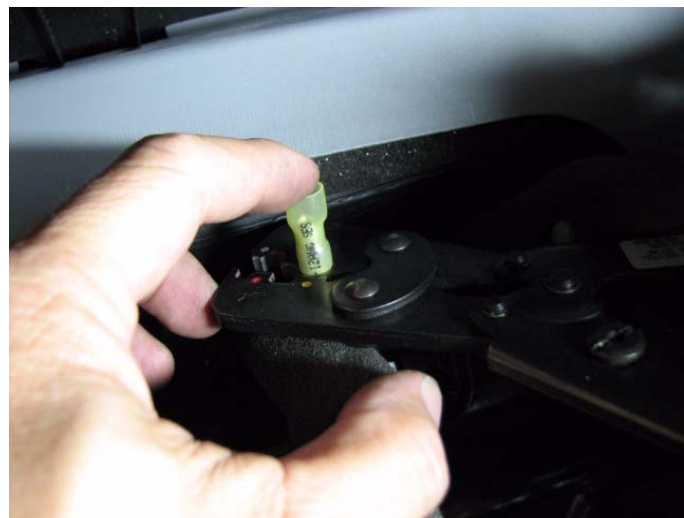
11. Fully crimp the connector using the ratchet crimper. Note the crimper will release automatically if crimped properly.

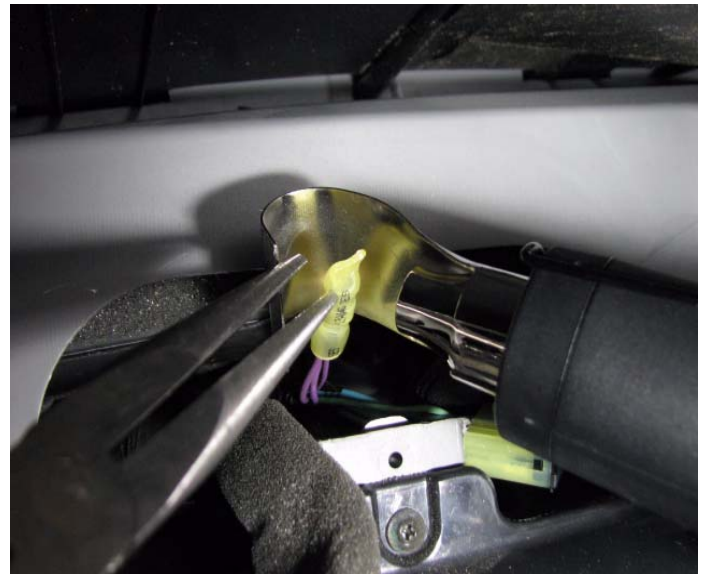
12. Shrink the crimp connector with the specified heat gun. Start at the open end off the connector. DO NOT use an open flame.
13. Once the end shrinks, gently squeeze it flat with a pair of needle nose pliers before it cools. Continue to heat the crimp connector until the solder has melted and wicked into the wire.

Do not allow the heat gun shield to contact any of the plastic or foam in the dash area you are working in.

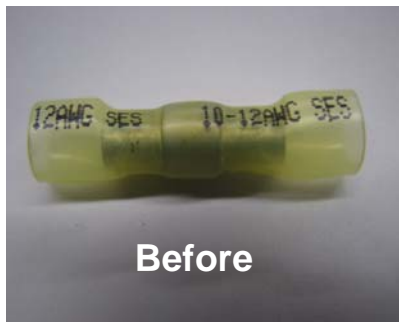
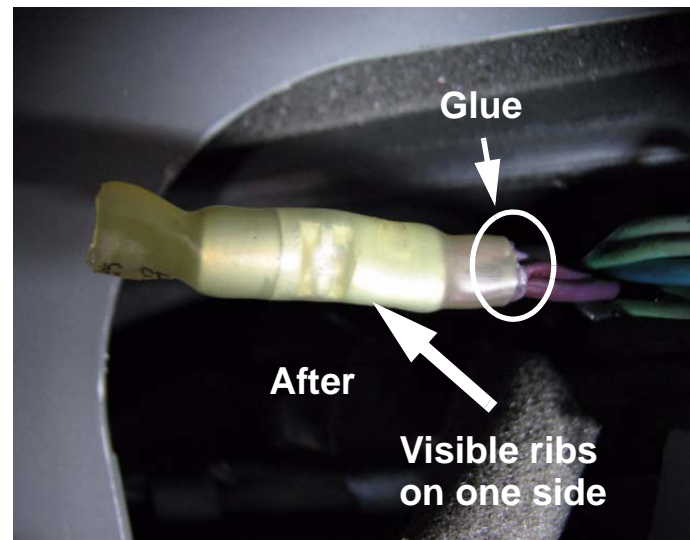
14. When the solder has melted you will see the centering ribs on one side of the crimp connector and the glue should start coming out around the wires.

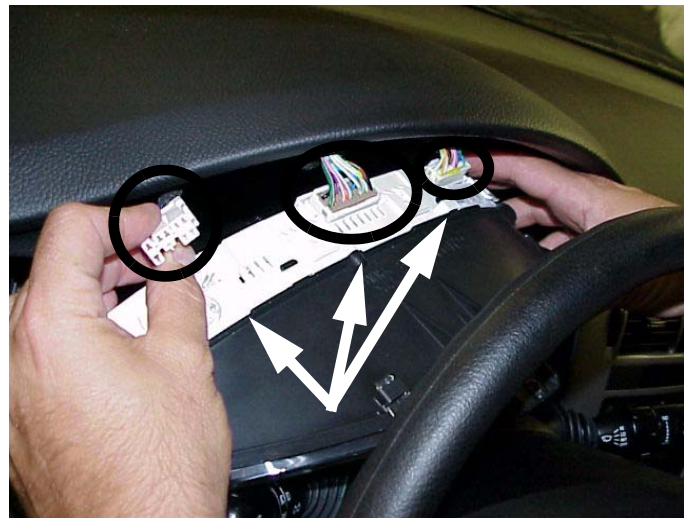
15. Temporarily connect the three instrument cluster connectors to the instrument cluster. Connect the battery negative terminal and test the headlight operation. The key must be in the ON position for the headlights to operate. If the headlights do not operate further circuit diagnosis will be required. Please contact the Suzuki Techline if assistance is required. If headlights operate, continue to step 16.

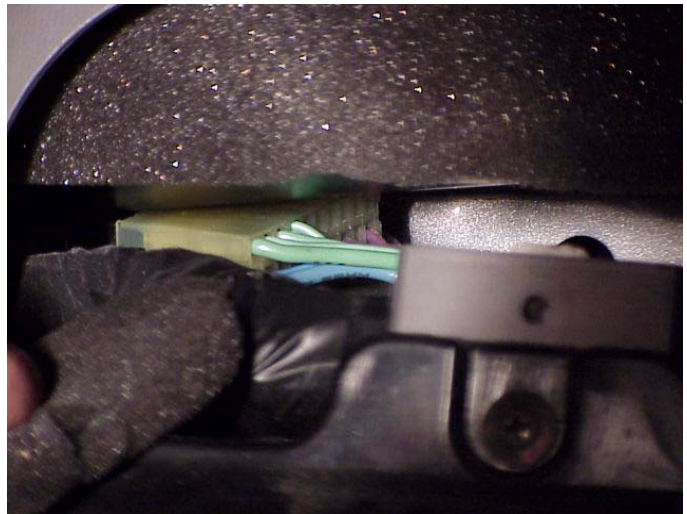
16. Turn ignition OFF. Disconnect battery negative cable. Remove instrument cluster.
17. Re-install the splice pack back into its original position to prevent dash rattles. It is not necessary to insulate the wires on the splice pack they are no longer powered.
18. Re-install the instrument cluster and bezel. Re-connect the battery negative terminal.
19. If the "Air Bag"

warning light is ON after repair, clear the DTCs. The light will not go OFF until the ignition key is cycled OFF then ON.
