**VEHICLE SAFETY DEFECT SERVICE BULLETIN**  
**NHTSA Recall Campaign # 07V476**  
**Foretravel File # R07V-476**

**Re: Safety Recall – Villa Isri Air Base Seat**

# Foretravel Service Bulletin

**Subject:** Safety Recall #R07V-476-Villa Isri® Air Seat Base Tether

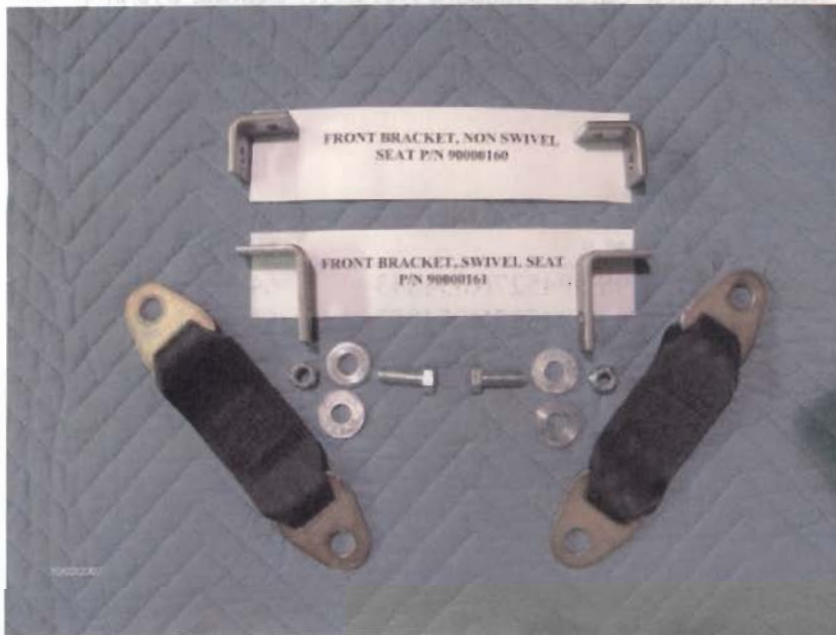
The Recall kit # Villa-Kit-R07V476 includes the following parts:

Quantity	Name / Part Number
1.	2	Front Bracket, Swivel Seat, P/N 90000161
2.	2	Front Bracket, Non-swivel Seat, P/N 90000160
3.	2	Amsafe 7" Tether, P/N 71800001-02
4.	2	3/8-16x1" Hex Bolt, Steel, Grade 5
5.	4	3/8 USS Flat Washer
6.	2	3/8 Hex Nut, Nylon Insert Lock

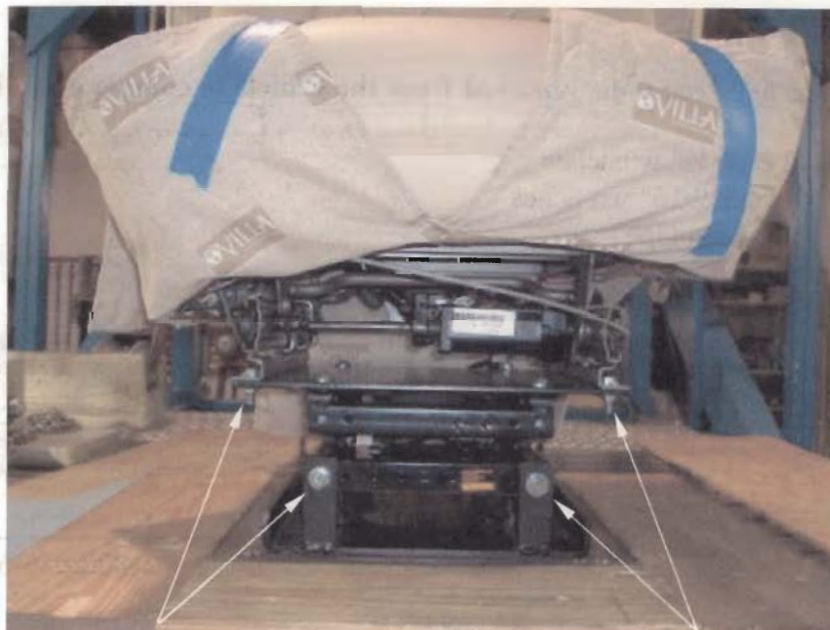
**NON SWIVEL SEAT INSTALLATION INSTRUCTIONS:**

Pull skirt of seat up, and secure with masking tape. The tethers are attached from the adapter plate to the floor plate.

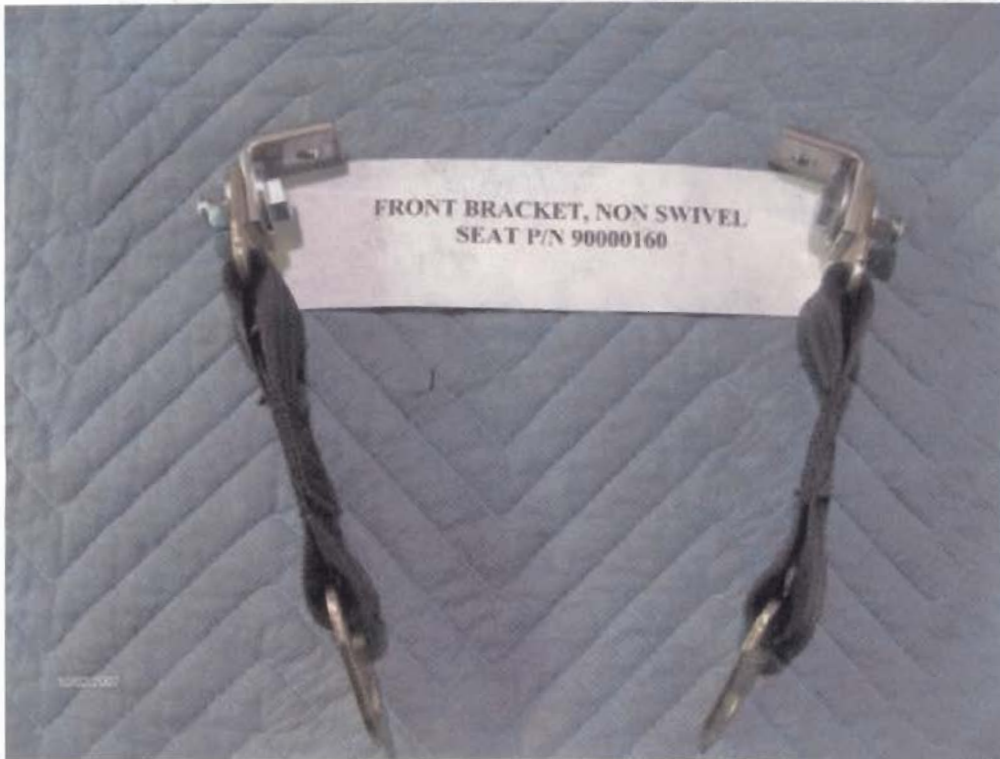
Assemble the brackets to the tethers with the 3/8" bolt head to the inside

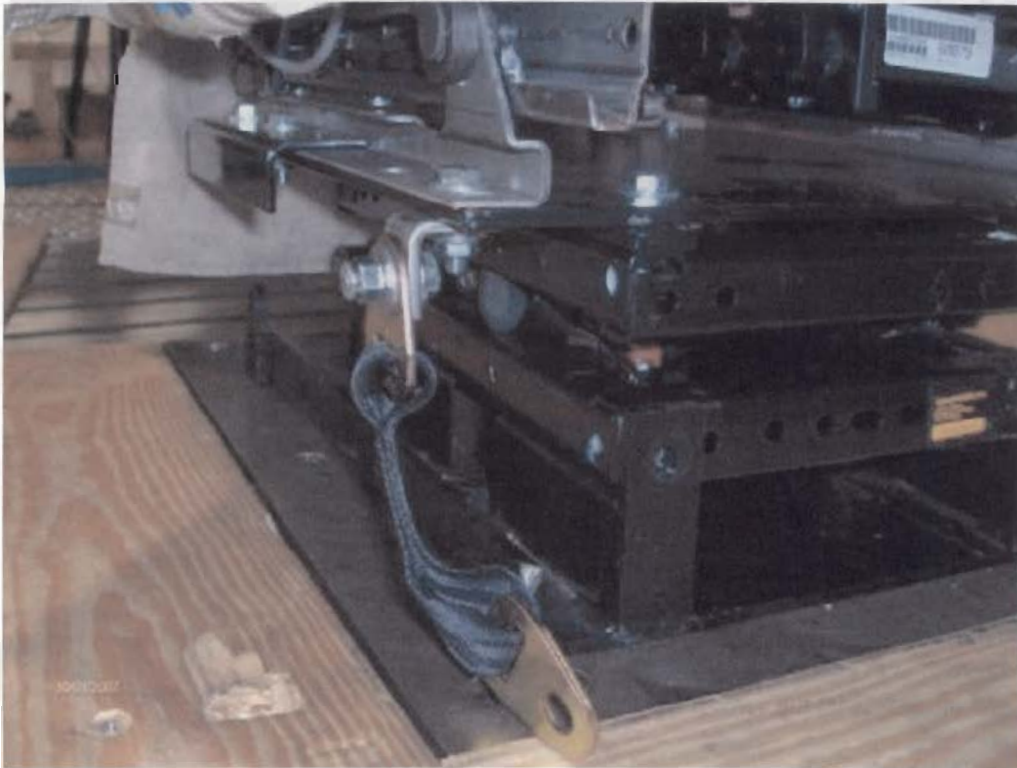
Remove the nut and washer from the top front bolt. Install the bracket, reinstall the washer and nut on the bolt. Tighten the bolt and nut with two 1/2" wrenches.

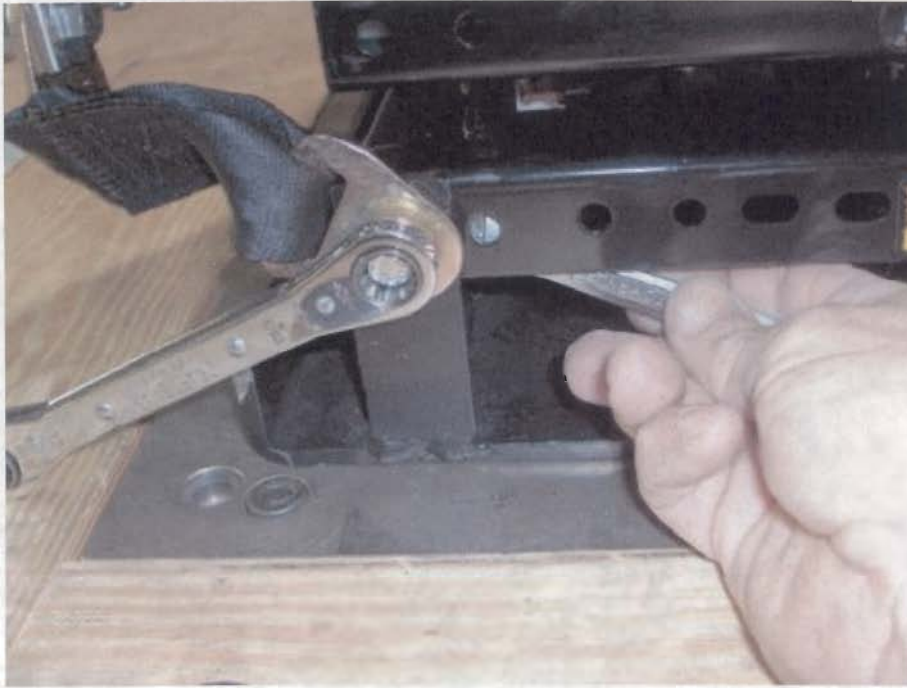
The bottom bolt is a tight fit, but a ½" open end wrench will fit inside the channel to hold the nut. Angle the belt up at about a 30 degree angle as you tighten. Install the tether on the other side of the seat in the same sequence.

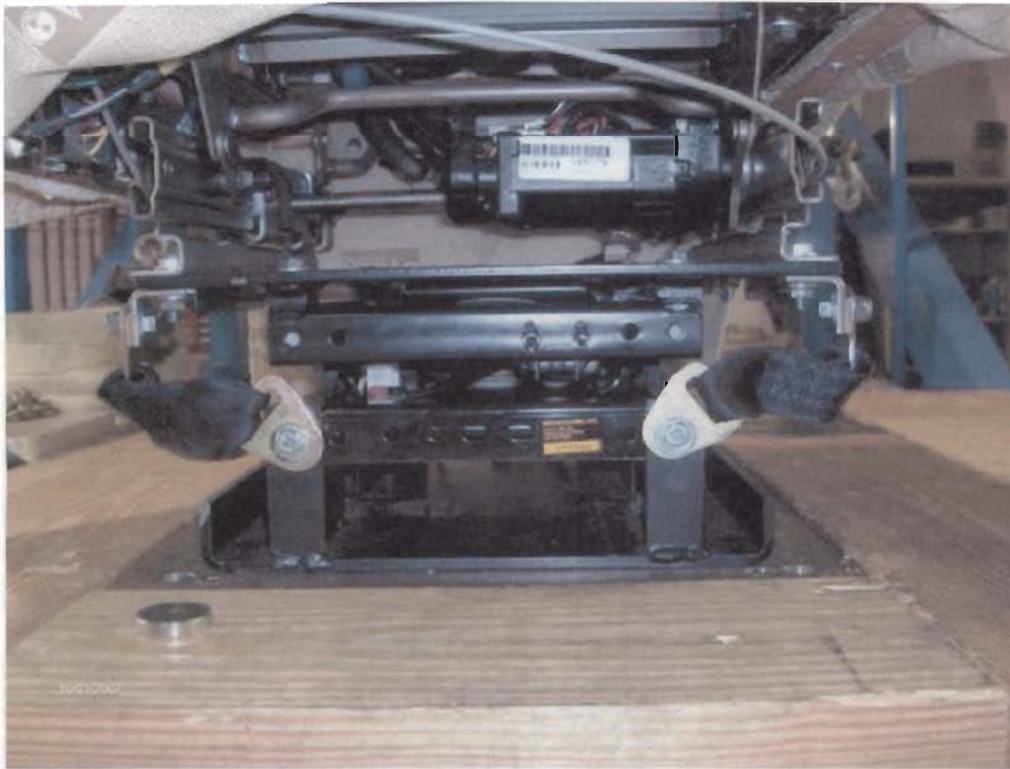
This is the completed installation.

1. Bottom bolts tight
2. Bottom tether sloped upward about 30 degrees
3. Tether to bracket bolt tight, nut facing outward
4. Tether bracket mounted with the vertical leg to the outside
5. Top bolt tight.

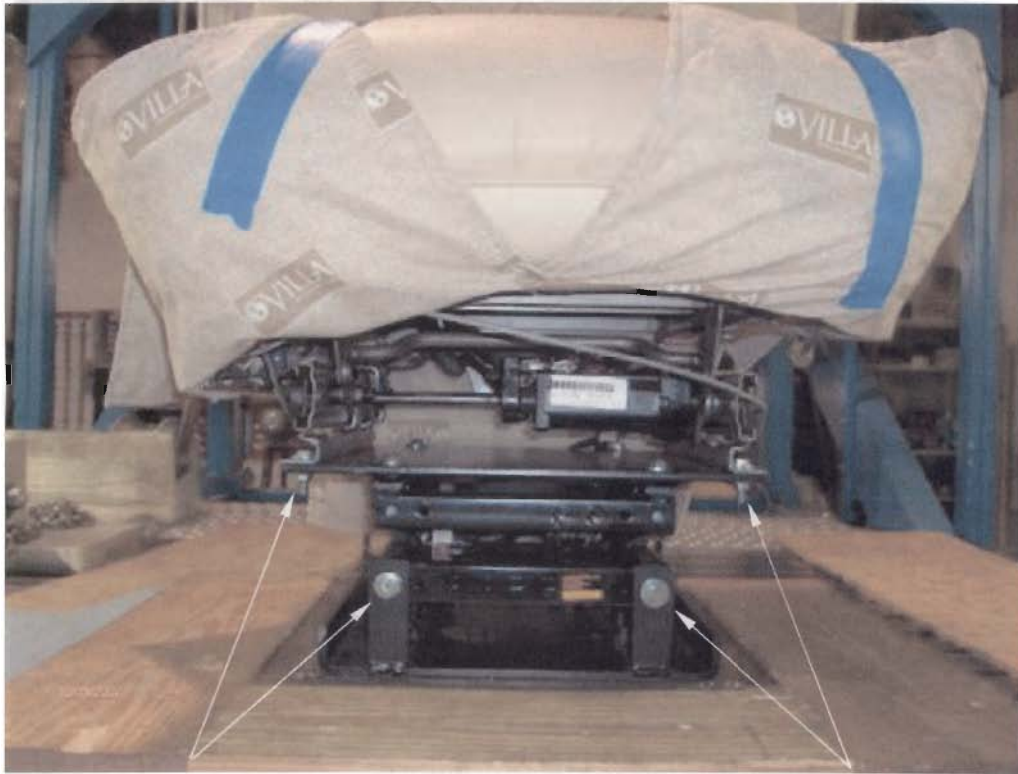
Pull skirt of seat up, and secure with masking tape. The tethers are attached from the adapter plate to the the top plate of the swivel riser.

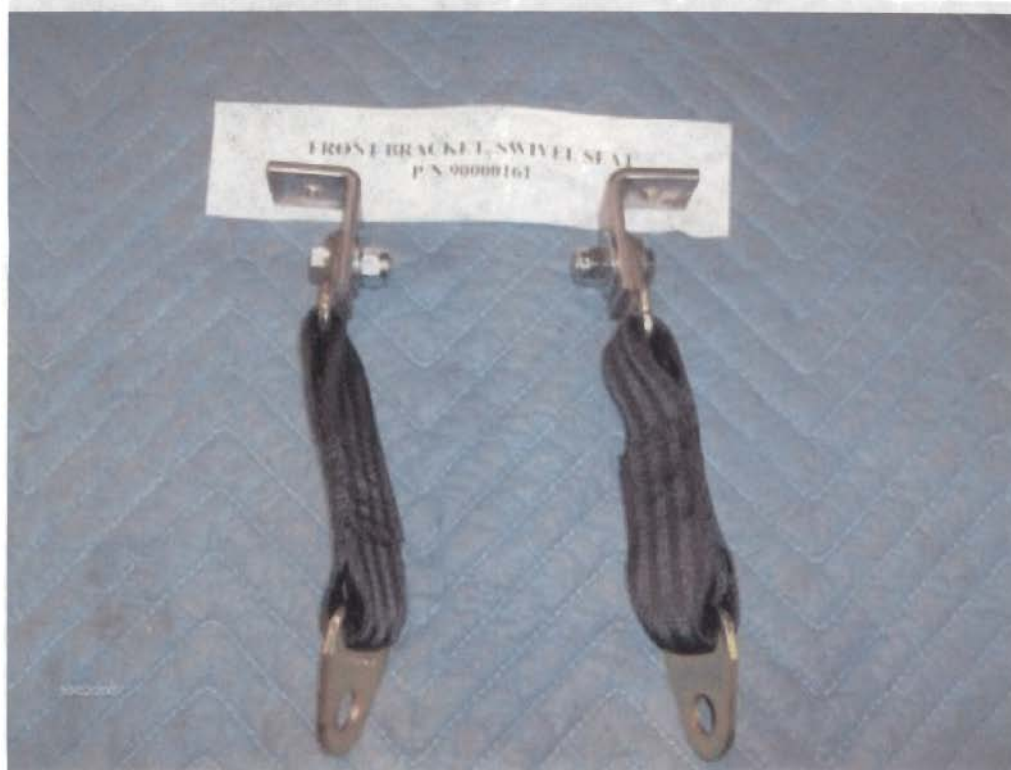
Assemble the brackets to the tethers with the 3/8" bolt head to the outside.

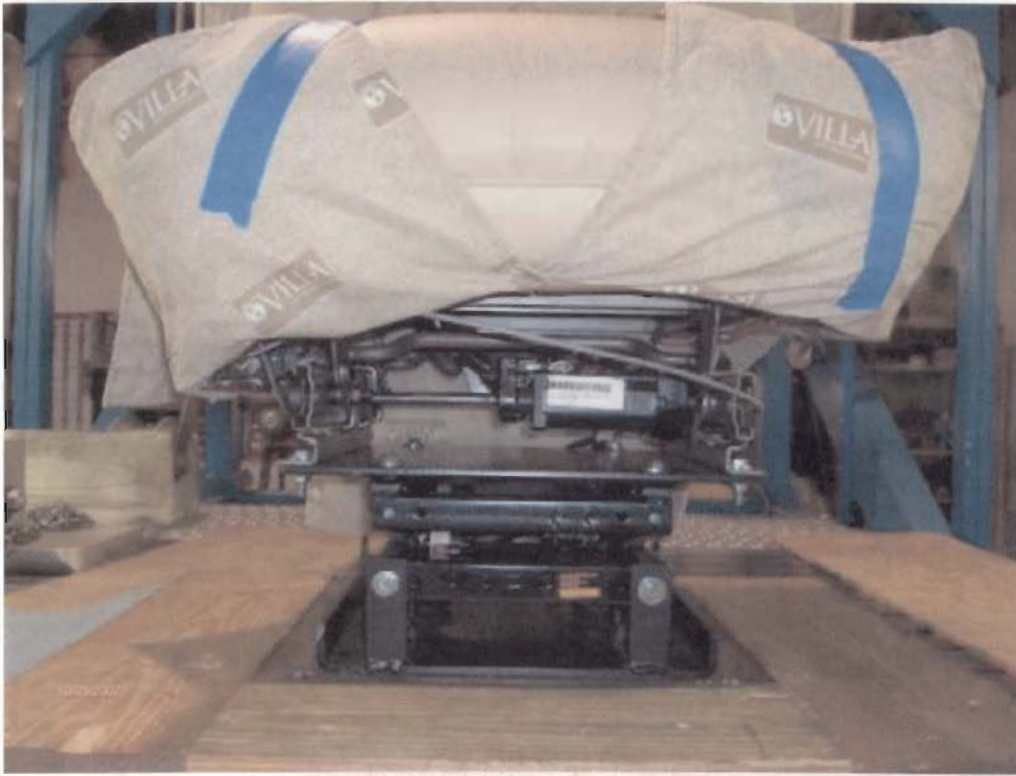
Pull skirt of seat up, and secure with masking tape. The tethers are attached from the adapter plate to the the top plate of the swivel riser.

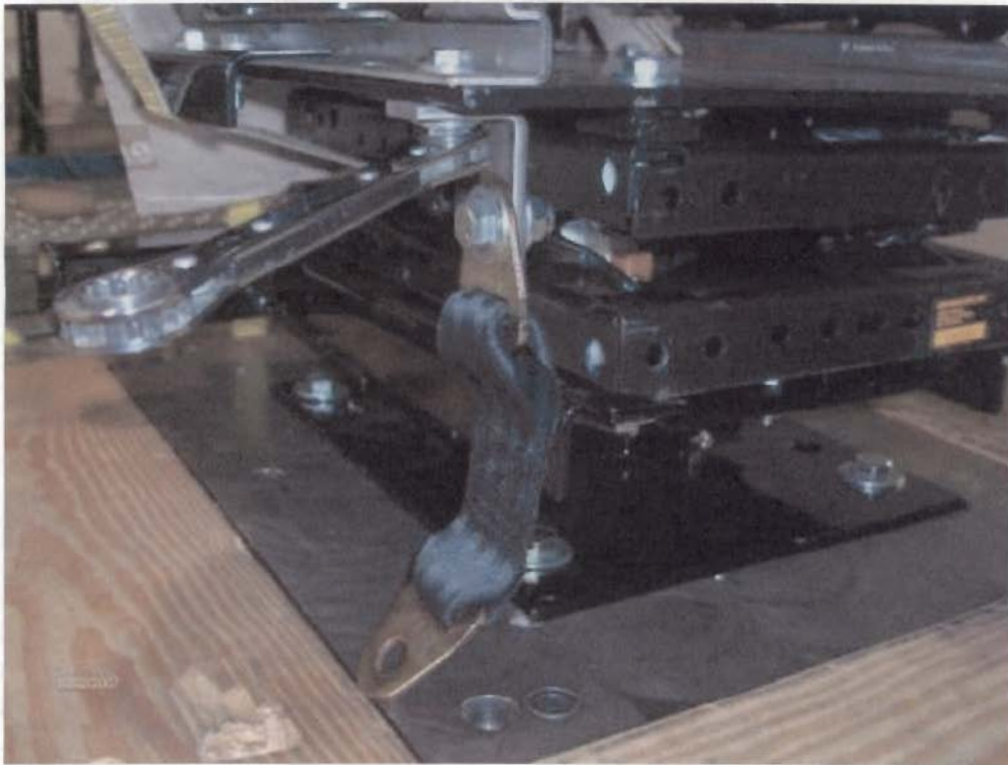
Remove the nut and washer from the top front bolt. Install the bracket, reinstall the washer and nut on the bolt. Long leg of the bracket faces to the inside.

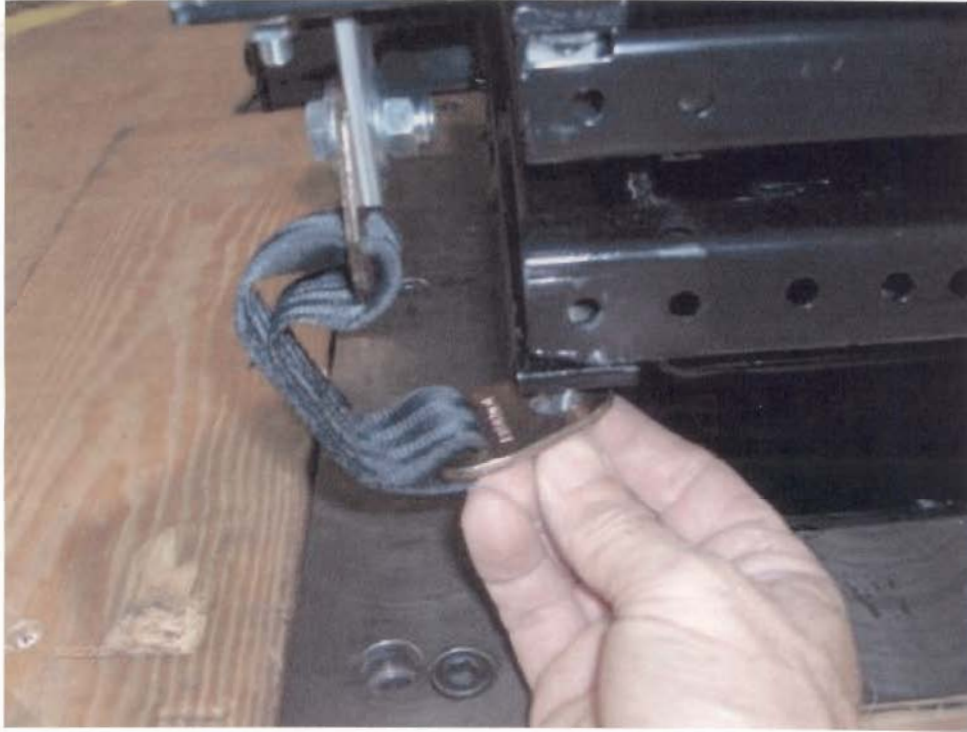
Remove the bolt and washer from the front of the riser and insert the tab from the tether

Reinstall bolt and washer with tether, and tighten. Install the tether on the opposite side of the seat in the same sequence.

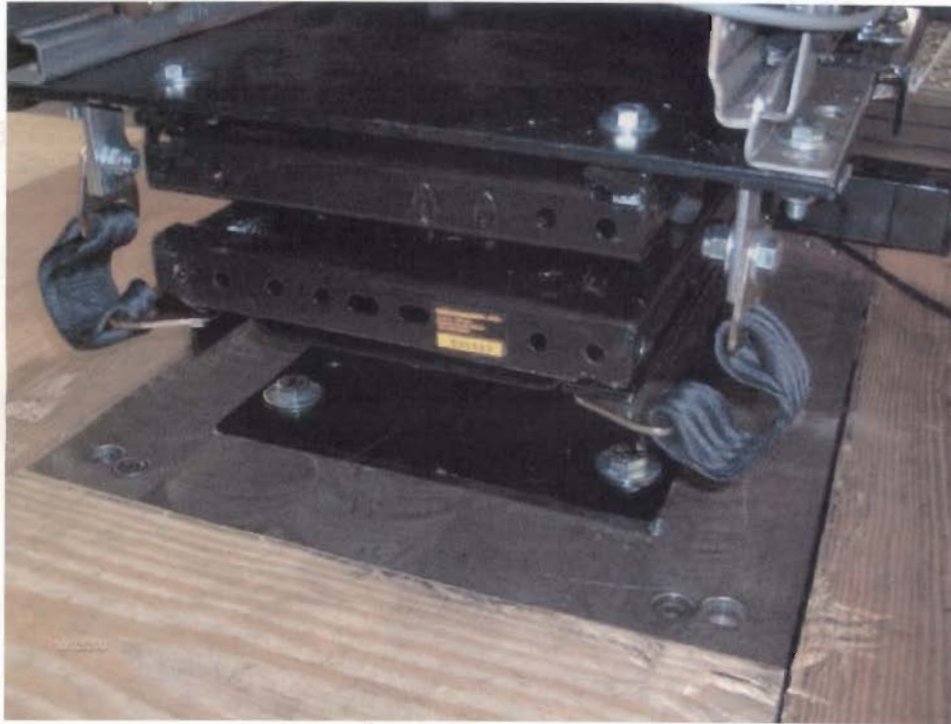
This is the completed installation

1. Bottom bolts tight
2. Bottom tether tab turned outward 90 degrees
3. Tethers to brackets bolts tight, nuts facing inward
4. Tether bracket mounted with the vertical leg to the inside
5. Top bolts tight.
