# COACHMEN RV GROUP

RE: Safety Recall 07V-483

Coachmen RV Company has decided that a defect which relates to motor vehicle safety exists in 2006 Aurora Motorhomes, model numbers 3180DS, 3480DS, 3580TS and 3650TS. These vehicles were manufactured at Coachmen RV's Middlebury, Indiana facility from November 9, 2005 through May 2, 2006.

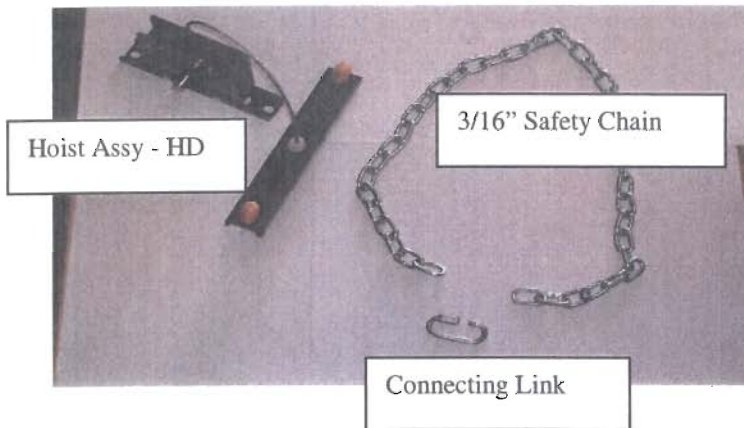
**Your Field Program Replacement Parts are:**

- Hoist Assembly, spare tire custom HD lift bar large wheel – 1 pc – #1160442
- Chain, 3/16" Proof Coil – 4ft - #7100892
- Chain, Link Connecting – 1pcs - #649550
- 1/4" Fender Washer – 1pc –
- 1/4" x 1-1/2" x 20 bolt 4 pcs -

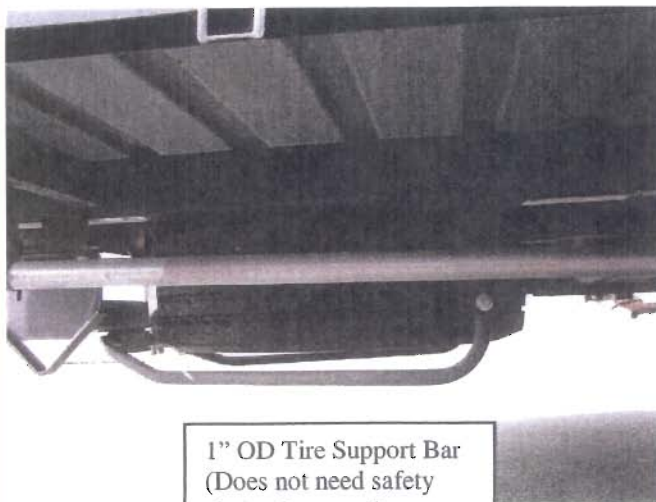
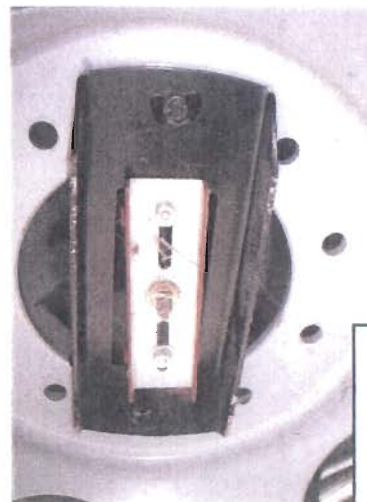
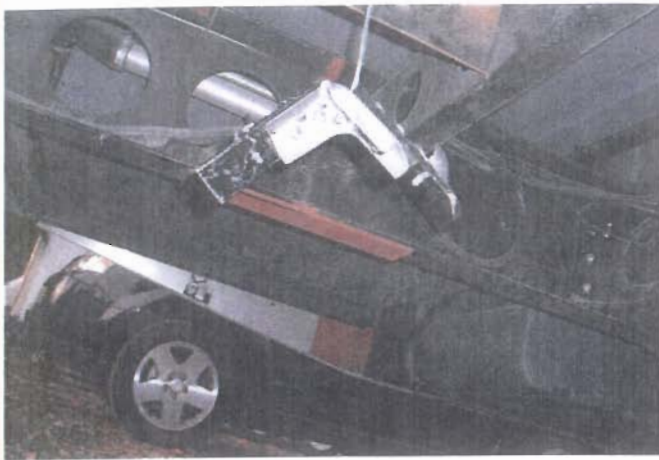
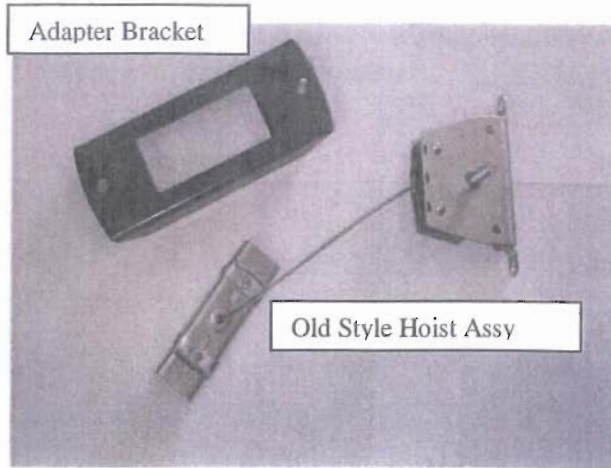
### **EXAMPLES OF SYSTEMS NEEDED TO BE REPLACED**

**BAD – MUST BE REPLACED WITH NEW WINCH ASSY & SAFETY CHAIN & CONNECTING LINK**  
 \*All system types ***must*** have the Hoist Assembly replaced and if no secondary safety device is provided, you must install the Safety Chain with Connecting Link. \*\* If your particular system is not shown, replace the Hoist & add Safety Chain or call the number at the end of this bulletin for assistance. \*\*

On affected vehicles, the spare tire carrier assembly mounted under the rear of the unit is the incorrect model to properly support the spare tire. As a result, the potential exists for the spare tire to become detached from the carrier assembly and fall to the road surface. Should the spare tire detach itself from the carrier while the vehicle is in motion, a crash may result. *Customers will be instructed to not operate affected vehicles without first removing the spare tire from the carrier assembly.*
