## SIMPLEX FIFTH WHEEL FIELD CAMPAIGN NOTIFICATION

This notification is to make you aware of a field campaign that SAF-HOLLAND is undertaking to replace a spacer in the lever bar connection that could affect the timing of the fifth wheel's lock mechanism. This is **NOT** a safety related issue as this condition is evident to the driver when visually inspecting the release handle and position of the red indicator in accordance with the proper coupling procedure.

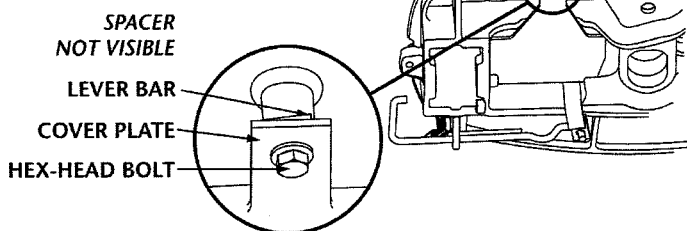
**FIGURE 1 – AFFECTED UNIT**

The Simplex fifth wheels that should be inspected were manufactured between January 3, 2006 and July 2, 2007. Visually inspect the cover plate/lever bar connection on the underside of the fifth wheel. The fifth wheel is **affected** if a hex-head fastener is used to secure the connection as shown in Figure 1. The fifth wheel is **unaffected** if a pin is used to secure the connection as shown in Figure 2.

**HEX-HEAD BOLT CONNECTION**

If you have a fifth wheel that matches the image in Figure 1, we strongly encourage you to contact us for a repair kit(s), free of charge, at (888) 396-6501 ext 4343. Be prepared to provide: serial number of the wheel, VIN # of the vehicle, date and service. If you have any questions concerning this notification, please ask for technical assistance when you contact us.

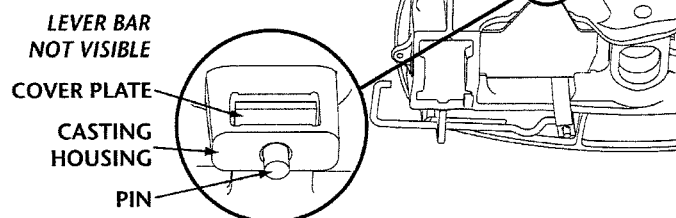
**FIGURE 2 – UNAFFECTED UNIT**

**PIN CONNECTION**
