File In Section: Product Recalls Bulletin No.: 08244A

### **PRODUCT SAFETY RECALL**

Transfer Case - Inspect / Replace SUBJECT:

**MODELS:** 2008 Chevrolet 1500 AWD Express

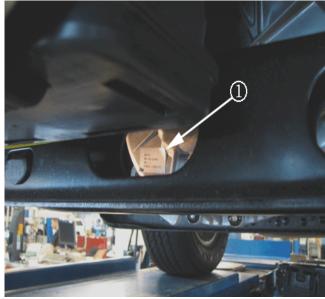
2170234

- Locate and inspect the transfer case date sticker. The transfer case date sticker is located on the back of the transfer case (1) near the left (driver side) front of the torsion bar mounting bracket.
  - 2.1. If the date code, located on the second line of the sticker, indicates **06/18/2008 or 06/20/2008**, continue to Step 3 and replace the transfer case.
  - 2.2. If the date code is **not** 06/18/2008 or 6/20/2008, the transfer case is okay. No further action is required.
- 3. If the inspection determines that a transfer case replacement is required, contact the Product Quality Center (PQC) and request a transfer case. The full 17-character VIN, the

date code from the transfer case date sticker, and the 08244 bulletin reference number will be required when ordering.

- 4. Refer to SI and replace the transfer case. All removed transfer cases should be held until a Warranty Parts Center (WPC) request for return is received. **DO NOT SHIP WITHOUT AN OFFICIAL WPC REQUEST.** If you do not receive a WPC Request, contact Annette Quince at 248-371-9939 (for French call the PQC at 1-866-654-7654).
- 5. Return the removed transfer case to the WPC following the procedures outlined in bulletin 99-00-89-019E, including the draining of fluids.
