**Subject: Safety Recall 26E5/R5
2001 and 2003-2005 Model Year Volkswagen Passat and Passat Wagon (5th Generation) Vehicles
Install Underbody Heat Shields and Inspect/Replace Certain Fuel System Components if Necessary, and
Service Action 66C8/P9
Service Air Plenum Area to Improve Drainage & Install Improved Pollen Filter Seal**

Safety Recall 26E5/R5

Service Action 66C8/P9

Customer Letter Example (U.S.A.) (Vehicles with only 26E5/R5) June 2008

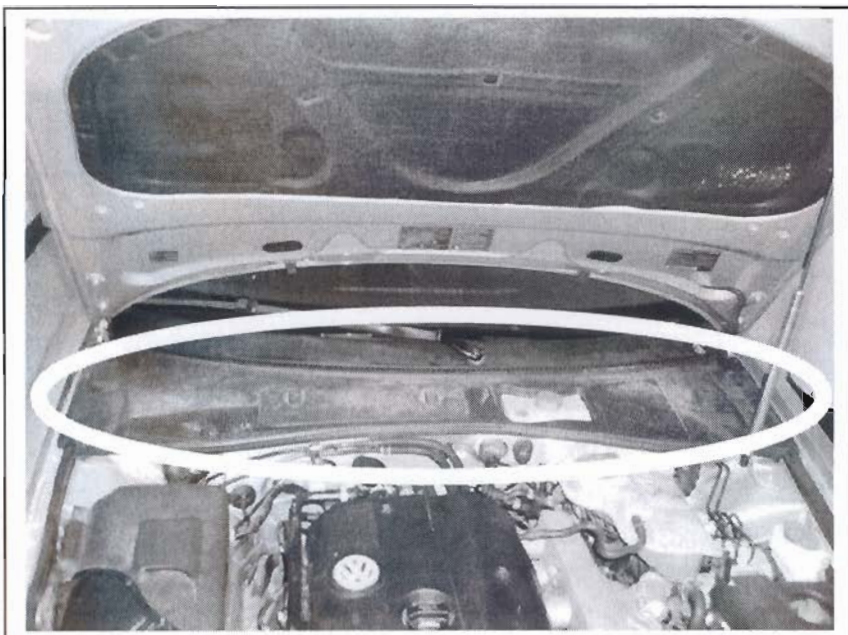
On some vehicles, moist debris might clog the air plenum drain area and water could leak into the passenger compartment. In order to prevent this condition, we will inspect, clean and modify the air plenum drain. We will also modify the sunroof drain (if equipped) and install an improved seal for the pollen filter on your vehicle.

To help ensure that the air plenum area remains clear in the future, we recommend regular inspection and, when necessary, cleaning of the air plenum area shown in the picture below. Please be sure to keep this letter with your owner's manual so it will be available for future reference.

Additionally, this condition can be prevented by ensuring that the air plenum area is maintained regularly to keep it clear of dirt and debris. This helps to avoid the water drain holes from becoming blocked, and it prevents water from entering the vehicle through the heating and ventilation ducts. Please refer to your owner's manual for additional information, including important warnings about working in and around the engine compartment and air plenum area.
