R08NC

**RECALL R08NC
INSPECTION SHEET**

RECALL

On some units, the rivet spacing may be incorrect in some segments of the rear roof sheet and rear roof cap joint, resulting in noncompliance with FMVSS 221, School Bus Body Joint Strength.

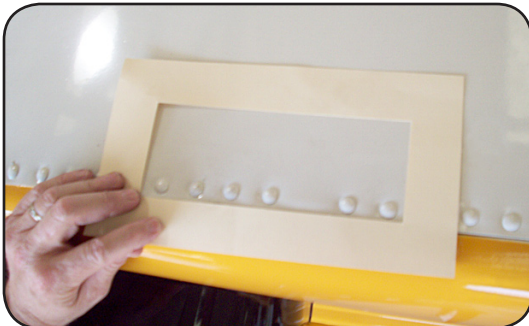
2.1 Place the template over the joint and parallel to the edge of the roof sheet, allowing roof rivets to be exposed through the opening in the template as shown.

2 Inspect rivet spacing at rear roof sheet and rear roof cap joint. Joint must have a minimum of six rivets in an eight inch segment.

2.2 Move the template from one side of the rear roof cap to the opposite side.

2.3 If a segment in the rear roof cap joint contains less than six rivets, additional rivets are required. Mark each area that requires additional rivets.

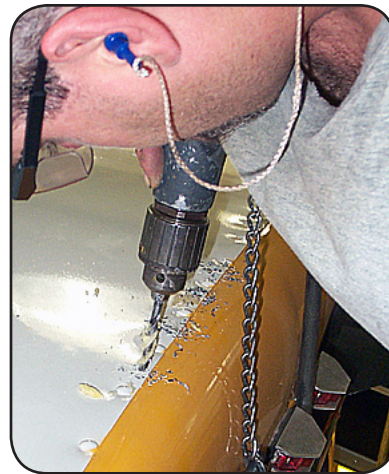
3 Install rivet/s at each mark. Using a short 17/64" drill bit, drill a hole through the roof cap, roof sheet, and rear bow flange. Be sure to drill hole on a common centerline with existing rivets.

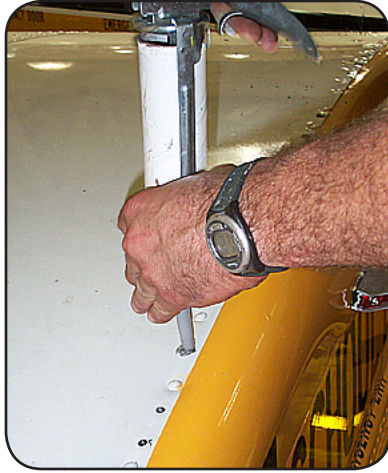
4 Place a small amount of Vinyl Gray 5522 Sealant (Blue Bird # 0898627) in each drilled hole.

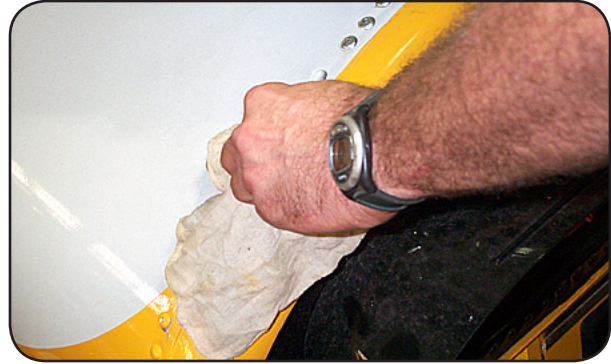
6 Clean up any sealant that may have squeezed out or smeared during rivet installation.

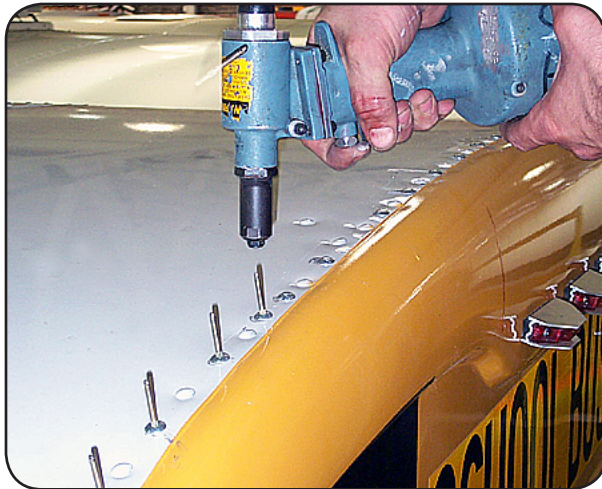
5 The supplied 1/4" blind rivets (Blue Bird # 1854397) are pre-painted white or school bus chrome yellow. Install a rivet of the appropriate color into each hole.

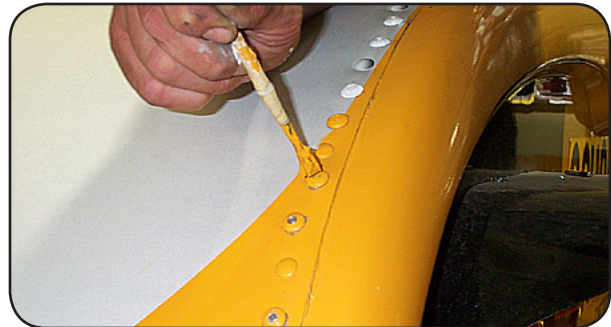
7 With the correct color paint, touch up the center of each blind rivet where the stem was removed during installation.
