**Safety Recall 66D1 (Q9)
2008 Model Year New Beetle Special Edition Triple White Sedan
Replace Roof Spoiler**

Safety Recall Circular

**Subject: 2008 New Beetle Special Edition Triple White Sedan
Replace Roof Spoiler**

Campaign Work Procedure

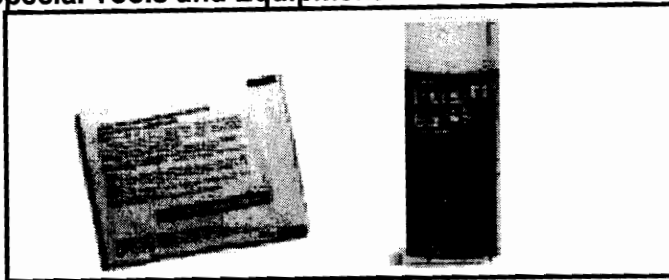
- Alcohol wipes
- Glass cleaner

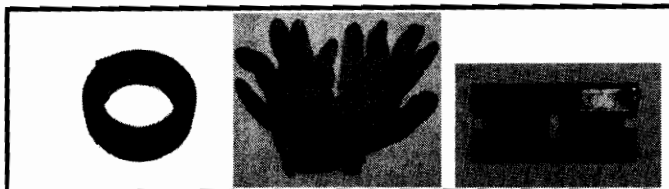
- Low adhesion tape
- Protective rubber gloves
- Single edge razor blade

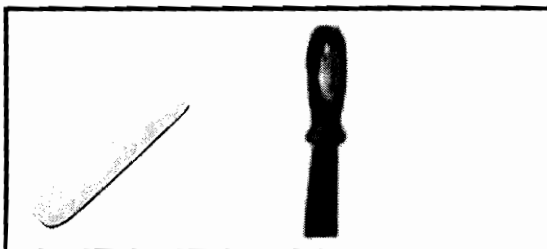
- Trim removal wedge 3409 or equivalent
- Gasket scraper (approx 4")

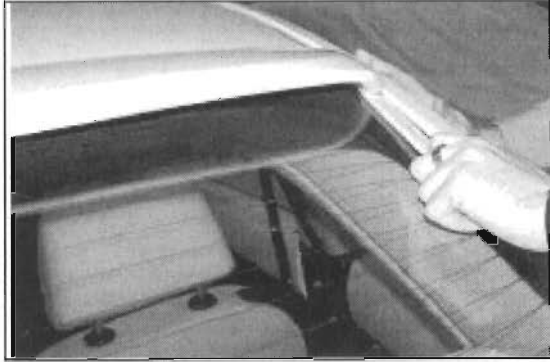
⚠ Note: DO NOT pull up on spoiler to remove it; doing so could result in damage to the rear glass

⇐ Carefully pry up on spoiler using wedge tool or equivalent and use gasket scraper to cut adhesive between spoiler and rear glass

• Once loose, remove spoiler from vehicle

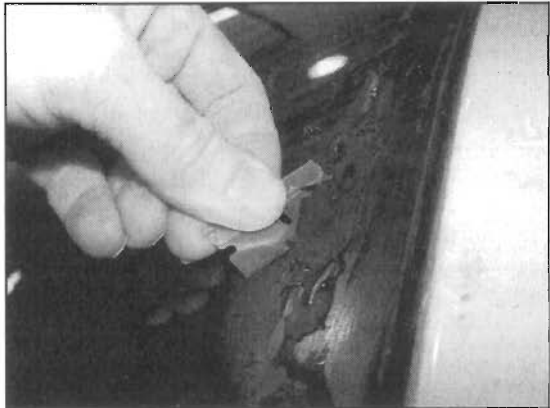
⇐ Using a razor blade, carefully scrape away any old adhesive and primer residue

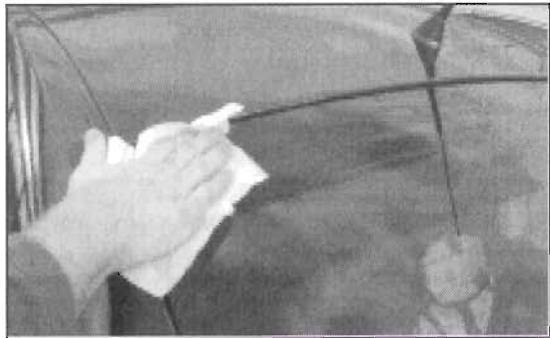
⇐ Clean area of window where spoiler will make contact with glass using isopropyl alcohol wipes – allow five minutes to dry

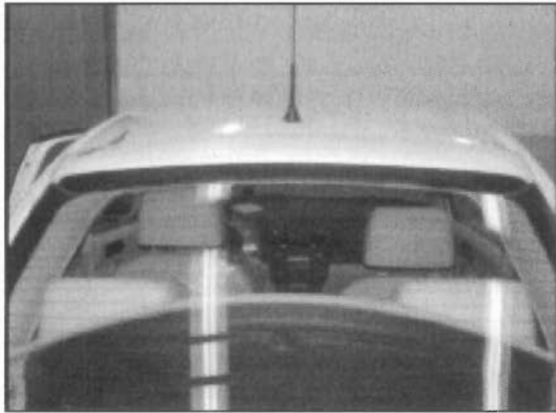
- ⇐ Remove spoiler from packaging and dry fit spoiler onto vehicle to ensure alignment of spoiler is not more than 1 mm from edge on each of the three sides

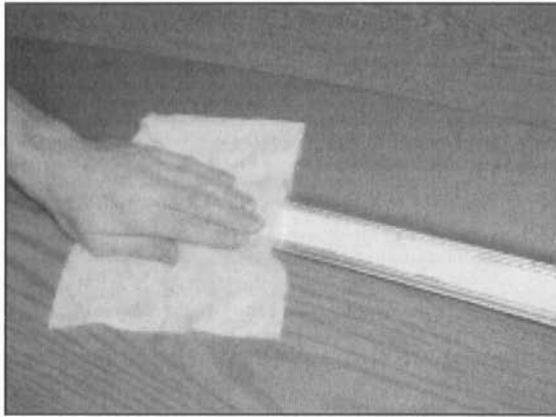
- ⇐ Clean adhesive surface on spoiler with isopropyl alcohol wipes – allow five minutes to dry

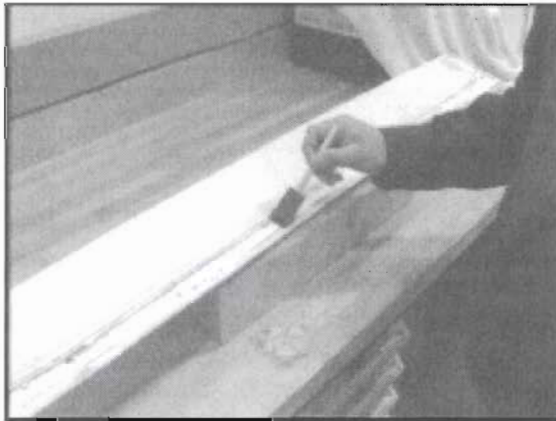
- ⇐ Using a foam applicator, apply primer (Betaseal 5404A) to adhesive channel on spoiler only
- Allow primer to dry for five minutes

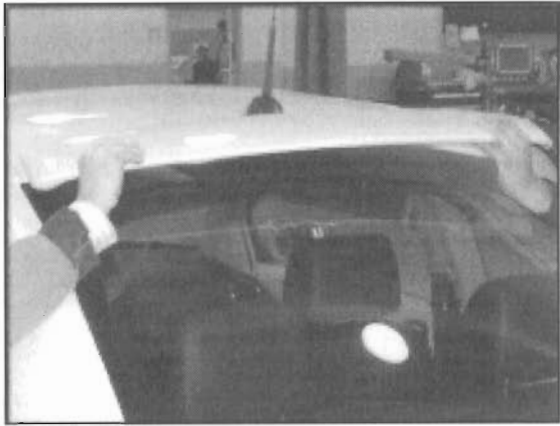
⇐ Using two people, attach spoiler to glass surface

⚠ Note: Be sure to align spoiler lip with front edge of glass first, then align with sides of the glass

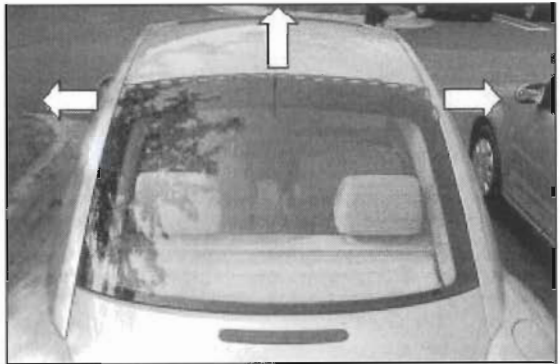
⇐ Ensure alignment of spoiler is not more than 1 mm from edge on each of the three sides

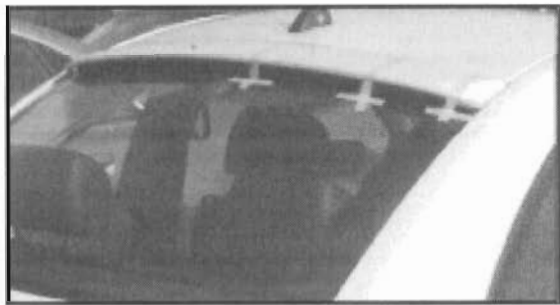
⇐ After spoiler is in place, apply tape in "T"-shape (as shown) across complete length of spoiler to secure spoiler while adhesive dries

- Allow adhesive to dry for three hours before removing tape
- After adhesive has dried, remove tape, clean off any excess adhesive using appropriate glass cleaner and single edge razor blade, if necessary
