**Subject: Recall Campaigns 07V-063 (N400/N4) and 08V-036(66D1/Q9)**

# Safety Recall Circular

**Subject: 2008 New Beetle Special Edition Triple White Sedan  
Replace Roof Spoiler**

**REVISED**

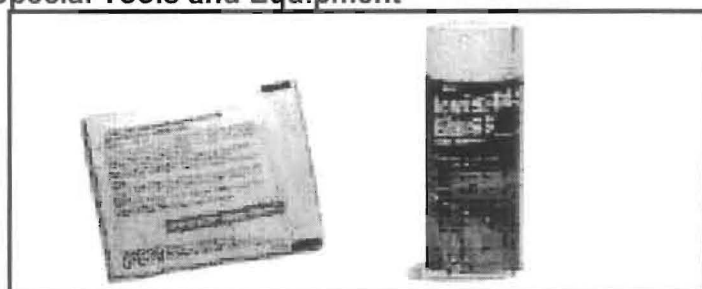
- Alcohol wipes
- Glass cleaner

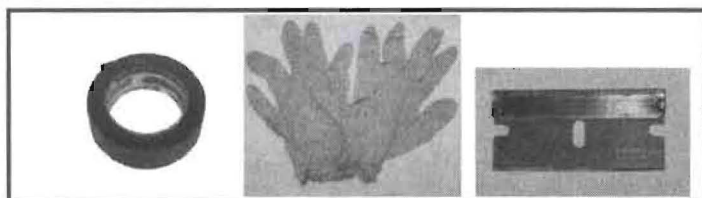
- Low adhesion tape
- Protective rubber gloves
- Single edge razor blade

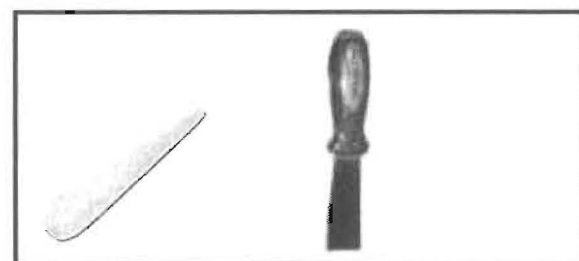
- Trim removal wedge 3409 or equivalent
- Gasket scraper (approx 4")

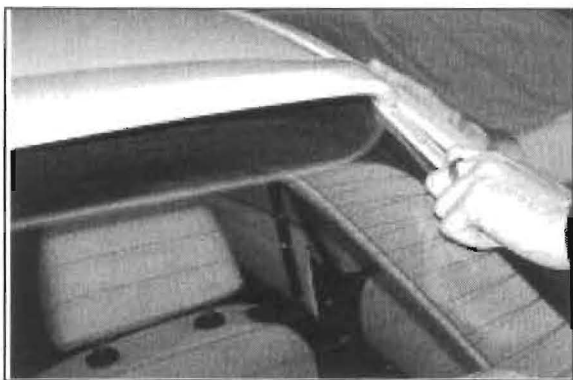
- ⇐ Carefully pry up on spoiler using wedge tool or equivalent and use gasket scraper to cut adhesive between spoiler and rear glass
- Once loose, remove spoiler from vehicle

Note: **DO NOT** pull up on spoiler to remove it; doing so could result in damage to the rear glass

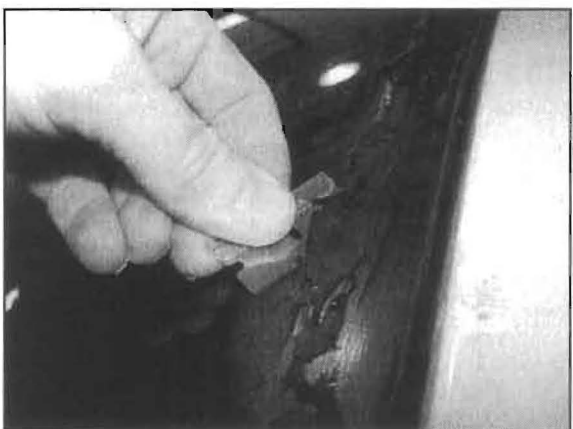
- ⇐ Using a razor blade, carefully scrape away any old adhesive and primer residue

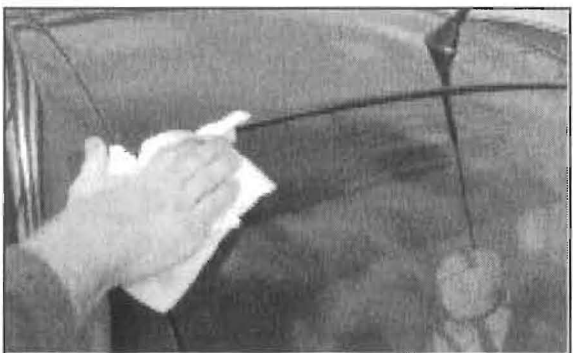
- ⇐ Clean area of window where spoiler will make contact with glass using isopropyl alcohol wipes – allow five minutes to dry

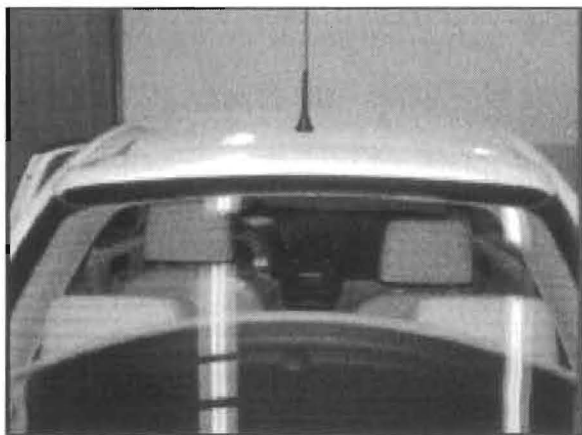
- ⇐ Remove spoiler from packaging and dry fit spoiler onto vehicle to ensure alignment of spoiler is not more than 1 mm from edge on each of the three sides

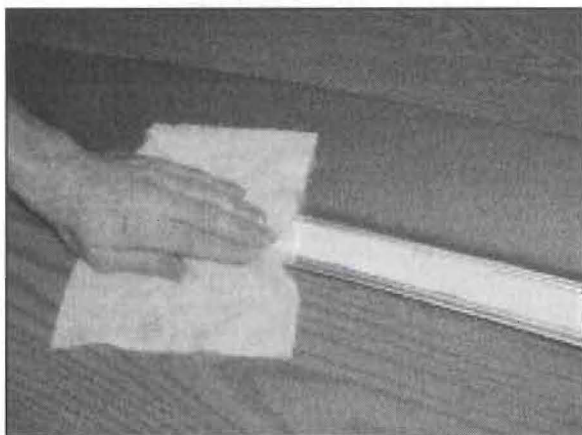
- ⇐ Clean adhesive surface on spoiler with isopropyl alcohol wipes – allow five minutes to dry

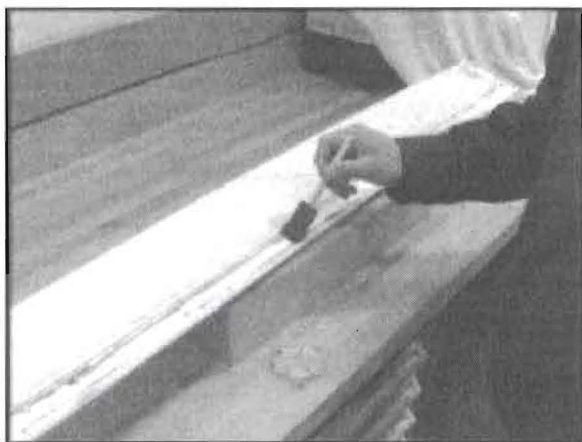
- ⇐ Using a foam applicator, apply primer (Betaseal 5404A) to adhesive channel on spoiler only
- Allow primer to dry for five minutes

- ⇐ Apply Betaseal U-418HV adhesive to outer edge of spoiler mounting surface only

**Note:** Apply adhesive to outer edge of mounting surface only. **DO NOT** apply a single cord of adhesive to the middle of spoiler surface

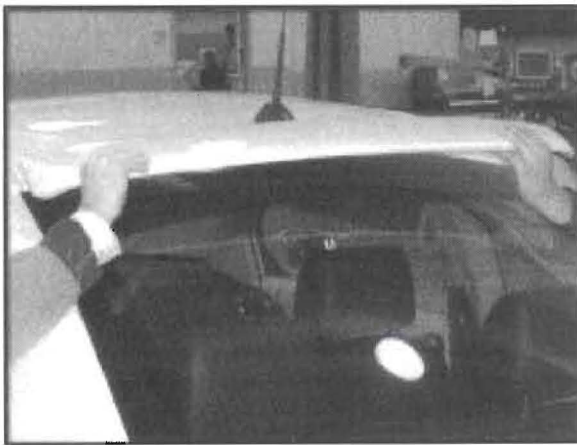
⇐ Using two people, attach spoiler to glass surface

Note: Be sure to align spoiler lip with front edge of glass first, then align with sides of the glass

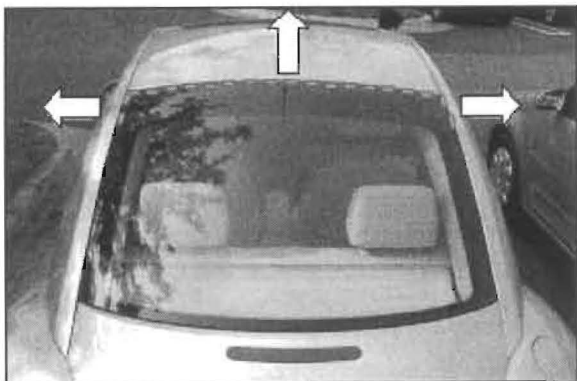
⇐ Ensure alignment of spoiler is not more than 1 mm from edge on each of the three sides

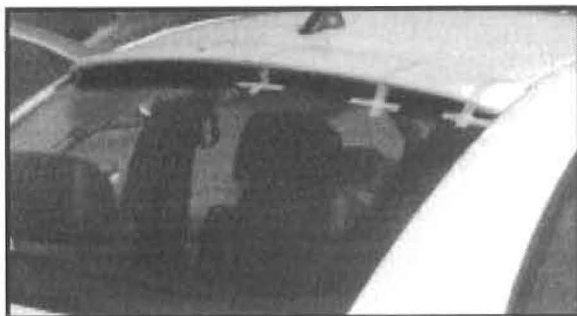
⇐ After spoiler is in place, apply tape in "T"-shape (as shown) across complete length of spoiler to secure spoiler while adhesive dries

- Allow adhesive to dry for three hours before removing tape
- After adhesive has dried, remove tape, clean off any excess adhesive using appropriate glass cleaner and single edge razor blade, if necessary
