Subject: Recall Campaign 70D1/JX (08V-064)

**Subject: Safety Recall JX / 70D1
2008 Model Year Audi TT Coupe
Replace C-Pillar Trim Cover Clip**

**Subject: 2008 MY Audi TT Coupe
Replace C-Pillar Trim Cover Clip**

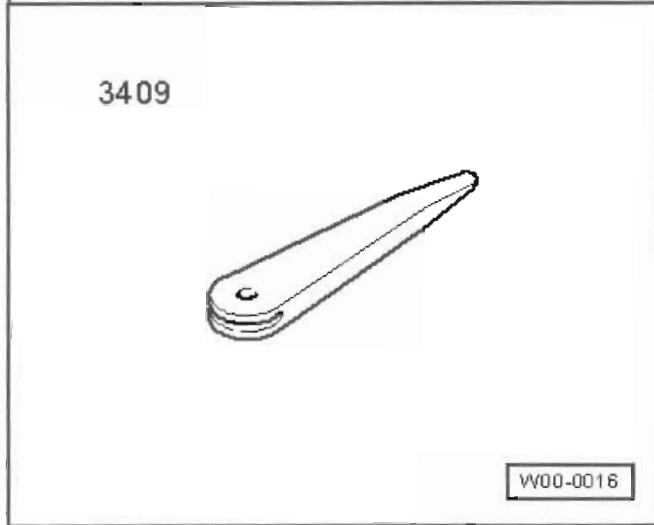
⇐ Trim Removal Wedge -3409-

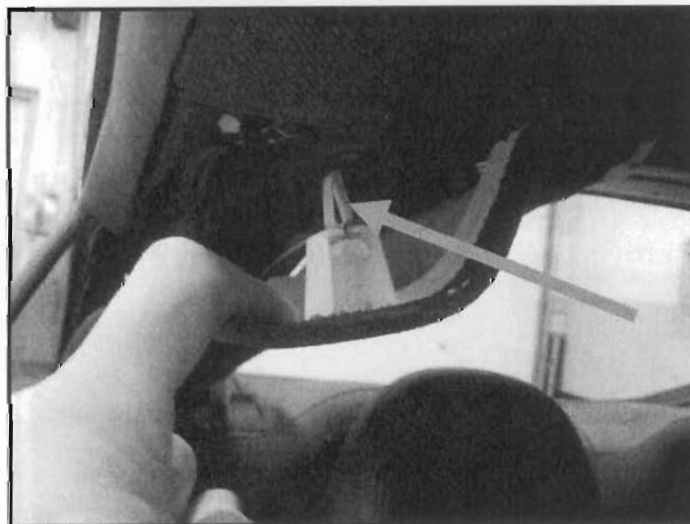
Audi has decided that certain model year 2008 Audi TT Coupe vehicles were produced with C-pillar trim cover clips that do not provide adequate retention. In the event of a deployment of the rear pyrotechnic safety belt, the C-pillar trim cover may become detached from the sheet metal due to low retention force of the trim clip. The detached trim cover could pose a risk of personal injury for vehicle front seat occupants.

- ⇐ Remove clip at front of right side C-pillar trim and discard. Install new clip (8P0 867 276 B) on right side C-pillar trim
- Repeat removal of clip on left side C-pillar trim
